Property Inspection Report

10006 Sample House Place
Silver Spring, Maryland 20901

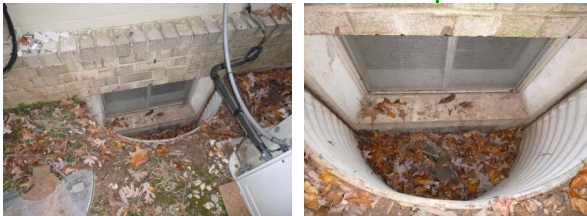
6. ☐ ☒ ☐ ☐ Basement Window Well * Recommend installing a new plastic window well cover on the rear basement window well to prevent water collecting in the bottom of the well.

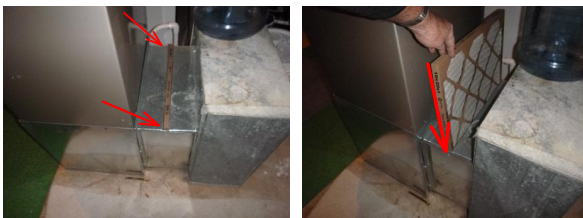
7. ☐ ☒ ☐ ☐ Blower Fan, Filter: Direct drive with disposable filter Install a metal reusable and removable furnace filter cover.

Recommend having a licensed HVAC contractor clean the interior coils in the basement air handler for improved efficiency and air quality.

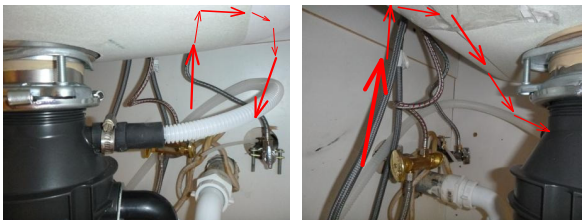
2. ☒ ☐ ☐ ☐ Ventilator: Not vented to the exterior. Install two light bulbs in the hood fan.
 3. ☒ ☐ ☐ ☐ Kitchen Sink:
 4. ☒ ☐ ☐ ☐ Garbage Disposal:
 5. ☐ ☒ ☐ ☐ Dishwasher: Loop the dishwasher drain hose up to the bottom of the counter top and secure it there to prevent dirty sink water from draining down the hose from the disposal and into the dishwasher.

Properly secure the dishwasher to the countertop or base cabinets.

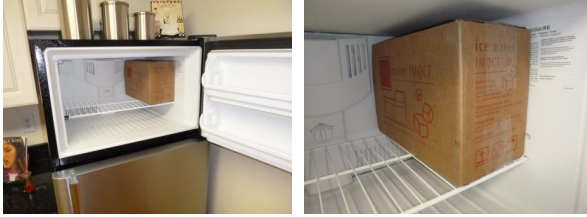
8. ☐ ☒ ☐ ☐ Refrigerator: Install the refrigerator ice maker.

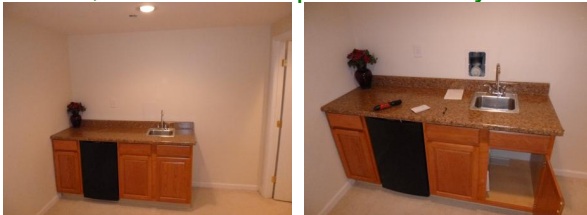
10. ☐ ☒ ☐ ☐ Bar Sink: The hot and cold water supply lines are reversed at the basement wet bar sink faucet, correct for improved safety.

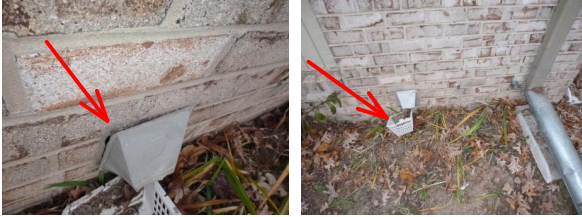
5. ☐ ☒ ☐ ☐ Dryer Vent: Remove the cage over the front dryer vent wall cap to prevent lint from catching and clogging the cage.

Seal the dryer vent wall cap to the brick.

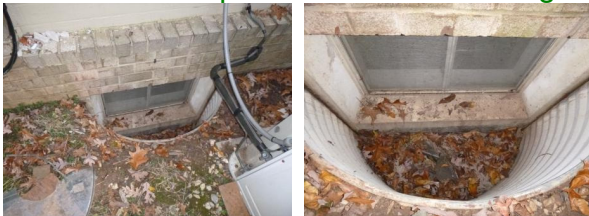
3. Basement Window Well * Recommend installing a new plastic window well cover on the rear basement window well to prevent water collecting in the bottom of the well.

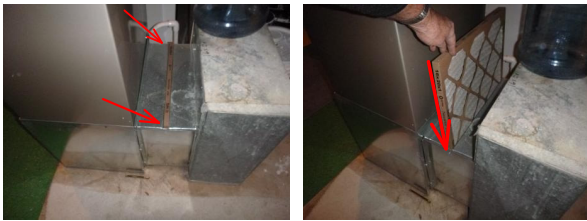
8. Basement utility room Heating System Blower Fan, Filter: **Direct drive with disposable filter Install a metal reusable and removable furnace filter cover.**

Recommend having a licensed HVAC contractor clean the interior coils in the basement air handler for improved efficiency and air quality.

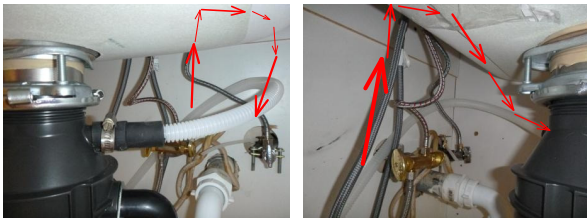
14. Kitchen Dishwasher: Loop the dishwasher drain hose up to the bottom of the counter top and secure it there to prevent dirty sink water from draining down the hose from the disposal and into the dishwasher.

Properly secure the dishwasher to the countertop or base cabinets.

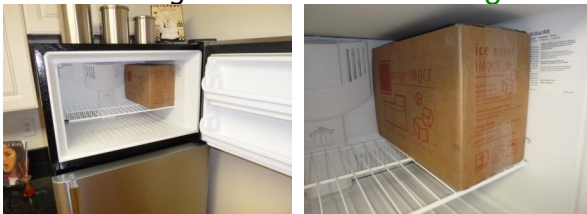
17. Kitchen Refrigerator: Install the refrigerator ice maker.

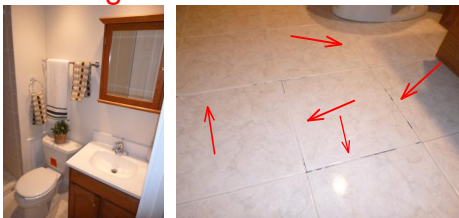
3. Bathroom Walls, Ceiling, Floor: * Re install the 8 to 10 loose ceramic floor tiles in the master bathroom and re grout the floor.
