White Pine Tree Assessment

Prepared for:
Mrs. Lois Lane
60 Wehee Ln.
Gotham, NY

Prepared by:
Howard Gaffin
MCA #1468
BCMA # NE-0363B
RCA #458

August 13, 2012

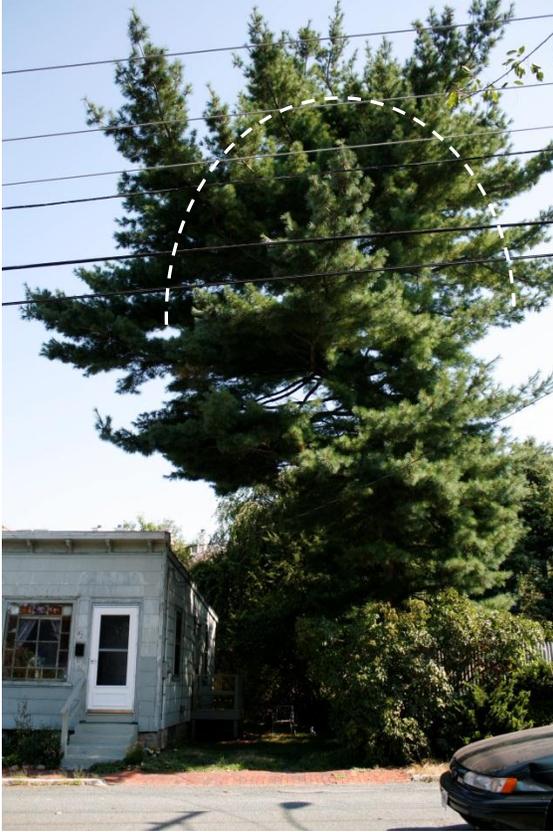
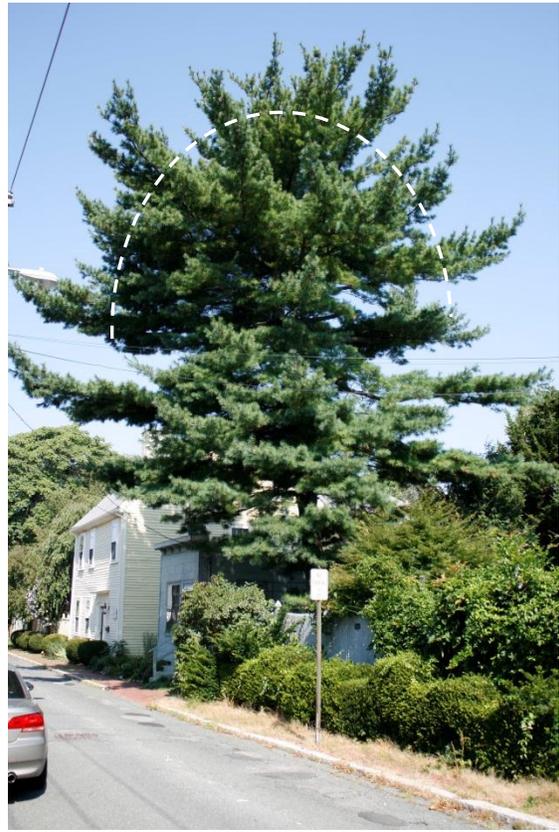
Photos 1&2

This large White Pine (*Pinus Strobus*) has a dbh (diameter at breast height) of approximately 24 inches, a height of 50 feet and an average crown spread of about 35 feet (see photos 1&2, pg. 6).

The area around the root zone is undisturbed, and the **root collar**¹ appears sound. The trunk is healthy with few visible signs of defects on the lower portions. The tree is single stemmed, with a healthy **live crown ratio**² of about 80 percent. Branch attachments are good. Limbs have been removed, broken, or pruned back on the lower portion of the tree. The upper limbs are exceptionally long. All of the limbs to the west are growing over the property line. Many are growing directly over the house.

While this particular pine benefits both properties by providing shade, screening, aesthetics, and wildlife habitat, the negative aspects to the Farmer property cannot be denied. The tree trunk is located primarily on the neighboring property, but the upper crown overwhelms the Farmer house and parking area. In the spring, large masses of pollen are produced, coating everything with a yellow dust. In the fall, annual needle drop occurs. Sap frequently drips from the above foliage due to twig and branch breakage or insect activity. While the former slights may be construed as an inconvenience, the threat of branch breakage due to the excessively long limbs is a safety and liability issue.

Views from the south and east. The large white pine overwhelms the small house. Many large excessively long limbs overhang the house and property. The dotted white lines indicate the suggested outline of the crown after a reduction pruning.

The longest limbs should be reduced by a third or more, depending on the size of cut required and the amount of live growth remaining. Cuts should not be more than 3 inches in diameter, and close to existing lateral branches not less than one third the size of the branch being removed. Pruning should be continued on a 3 to 5 year cycle (see photo #1&2, pg.6).

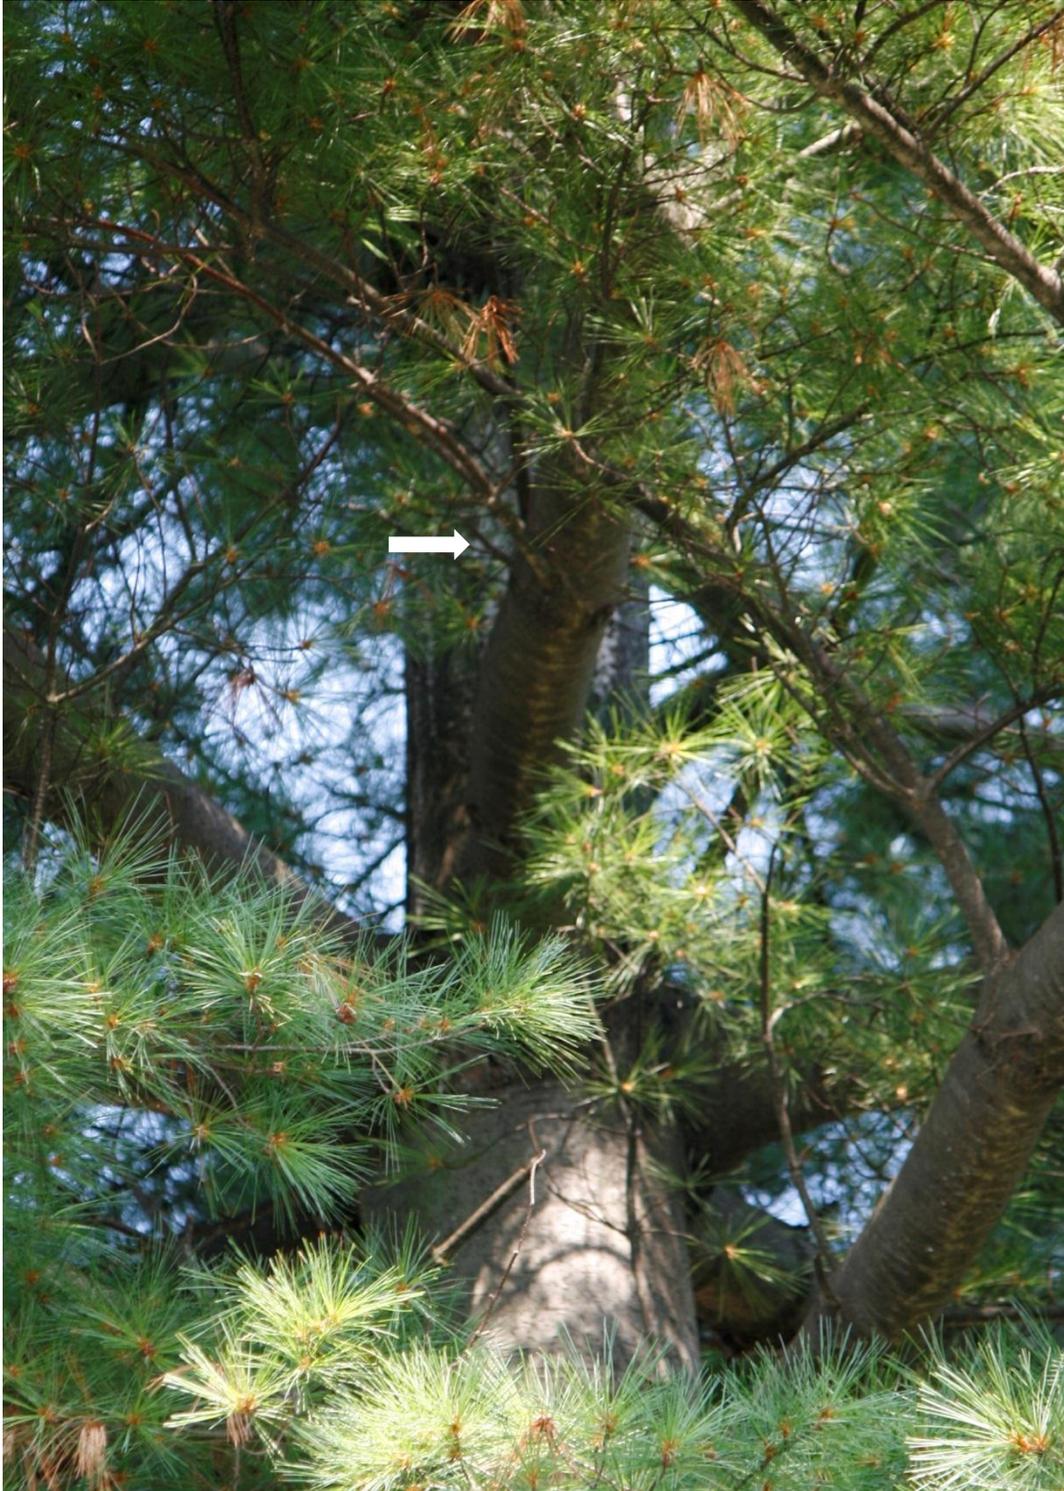
Photo 3

At about 25 feet, the main trunk makes a bend toward the west. I was not able to get a good view of the area. I also noted some sap flow on the trunk and an area of possible stem cankers above the bend on the east side of the tree (photo 3, pg. 7).

The area where the trunk bends should be investigated further for possible defects. The area of sap flow and possible canker formation on the upper trunk may be signs of White pine blister rust and needs closer examination.

The white areas on the trunk (arrow) indicate sap flow, either from wounds or stem cankers, a possible sign of White pine blister rust
