H. Gaffin  
*Consulting Arborist*

## Hemlock Hedge Appraisal

Prepared for:  
Mr. Jack Shea  
221 Conant Road  
Hooterville, MA

Sept. 27, 2011

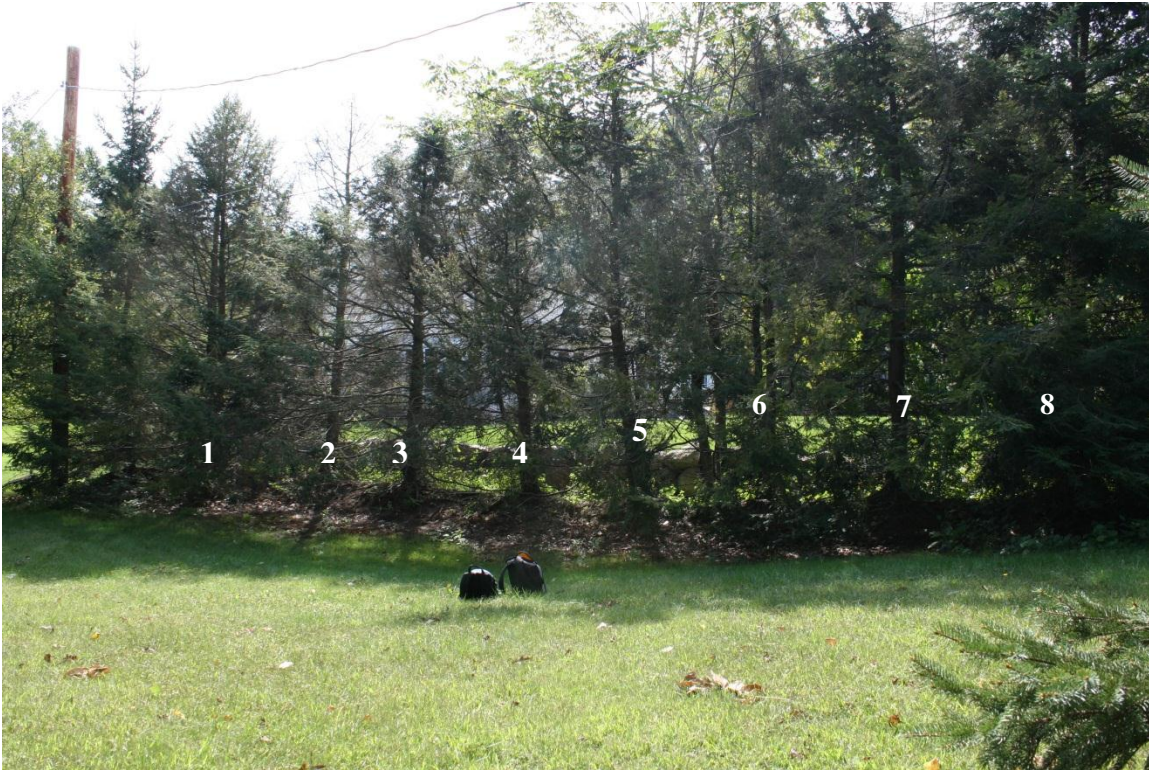
## Photo 1 – Hemlock hedge

I arrived at the site on September 5, at 10:00 am. The eight trees in question are located along the southern property line (see site map, pg.7 and photo #1, pg.8). The site is sloped downward from the west. The majority of the trees sit in a low laying area. They have an average height of 23 feet, and range from 7 to 9 inch dbh (diameter at breast height).

All the trees are planted on a raised berm, approximately two feet in height. Tree number 8, located furthest to the west, appears to be in good health. Numbers 2 and 4 are dead,

and the remaining five are in varying states of decline. A 4-foot high retaining wall is located 7 feet from the base of the trees.

Except for tree number 8, there is little to no vigor evident in the current twigs and shoots of the remaining live trees. Tip dieback is evident throughout the crowns. The buds appear small and dry. Needles are yellowish, stunted, and falling from the tree. Although some hemlock woolly adelgid was present, there is little other evidence of insect or disease issues.

*The view from the Shea property*

- Plant trees above grade, using quality fill soil with good drainage qualities, high in organic matter.
- Spread composted wood chips to a depth of 4” throughout the planting area.
- Careful attention should be paid to grading for proper drainage away from the planting site.
- Install a soaker hose system for easy and efficient watering.
- Trees will likely need to be guyed for 2 to 3 years.
- A qualified professional should be contracted to plant the trees in accordance with ANSI 300 standards for tree planting.

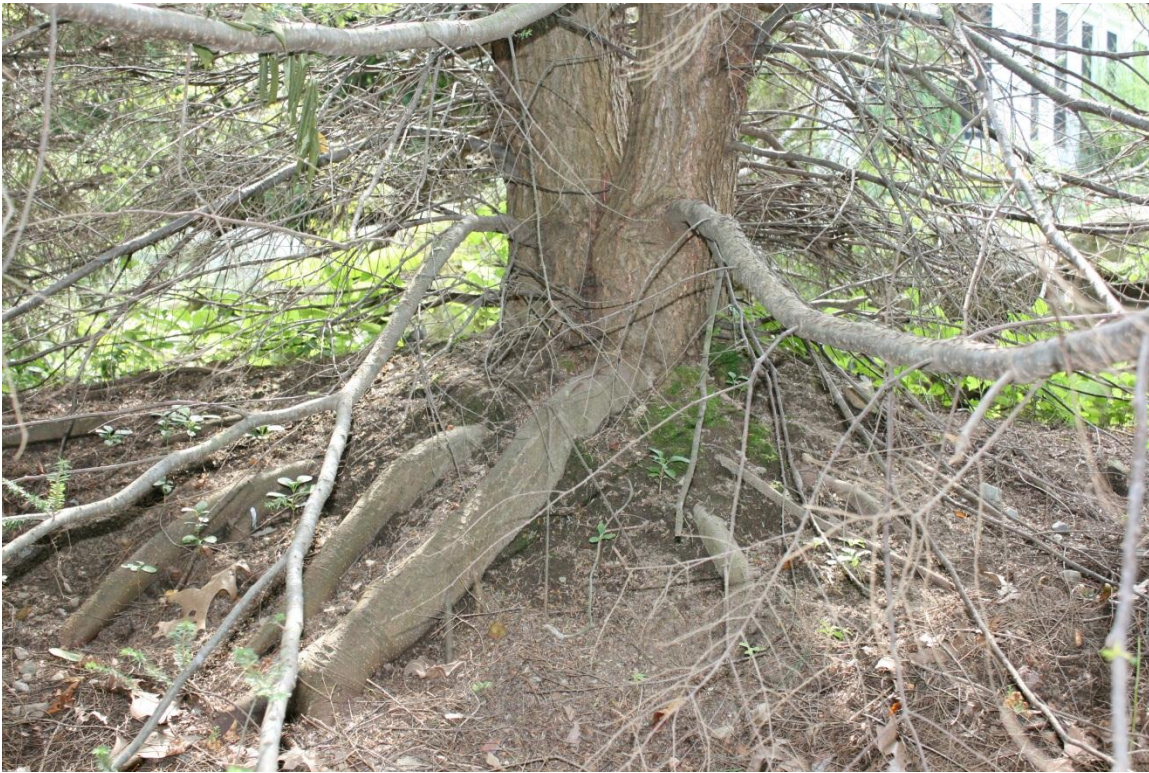
## Photo 2 – Roots

Inspection of the root zone revealed exposed roots all along the berm with evidence of erosion (photo #2, pg.9). Root anchorage still appears good, with minimal numbers of kinked or girdling roots observed. Some roots appear to have mechanical damage. The bark and trunks appear sound. No cavities, cracks, or unusual formations were noted. Branch attachments and distribution are good. No visible wounding was noted. Trees numbered 1 and 6 are composed of two stems arising from the trunk.

*The trees were planted on a raised bed to adjust for existing wet conditions. Root anchorage is still good, but exposure of large and fine roots indicates ongoing erosion.*

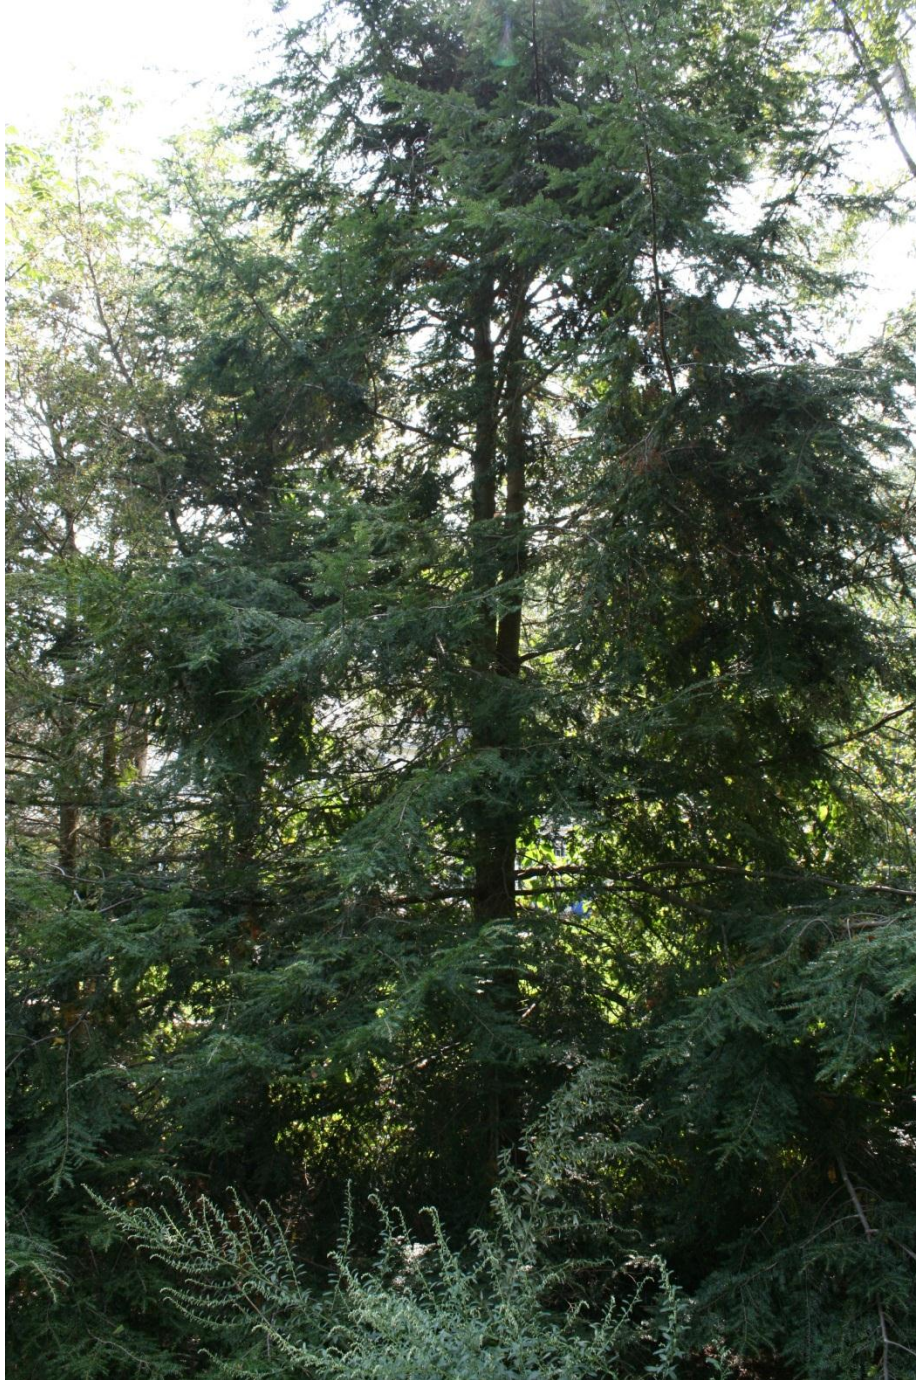
**Photo 3 – Tree # 8**

Tree number 8 (photo #3, pg.10) exhibits average vigor. Root anchorage is good, with less erosion evident than the other trees. The trunk splits into 2 leaders at approximately 10 feet. No cavities, wounding, or unusual features were noted along the trunk.

*Hemlock number eight as viewed from Mr. Sheas'. This tree sits on higher ground and likely exemplifies the pre-construction state of the other trees. The branching is somewhat sparse, but is normal for shady conditions.*

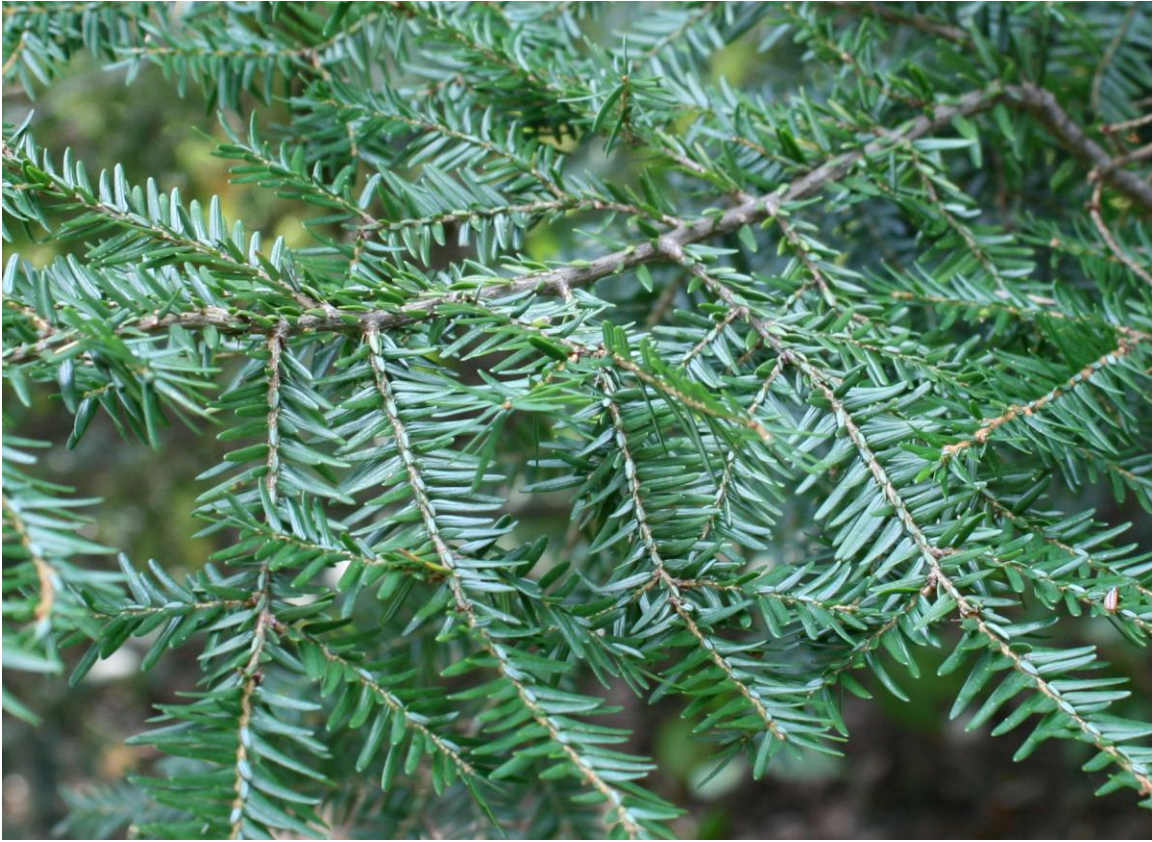
## Photo 4 - Foliage

Branching is somewhat sparse. Foliage is of normal size and good color (photo #4, pg.11).

*Foliage of tree number 8 appears of normal size and color.*
