Red Maple Assessment

Prepared for:
Mr. Joe Guy
56 Cable Rd.
Burg, NH

Prepared by:
Howard Gaffin
MCA #1468
BCMA # NE-0363B
RCA #458

May 29, 2012

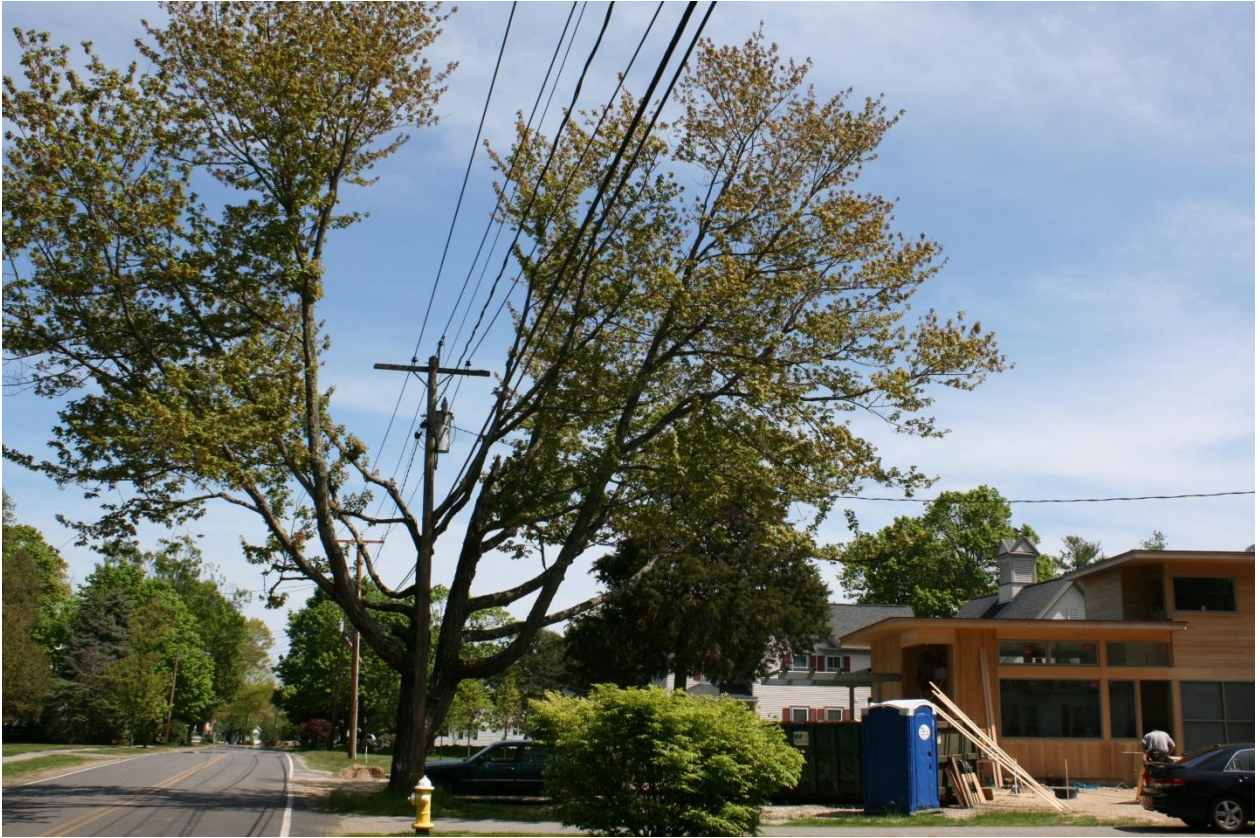
Photo 1

I arrived at the site on 59 Cable Rd., Burg, NH on May 18, 2012. The Red maple (*Acer rubrum*) is located on the south side of Cable St., a few feet from the road. A private drive is located about 6 feet to the west. A utility pole is located between the tree and the private drive. New construction surrounds the previously undisturbed root zone. A new utility trench runs from the pole to the northwest corner of the new house. Vehicle parking and traffic impact the area to the east. A dumpster and port-o-potty are located to the southeast (see site map, pg. 3 and photo 1, pg. 4).

crown. Large lateral limbs, excessive in size in relation to the main trunk, extend well into Cable Rd. to the north and toward the house to the south. One of the utility lines rubs against the northern scaffold.

Utility lines run directly through the center of the tree. Two major scaffold limbs, heavily cantilevered toward the house and over the street, arise from a poor structure (see photo 4, pg.6). Lateral limbs are excessive in size in relation to the main trunk.

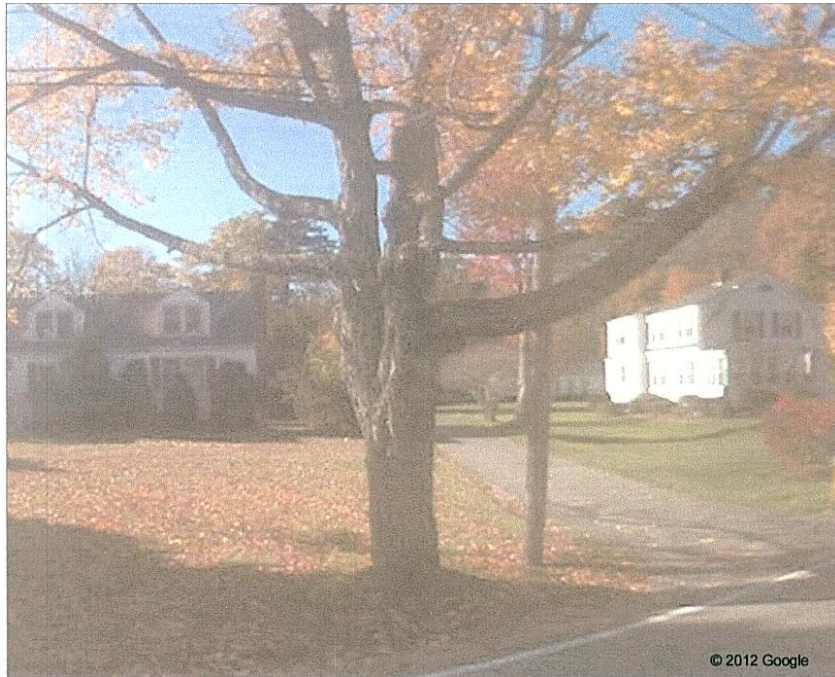
Photos 2 and 3

The tree on site, pre-construction

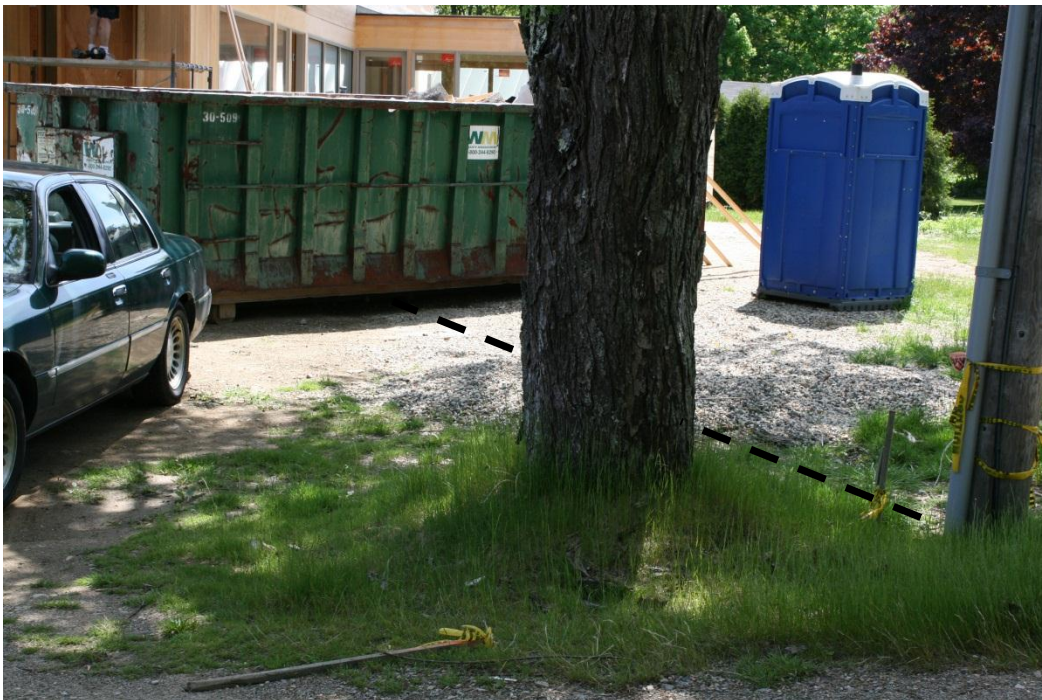
The root collar (the flared area at the tree trunk base where the roots and trunk converge) appears undisturbed and fairly solid. The area around the trunk and much of the root zone has been disturbed and compacted (see photos 2 and 3, pg. 5).

Another big concern with this tree is the impact of a utility trench and compaction from construction. As there was no root protection zone established, most of this trees supporting root system was severely impacted. Given its pre-construction condition, I believe a downward spiral to be imminent.

As no tree protection zone was established, the roots have been severely impacted by construction. The line indicates direction of utility trench.

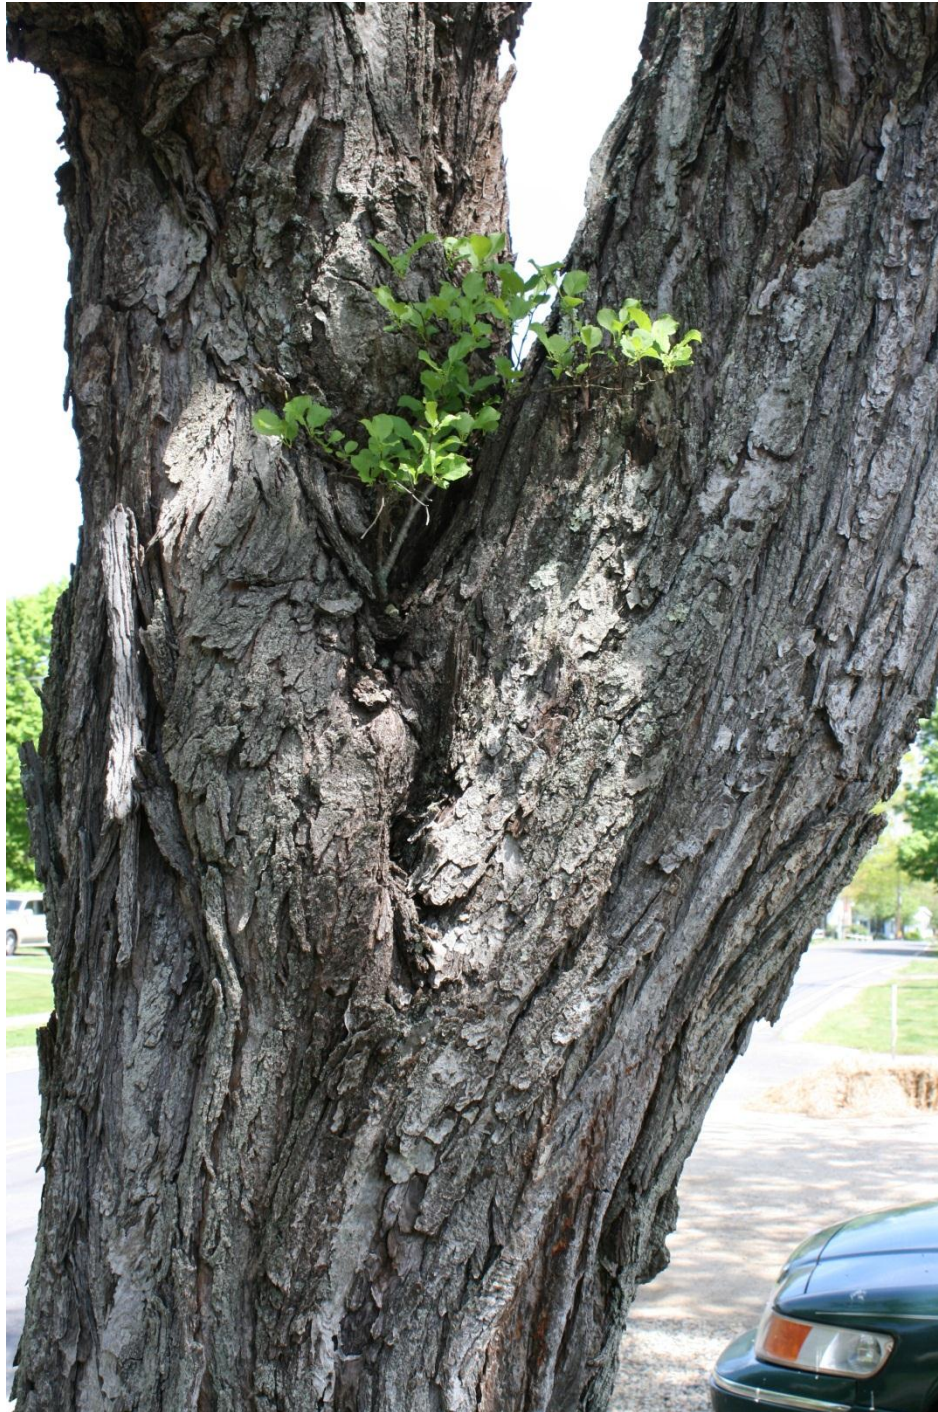
Photo 4

The trunk divides into two main leaders at about 4 feet, where there is evidence of decay and included bark (bark that becomes imbedded in a crotch between a tree branch and trunk or between co-dominant stems; causing a weak structure (see photo 4, pg. 6).

The structure of the tree raises many concerns. The area of included bark, in close proximity to areas of suspected decay, supports two heavily cantilevered main scaffold limbs. These scaffolds give rise to limbs excessively large in relation to their attachment points. The main central leader is in poor condition. Many of the major limbs have poor taper, with little or no inner growth. Most of the live growth is located at the end of the limbs. All these factors increase the likelihood of limb failure, especially in extreme weather events.

Area of included bark at the junction of the two main scaffold limbs
