Anytown Farms Tree Risk Assessment

Prepared for:
Anytown Farms Homeowners Association
PO Box 222
Anytown, MA 03833

Prepared by:
Howard Gaffin
MCA #1468
BCMA # NE-0363B
RCA #458

September 2, 2010

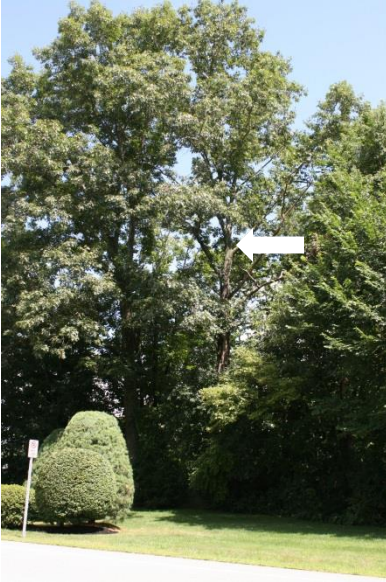
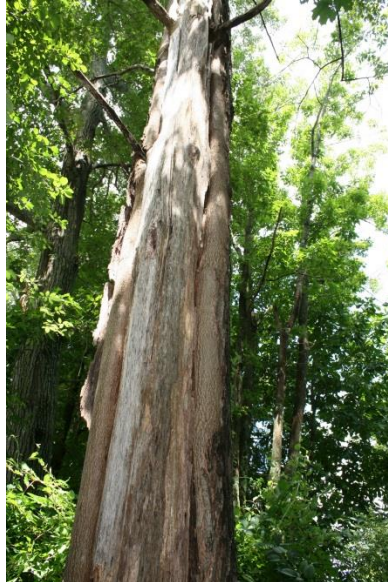
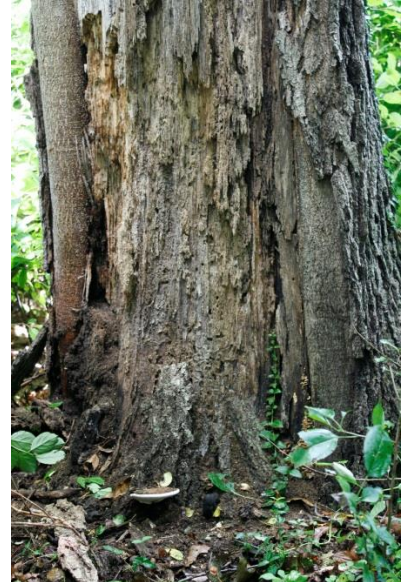
Tree: 1, Red Oak, 26" dbh

Likelihood of Failure: Probable

Observations: This large Red oak exhibits a large open wound with exposed, decaying wood running from the base of the tree to about 25 feet up the trunk. The wound is approximately one third the circumference of the tree at the base. *ganoderma applanatum* and *xylaria polymorpha* fungi are evident. While *xylaria* is not a serious threat, *ganoderma* indicates serious pending decay that can cause both root and butt rot. Sounding with a mallet indicates a thin shell wall. The foliage appears to be fair in color and density. Impact to Rt. 27 is a possibility should a failure take place.

Recommendations and Risk Abatement Options: No abatement options are applicable for this tree.

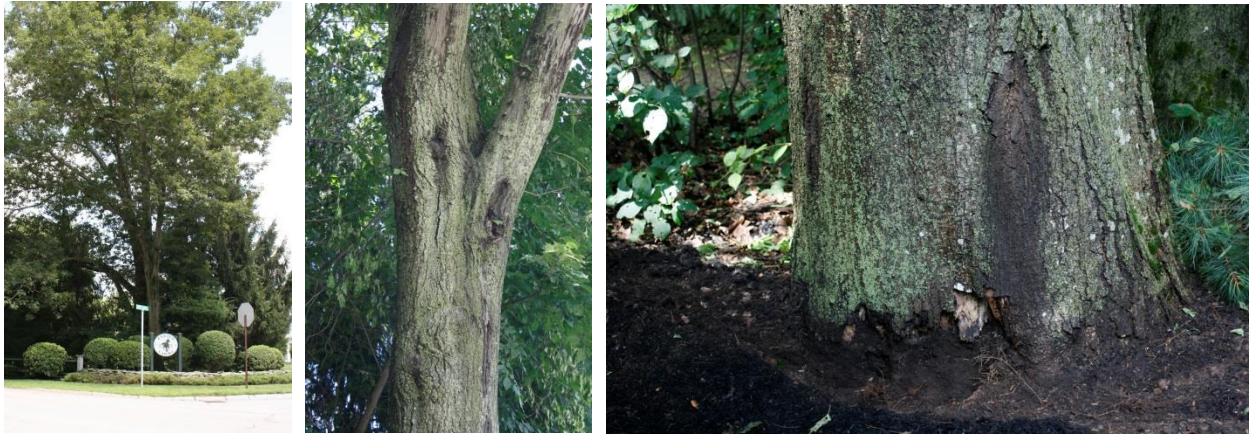
Tree: 2, Red Oak, 25" dbh

Likelihood of Failure: Root crown/lower trunk: Possible. Scaffold limb: Possible

Risk Rating: Root crown/lower trunk: Moderate. Scaffold limb failure: Low

Observations: This large Red oak stands at a main intersection. Old wounds, decay and fill soil are evident at the root crown. Dark staining from cankers⁴ along the lower trunk indicate possibility of *phytophthora*, a major root and trunk disease. Cracks are evident along the trunk. A large scaffold branch growing towards the intersection exhibits poor structure at the junction to the main trunk. An old branch wound has given way to a cavity just below this junction. Impact to the roadway is a possibility should a failure take place

Recommendations and Risk Abatement Options: It would be advisable to perform a root crown excavation⁵ on this tree. Sounding with a mallet did not suggest any hollowness of the trunk, but the combination of the fill soil, wounding, presence of decay, and possibility of *phytophthora* make the root crown and roots an area of concern. The level of risk could be reduced by having a better idea of what's happening underground. This tree should be monitored for changes in lean or root plate disturbance after any severe weather event

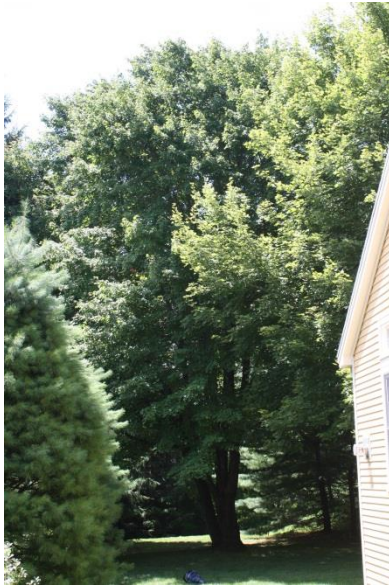
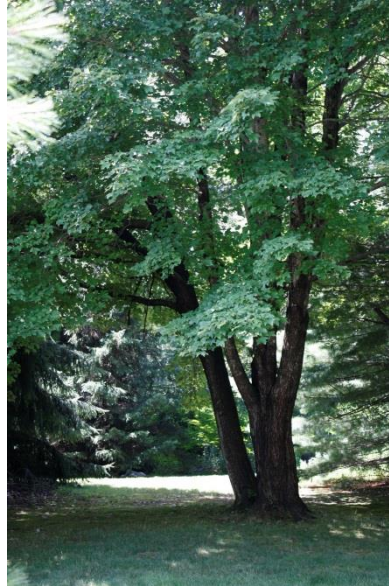
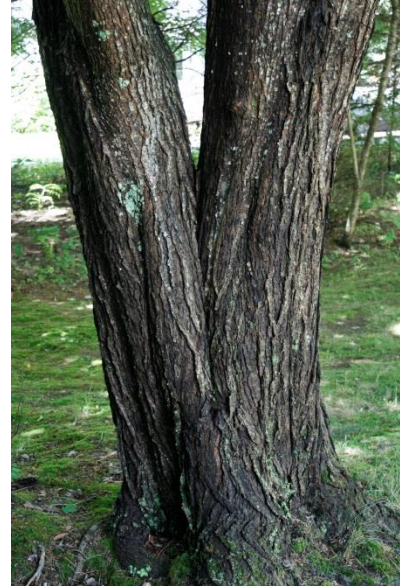
Tree: 3, Red Maple 26" dbh (below split)

Likelihood of Failure: Possible

Observations: This Red maple exhibits a solid root crown and trunk. Two main scaffold limbs arise from a v-shaped crotch with included bark⁶ near the base of the tree, but the relative vertical growth of the scaffolds arising from this junction makes the defect of less concern. The foliage color and density look good.

Recommendations and Risk Abatement Options: Installation of a support cable would greatly reduce the possibility for failure. Monitor the junction for any evidence of splitting, especially after a severe weather event.

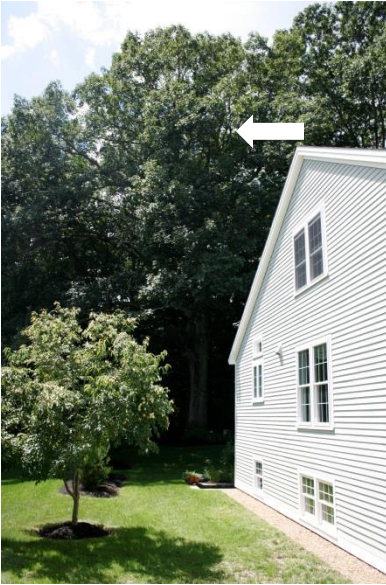
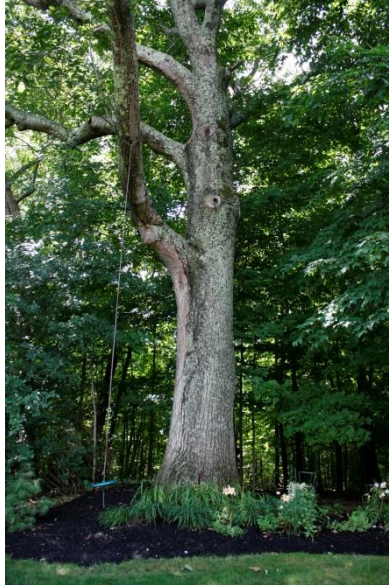
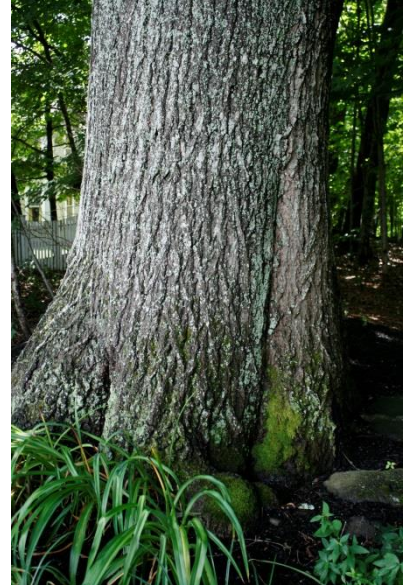
Tree: 4, Red Oak, 46" dbh

Likelihood of Failure: Root crown/lower trunk: Improbable. Limbs: Possible

Observations: This impressive oak has likely survived a wood harvesting or two and is one of the oldest trees on the site. A swing hangs off the lowest scaffold limb. The root crown, buttress roots and trunk all appear sound. Cavities are evident in the upper part of the main trunk at old branch sites. The upper crown architecture looks good. Three dead limbs greater than 3" in diameter were noted. The foliage is of good color and density.

Recommendations and Risk Abatement Options: Though I believe the upper trunk to be sound, further investigation of the trunk cavities would be prudent. Removal of any dead limbs over the lawn areas could also be performed at this time.

Monitor for any changes in lean or root plate disturbance after any severe weather event.

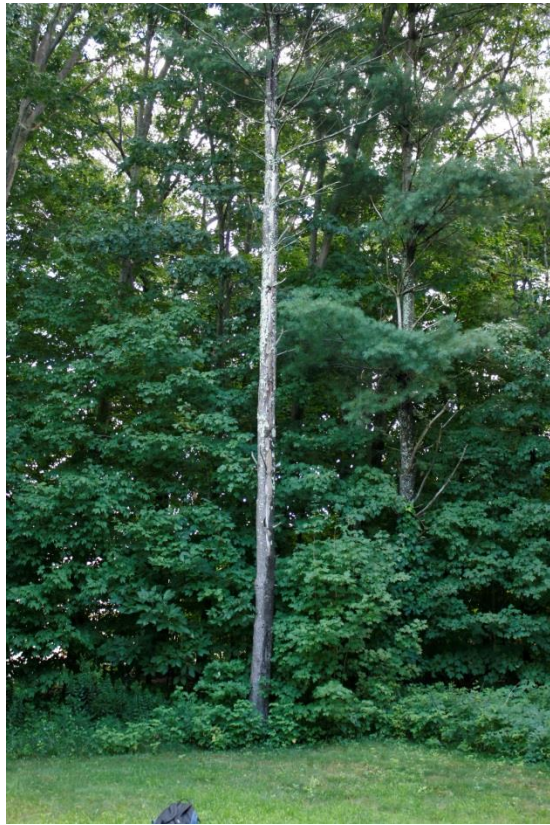
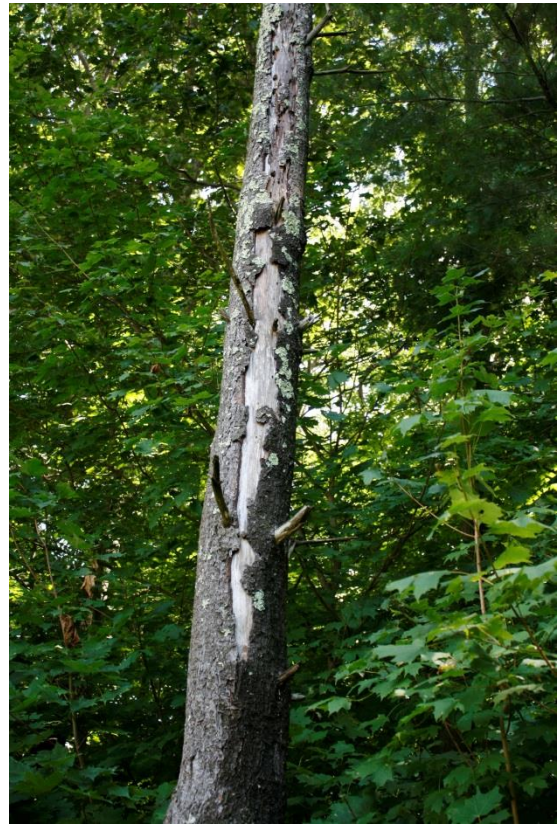
Tree: 5, White pine

Likelihood of Failure: Possible

Observations: This white pine tree growing along the forest edge has a long wound from near the base to about 20 feet up the trunk, possibly caused by lightning. The trunk still seems fairly solid, and the upper crown exhibits foliage of fair color and density. Possible targets include the house and an old, seemingly abandoned swing set.

Recommendations and Risk Abatement Options: This tree is unlikely to cause much damage to the house if it did fail. The swing set could be moved out of range of the tree. Removal could be considered, and would be relatively inexpensive. Monitor for any changes in lean or root plate disturbance after any severe weather event.

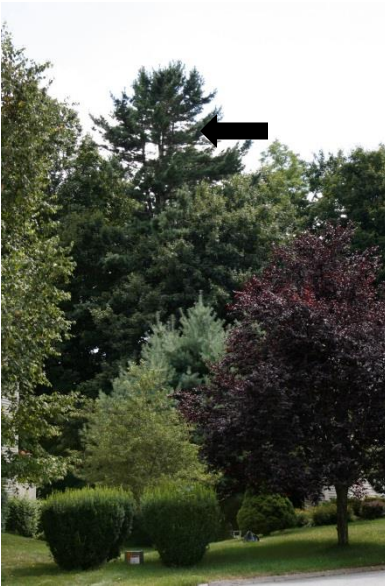
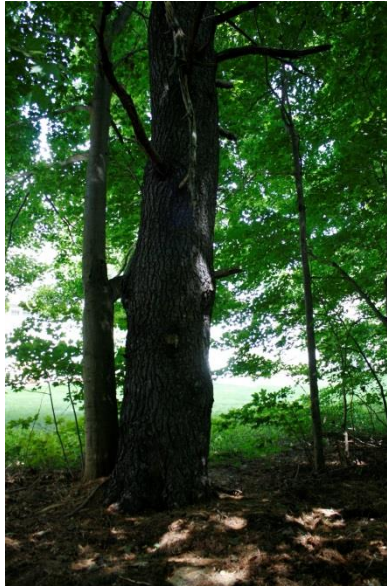
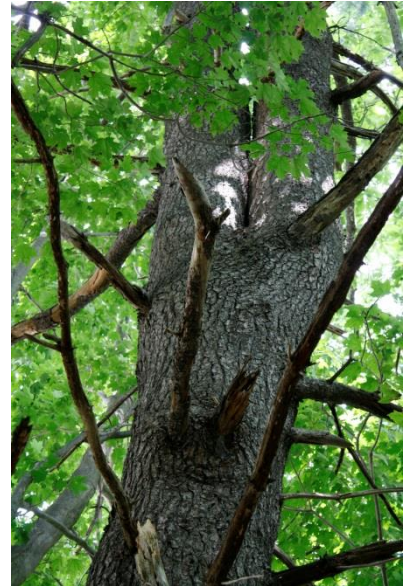
Tree: 6, White pine, 35" dbh

Likelihood of Failure: Possible

Observations: This large pine tree stands above the surrounding canopy. The root crown appears solid. Sounding with a mallet indicated areas of hollowness below old branch wounds at 6'. Two nearly vertical main stems diverge from a v-shaped crotch at about 20'. Little included bark was noted. The crown appears quite healthy with minimal dead wood.

Recommendations and Risk Abatement Options: The main risk for this tree lies with the stem junction. While the defect is not extreme, installation of a support cable between the two stems would be instrumental in reducing the risk.

Monitor for any signs of cracks forming below the crotch, especially after any extreme weather event.

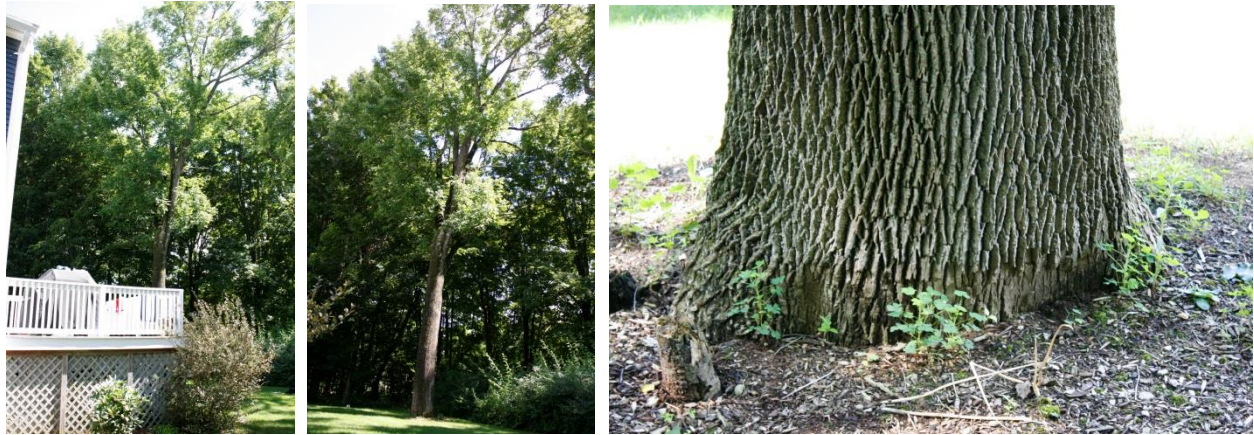
Tree: 7, White ash 26" dbh **Location:** 13 Hollowbrook Cir., rear

Likelihood of Failure: Probable

Recommendations and Risk Abatement Options: While rated a low risk at this time, the crown die-back suggests a tree in physiological decline. Measures to improve health would be advisable if this tree is valued. Removal of the large dead limbs could be considered.

Monitor for any changes in health, such as further decline of the upper crown.

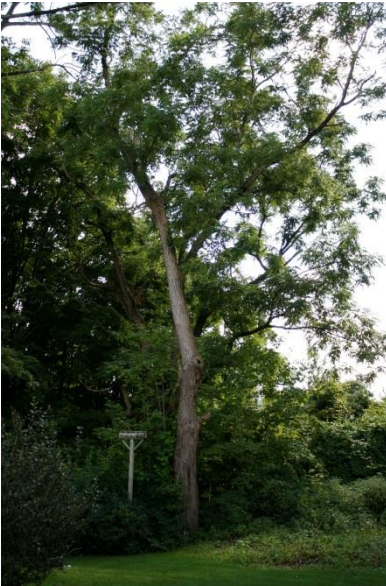
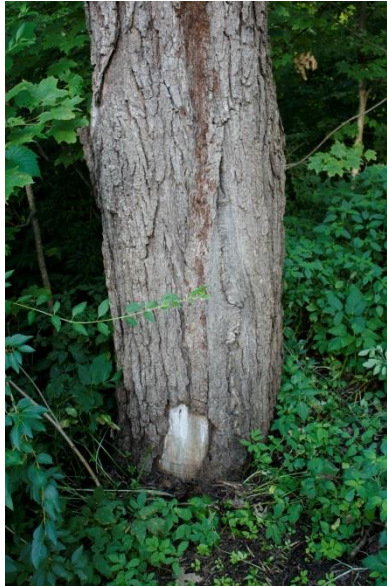
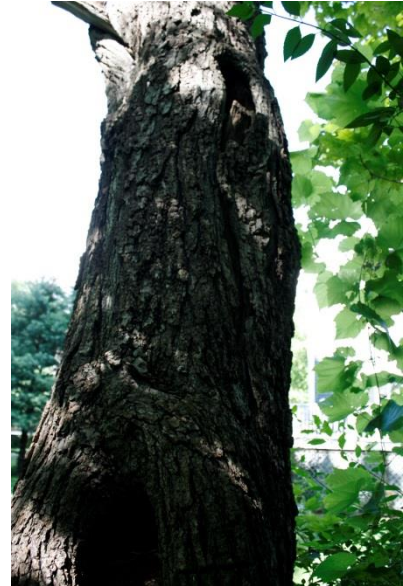
Tree: 8, Black Walnut, 35" dbh

Likelihood of Failure: Probable

Observations: No root flare is evident on this tree, indicating the area was filled. A large open wound is located to the north at the base. Large open cavities and cracks are on the lower trunk and continue up the hollow trunk on the south side. The trunk leans toward a deck and house. The upper crown retains enough leaf area and mass to enhance vulnerability during wind events. Though failure is more likely to happen during a weather event, it could occur at any time.

Recommendations and Risk Abatement Options: Remove as soon as possible.

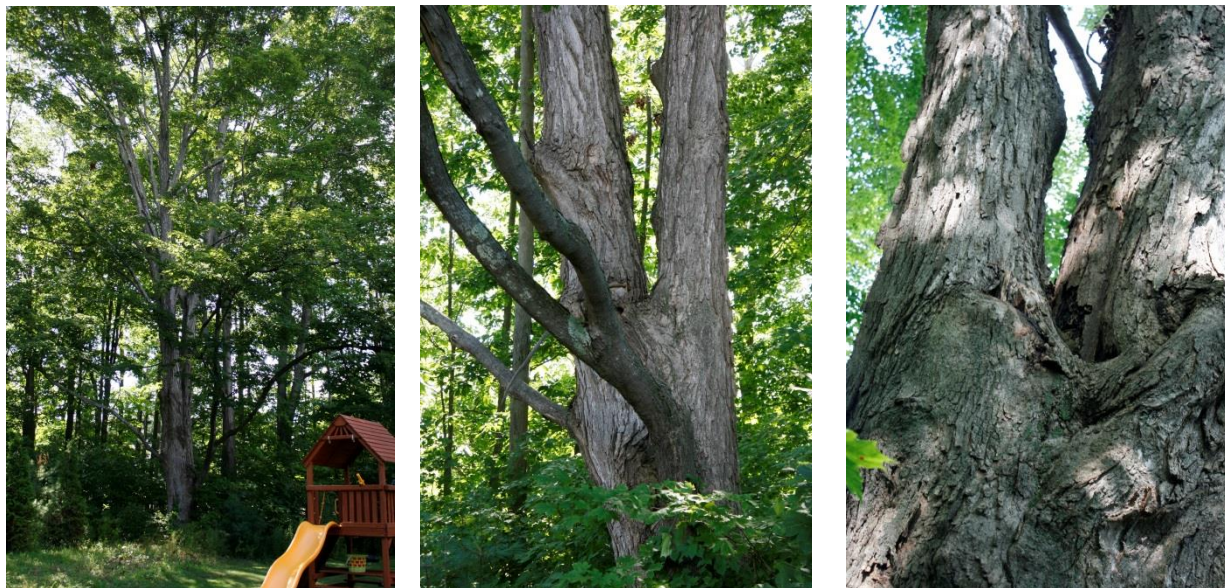
Tree: 9, Sugar maple, 42" dbh

Likelihood of Failure: Possible

Observations: This specimen sugar maple has great aesthetic appeal. The root crown and lower trunk are sound. Two main scaffolds arise from a tight crotch at about 10'. This area exhibits many old branch wounds with open cavities visible on both sides of the trunk. Areas of decay and loose bark are visible on the inner portion of the crotch. More branch wounds are visible further up the two main trunks. The foliage color, size and density appear to be fair to good.

A lower limb grows toward a swing set with visible cracks, but good wound response was noted.

Recommendations and Risk Abatement Options: The risk rating is low, but the aesthetic value of this tree may promote consideration of a support cable. The lower limb noted above would benefit from a reduction pruning to reduce any chance of breakage.

Monitor for any signs of cracks forming below the crotch, especially after any extreme weather event.

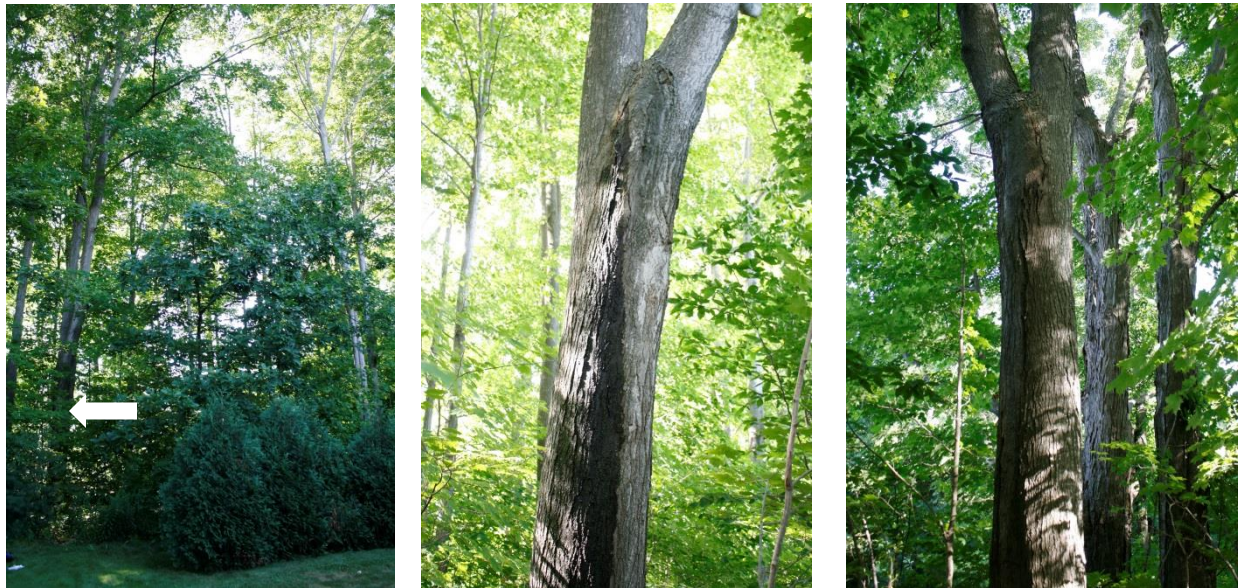
Tree: 10, Sugar maple, 26" dbh **Location:** 17 Hollowbrook Cir., near path to road in rear

Likelihood of Failure: Probable

Observations: The root crown and buttress roots are solid on this tree, but vertical cracks on either side of the trunk extend down from a v-shaped crotch with included bark at a height of about 16'. Two main stems arise from the defective crotch. The stem to the east has the potential to reach a house, but other plants would likely buffer a failure, and only the smaller portions of the crown would impact the house. The foliage color, size and density appear to be fair to good.

Recommendations and Risk Abatement Options: The risk rating is low, but eventual failure of the defective crotch is likely. Installation of a support cable would be highly advisable if the chance of failure is to be abated.

Monitor for changes in the cracks below the crotch, especially after any extreme weather event.

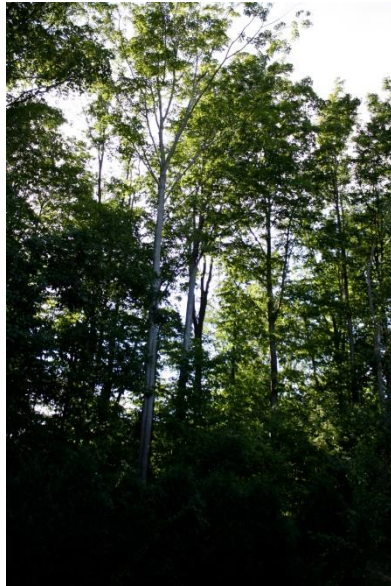
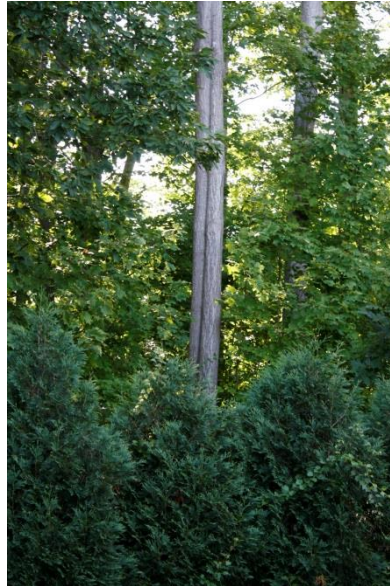
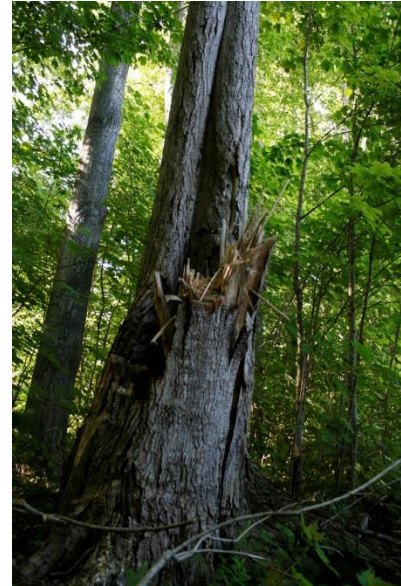
Tree: 11, Sugar maple, 20" dbh

Likelihood of Failure: Probable

Observations: The sister stem of this remaining sugar maple failed long ago. Many of the buttress roots show areas of missing bark and evidence of decay. The remaining stem sits on a hollow base and presents a long crack with a rams' horn⁷ formation running far up the stem. The upper crown is weak with off-colored, small and sparse foliage.

Recommendations and Risk Abatement Options: No abatement options are applicable for this tree.

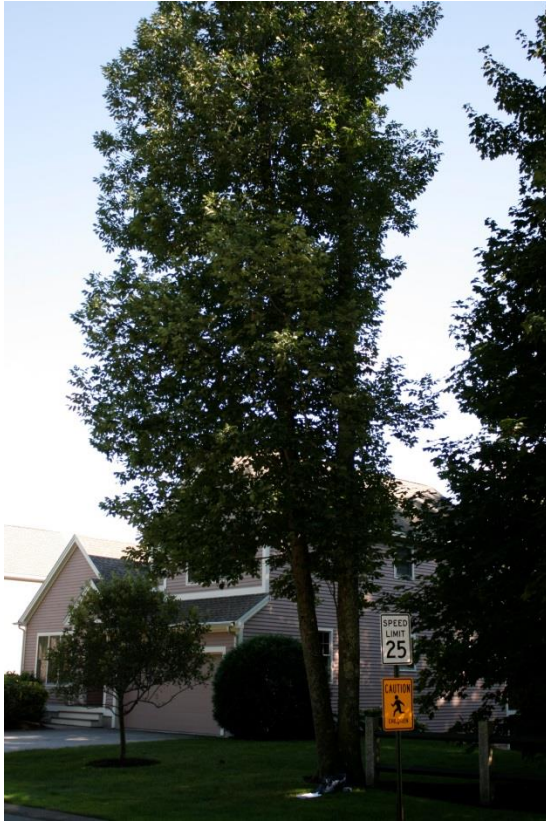
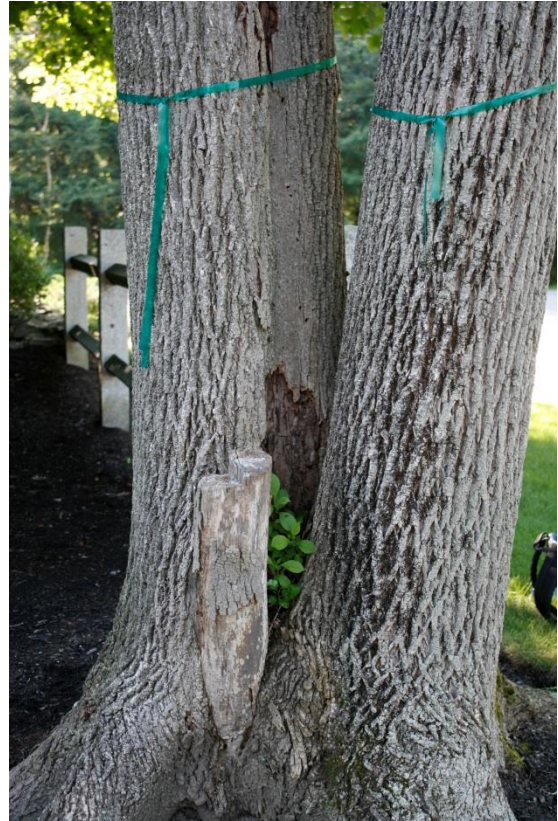
Tree: 12, White ash, 16” and 13” dbh

Likelihood of Failure: Possible

Observations: The buttress roots of this double-stemmed white ash tree are solid where they enter the ground. A column of decay runs along the inner portions of the trunks facing each other from the base to a height of 6 to 8’. There is die-back in the upper crown. The lower adventitious limb⁸ growth is quite vigorous, though poor attachment points to the main stem will become an issue.

Recommendations and Risk Abatement Options: The risk is low, but this tree would benefit from a crown cleaning and the installation of a support cable. Occasional pruning of the newer growth is also advised.

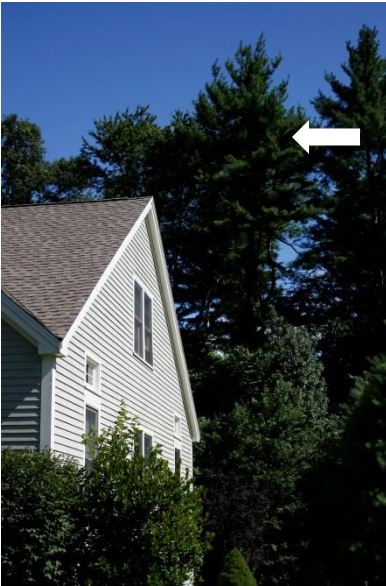
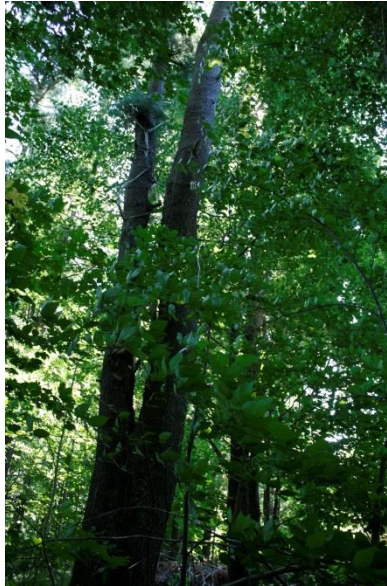
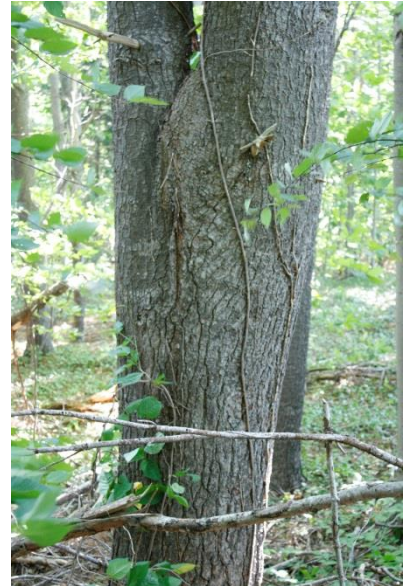
Tree: 13, White pine, 25" dbh

Likelihood of Failure: Possible

Observations: This 100' plus tree exhibits a slight lean toward the house. The root crown and trunk area are obscured by brush and some fill, but appear to be solid. The trunk divides into two main stems at 10'. The crotch exhibits a poor v-shaped form with included bark. Sounding with a mallet indicates areas of decay below this junction on the smaller stem to the north-east, which also exhibits an upper crown in decline. The larger stem to the south-west shows good foliage color and density, but only 30 percent of live crown ratio⁹.

Recommendations and Risk Abatement Options: As cabling is not an option, no abatement options are applicable for this tree. Monitor for any signs of cracks expanding below the crotch, especially after any extreme weather event.

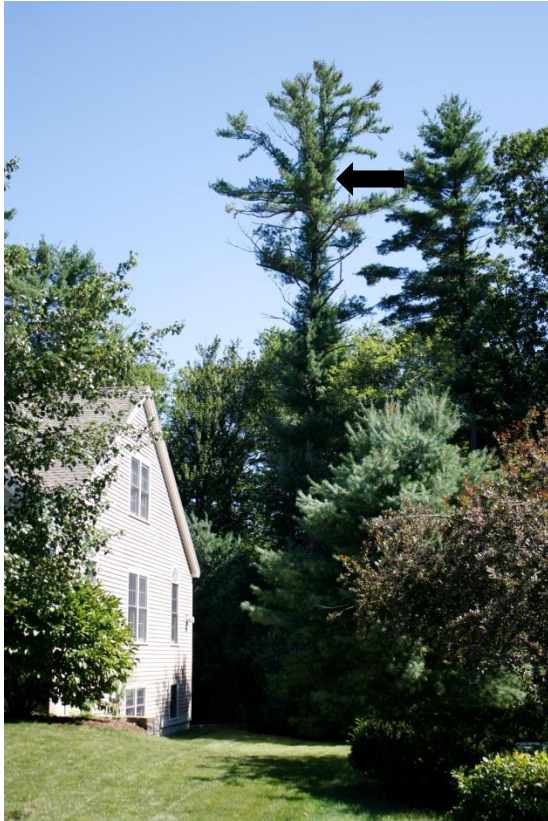
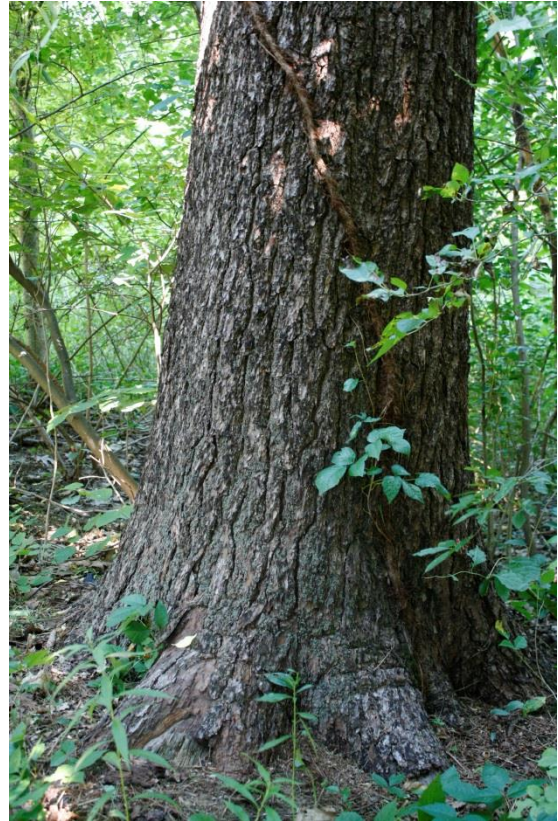
**Tree:** 14 White pine, 25" dbh**Location:** 40 Anytown Farm Rd., rear**Part(s) Evaluated for Failure:** Root crown/lower trunk**Potential Targets:** House**Likelihood of Failure:** Improbable**Likelihood of Impacting Target:** Medium**Consequences of Impact:** Significant**Risk Rating:** Low

Observations: This 100' plus tall pine is readily visible throughout the neighborhood. The root crown and lower trunk are solid. Old, dead limbs extend up to the trunk to the crown. Scarring along the entire trunk indicates a lightning strike may have taken place. New growth along the stem prohibits inspection of the wounds, but also indicates good response to injury. The upper crown is oddly shaped and of moderate health.

Recommendations and Risk Abatement Options: I believe the risk of the lower portion of this tree failing is low. It is more likely that portions of the upper crown will fail, but no discernible target was noted below. Monitor for any changes in the lean or changes in the soil area around the root crown, especially after any extreme weather event. Also watch for any changes in health of the upper crown.
