Third Church in Salem Linden Tree Assessment

Prepared for:
Third Church in Salem
3 Ell St.
Salem, MA

Prepared by:
Howard Gaffin
MCA #1468
BCMA # NE-0363B
RCA #458

August 10, 2017

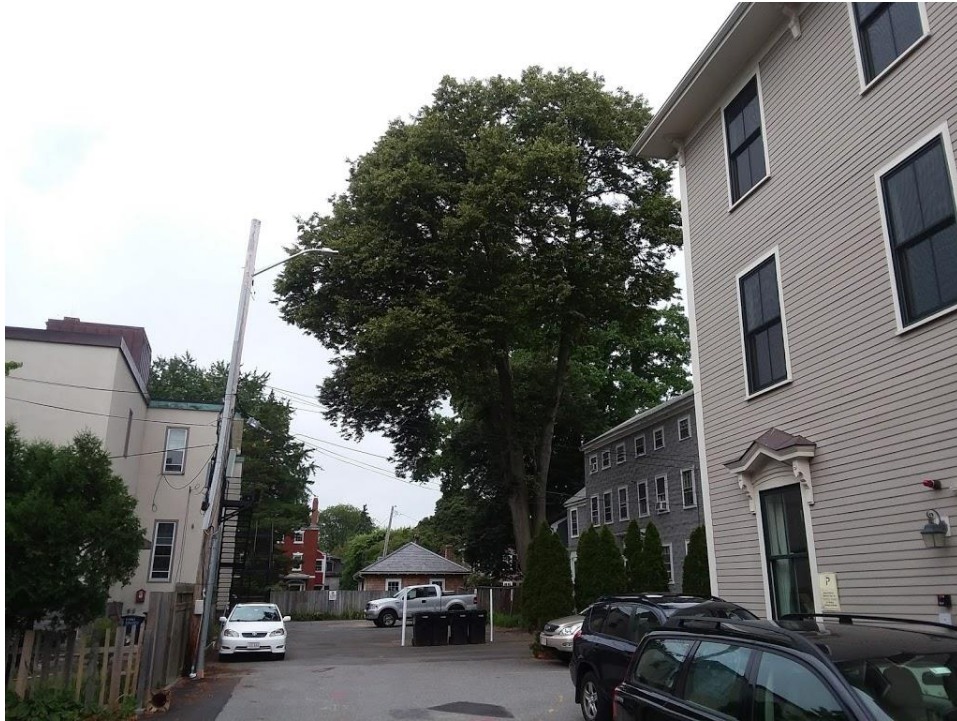
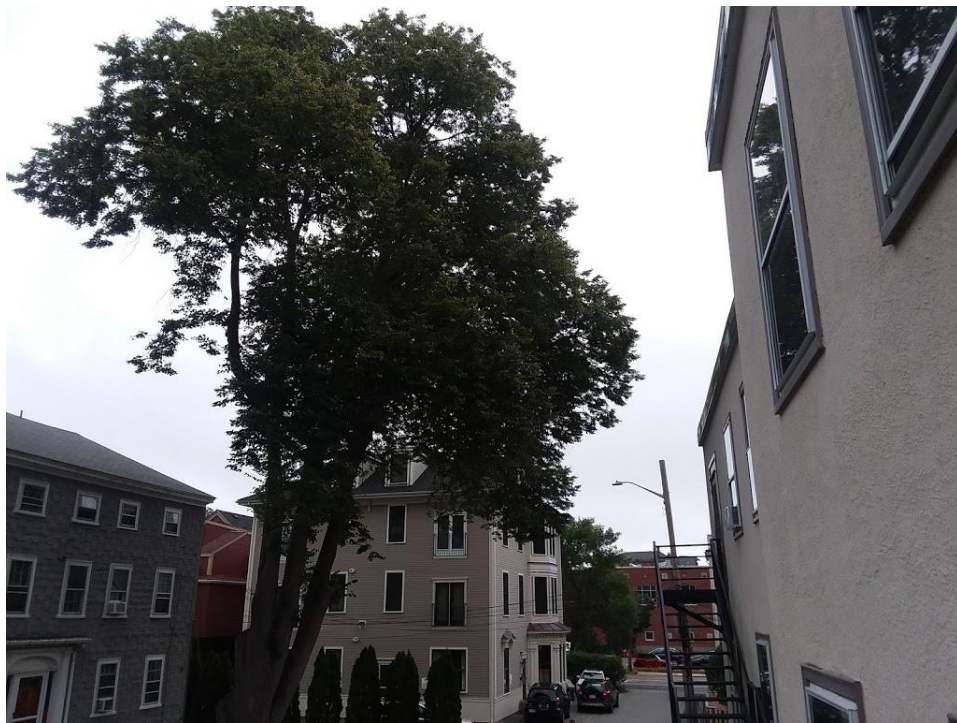
1 and 2, views from the east and west

The above images show the tree looking west and east respectively. Poor pruning decisions created a less stable structure. Reduction of the crown height over time is recommended if the tree is to be retained.

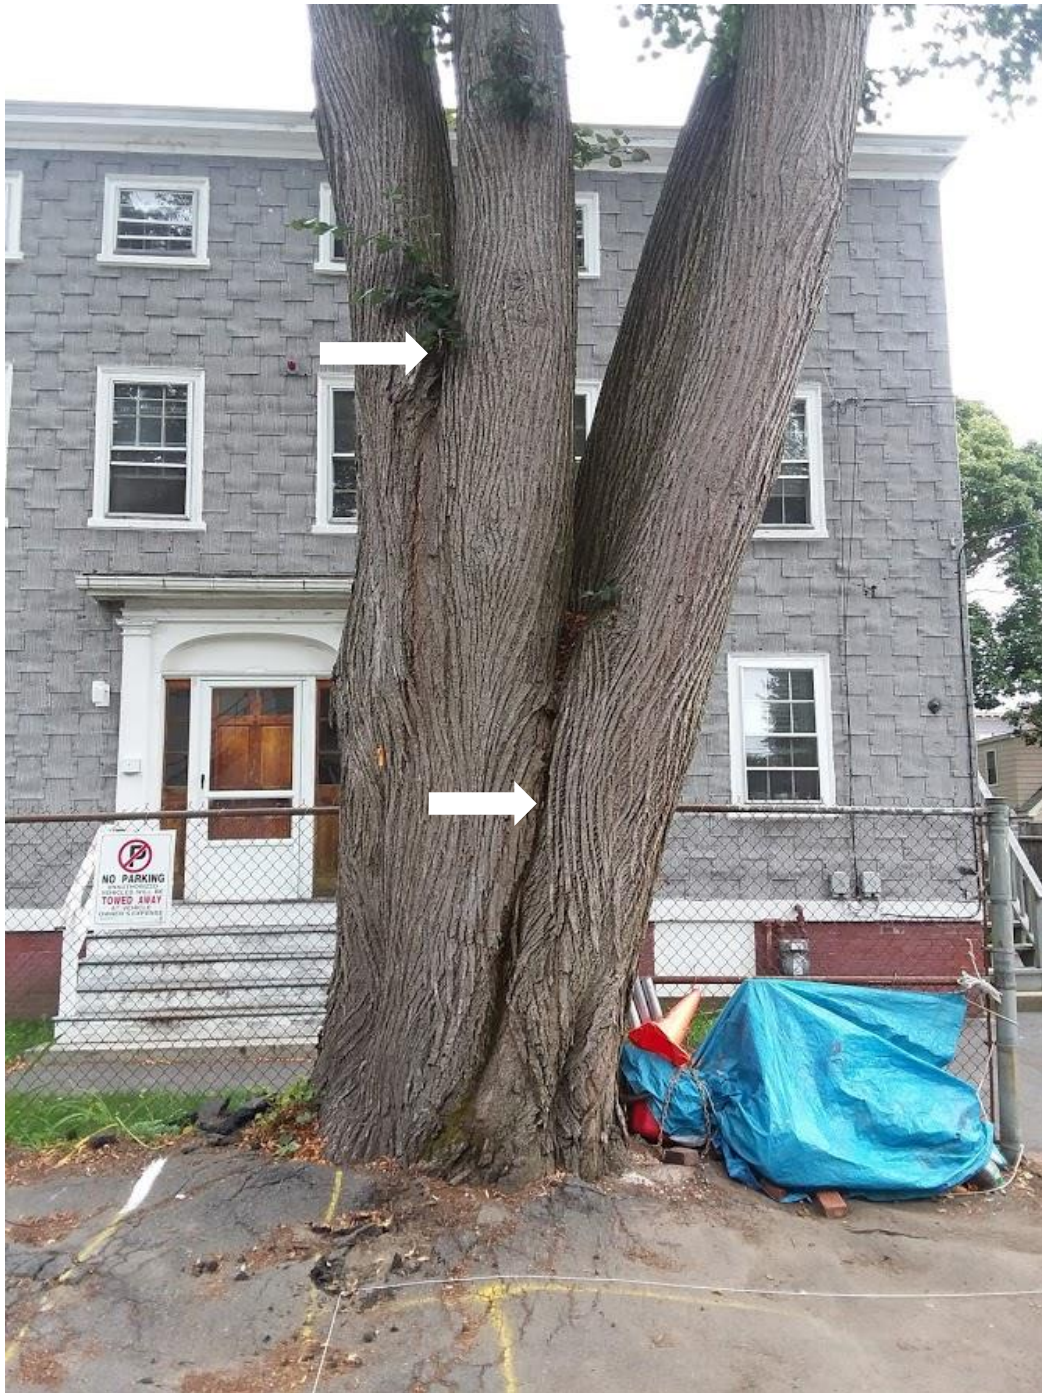
3, a view of the trunk looking north

This image shows the trunk looking north toward the neighboring property. The root system and pavement are certainly at odds. The 2 seams in the trunk indicate v-shaped unions with included bark but neither appear to be active at this time. The outline of the proposed shed placement is in the foreground.

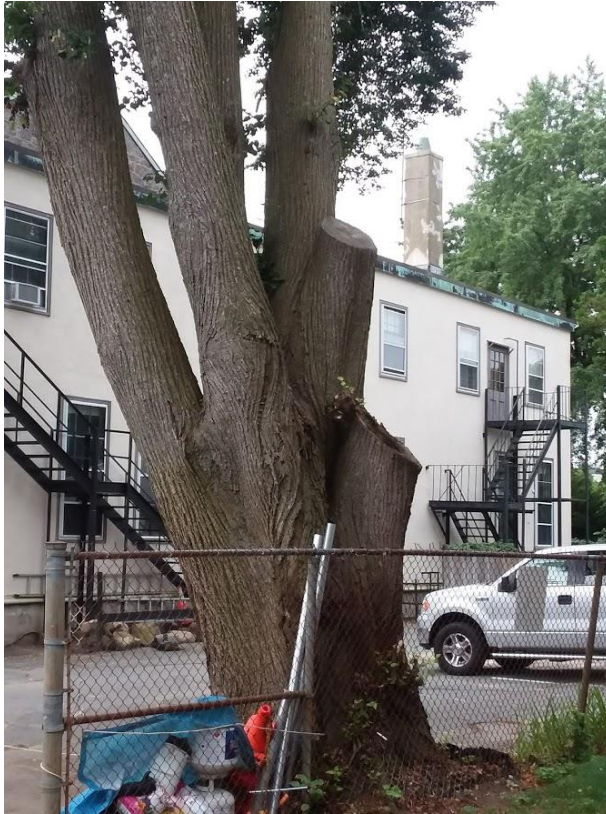
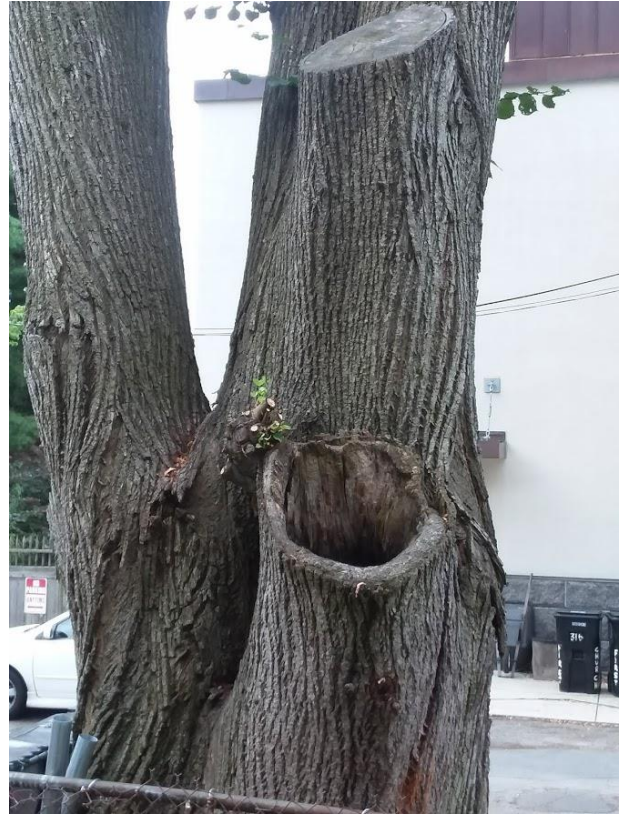
4 and 5, views of the trunk looking west and south

These images of the tree show where 2 major scaffolds were removed on the north side of the trunk. The lower scaffold was extremely compromised. It is likely that multiple pruning wounds over time created the cavity. The upper scaffold appeared to be solid.
