City Hall Park Tree Assessment

Prepared for:
Tree Guy
Green Park
Treetown, MA

Prepared by:
Howard Gaffin
MCA #1468
BCMA # NE-0363B
RCA #458

May 14, 2018

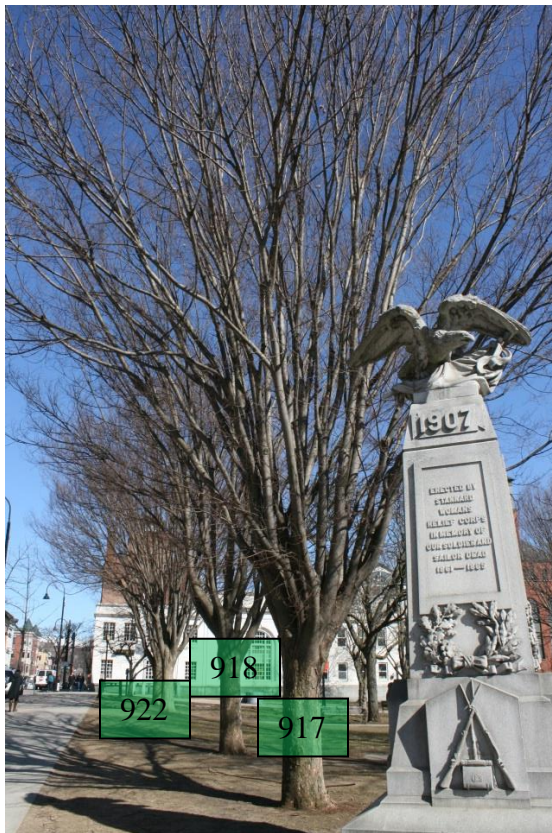
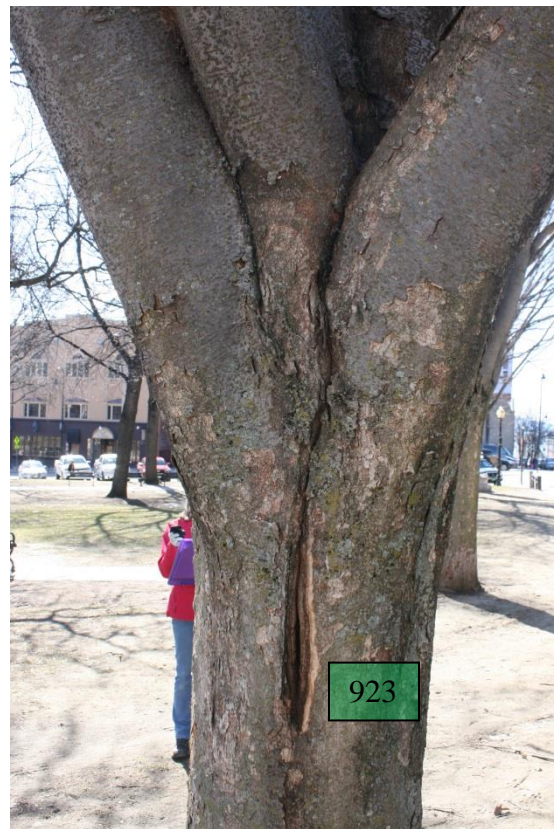
Zelkovas growing along College St. show typical form for the species. Tree 923 shows exceptionally bad form with an open seam along the trunk.

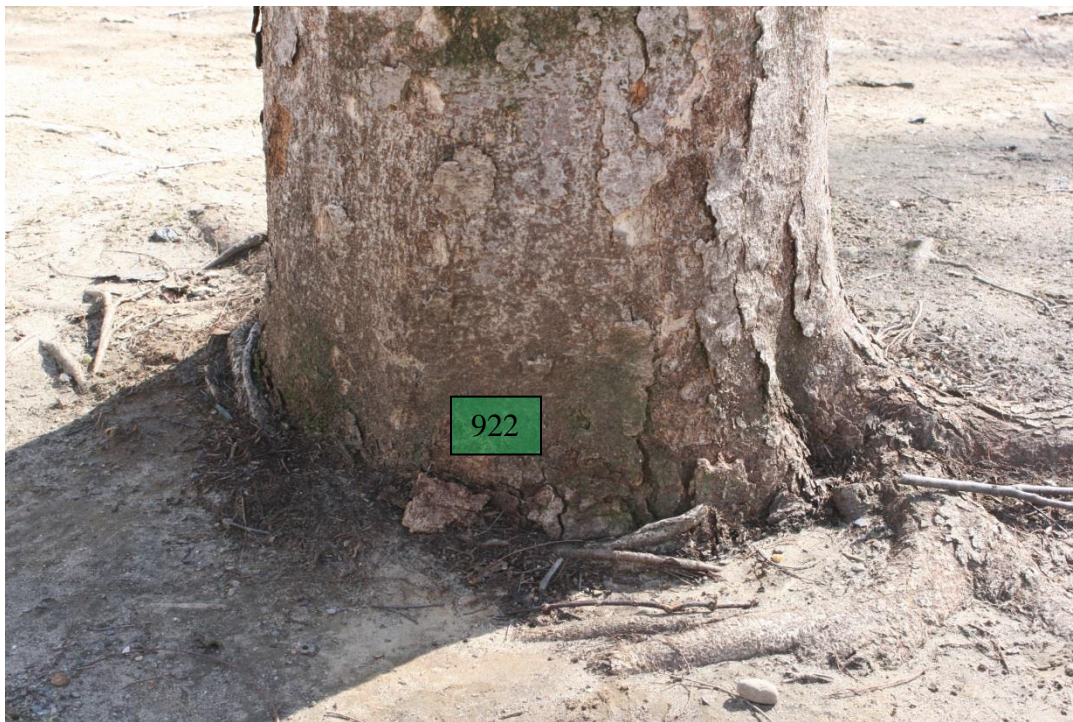
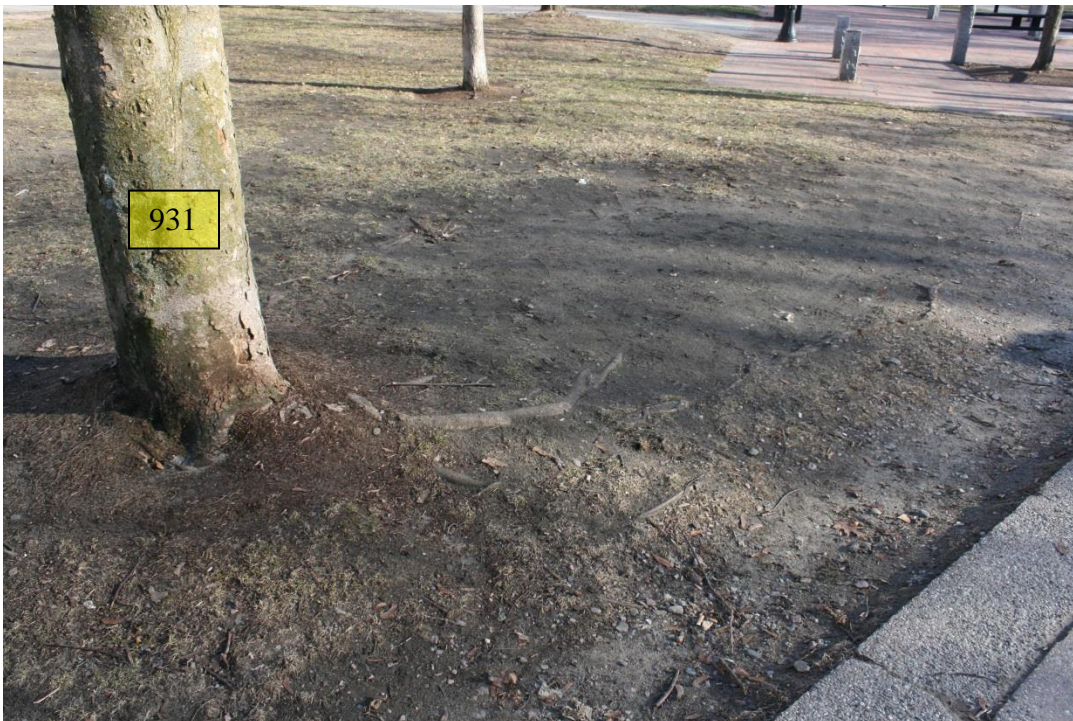
All the Zelkovas exhibited some degree of poor root crown formations, girdling roots and soil compaction.

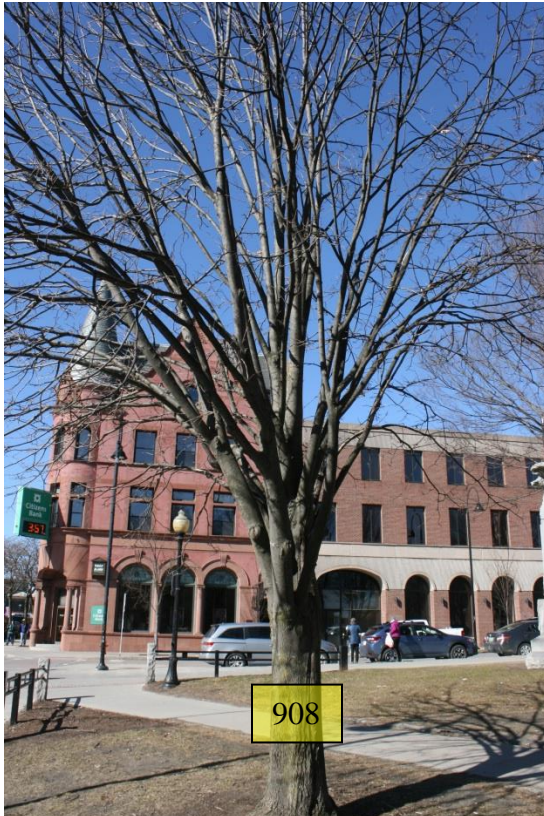
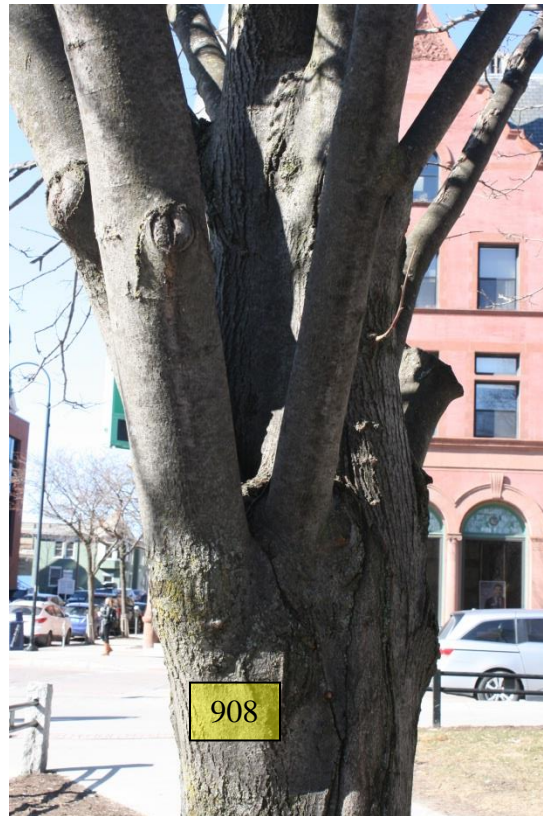
Tree 908 exhibits poor crown form and attachments, as well as an open seam along the trunk.

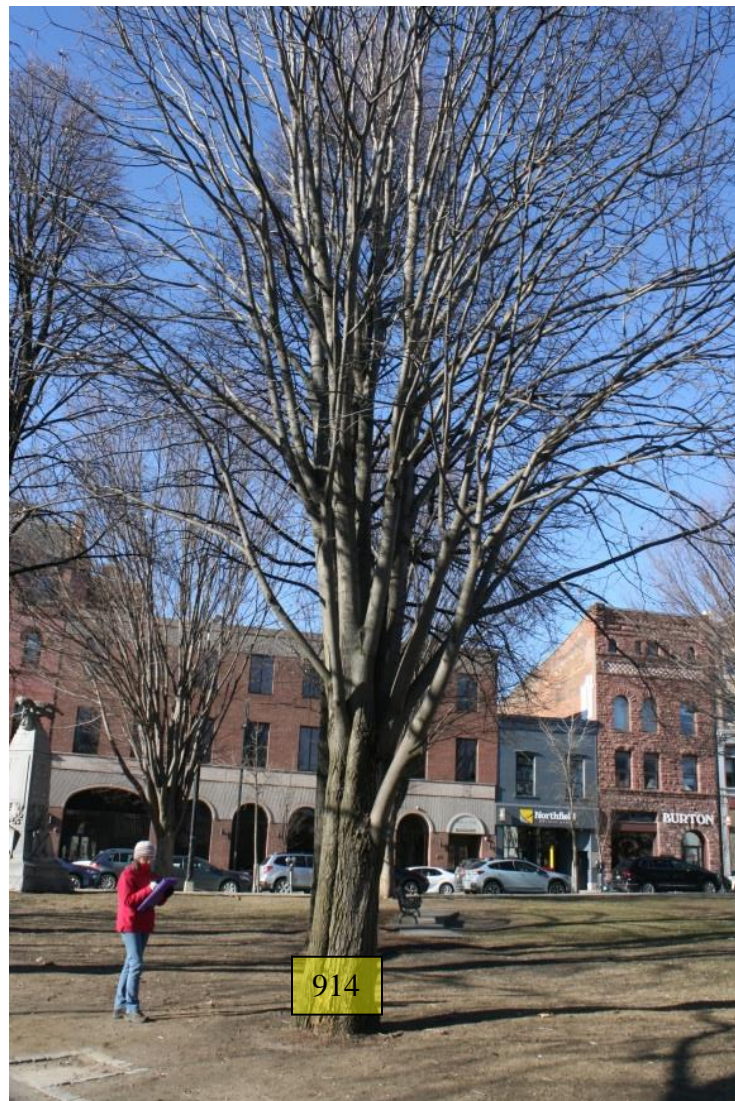
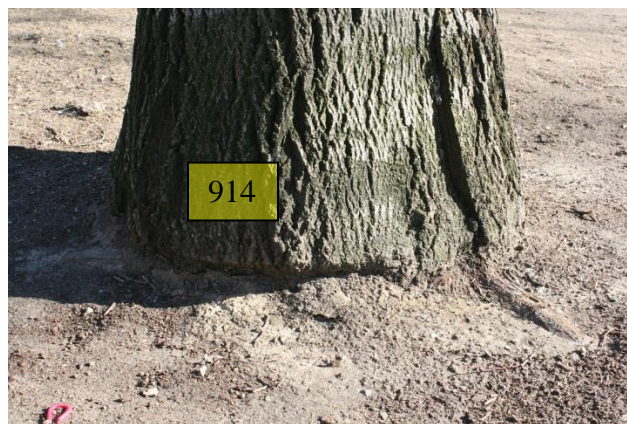
Tree 914 exhibits poor crown structure, trunk wounding, and signs of severe root girdling.

914	Silver Linden	23	Compact soil. Girdling root on north side. Open seam on west side of trunk. Poor structure, multi-stemmed with included bark. One-sided crown. Fair bud set.
910	Honey Locust	16	Compact soil. Solid root crown and buttress roots. Co-dominant stems at 8'. Some dead wood in crown. Twig and bud growth stunted.
926	Sugar Maple	18	Severe compaction. Girdling roots, flattened trunk on north side. Damaged surface roots. Severe die-back in crown.
931	Zelkova	16	Compaction. Girdling roots to the north-east. Exposed surface roots. Fair crown structure for species. Fair bud set.
932	Red Maple	15	Compaction. Large fibrous root mass on surface near trunk. Good root crown. Open cavities along trunk from large old wounds. Moderate die-back, poor bud set in crown
933	Norway Maple	21	Compaction. Large wound in trunk. Trunk divides into co-dominant v-shaped stems with open seams at 7'. Poor-fair bud set.

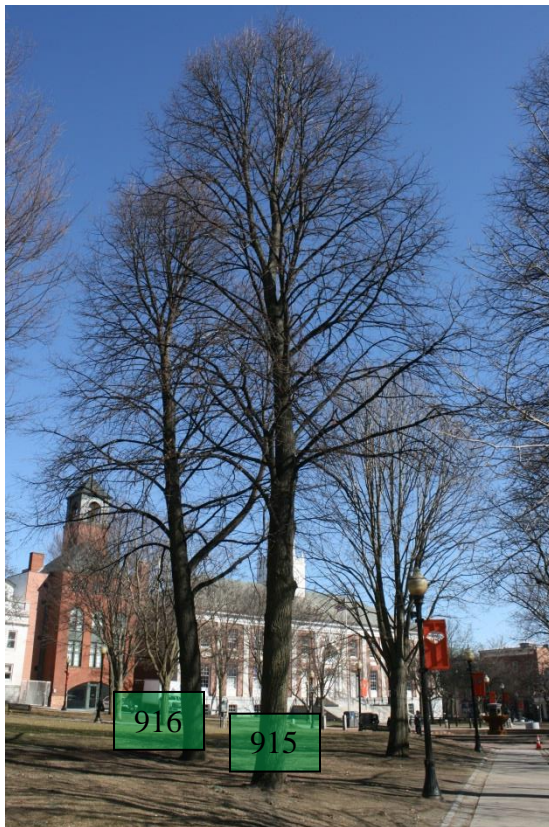
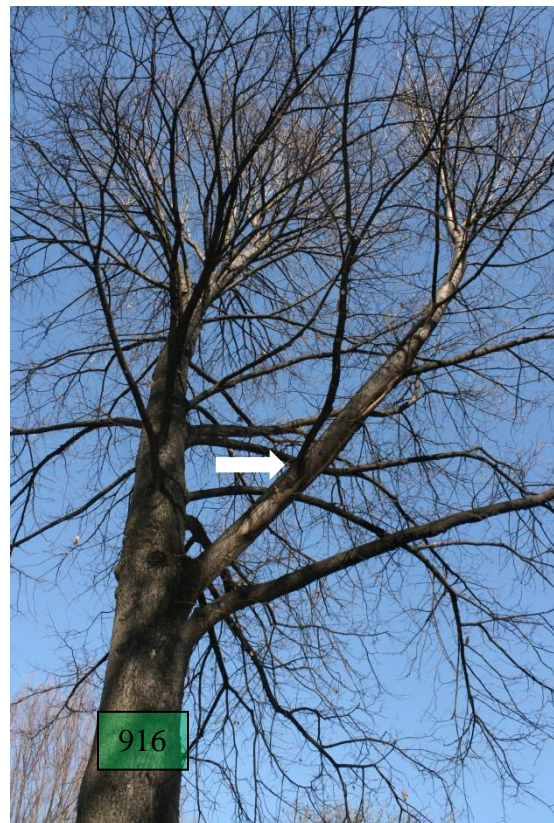
Left: Trees 915 (in the foreground) and 916 show decent forms. Tree 8 has a slight lean to the north. Right: Tree 916 has an oversized lateral limb (arrow) that should be reduced.

916	Little leaf Linden	22	Compacted soil, girdling roots, surface roots. Approx. 10 degree lean to north. Oversized lateral limb to south. Fair crown structure. Good bud set. Little limb die-back. Sooty mold.
112266	Honey Locust	18	Compact soil. Poor root flare, flat on west side. Surface roots. Solid trunk. Good crown structure. Fair bud set. Stunted growth.
925	Horse Chestnut	18	REMOVED
934	Horse Chestnut	20	REMOVED
936	Hackberry	10	Compact soil. Good root crown. Solid trunk. Large, oversized lateral to west, some splitting at union. Good crown, bud set.
909	Little leaf Linden	26	Compacted soil. Fair root crown. Large root growing laterally connected to seam running 18' up the trunk. Co-dominant scaffold. Sooty mold on trunk and limb bark. Good crown and bud set.
979	Norway Maple	17	REMOVED

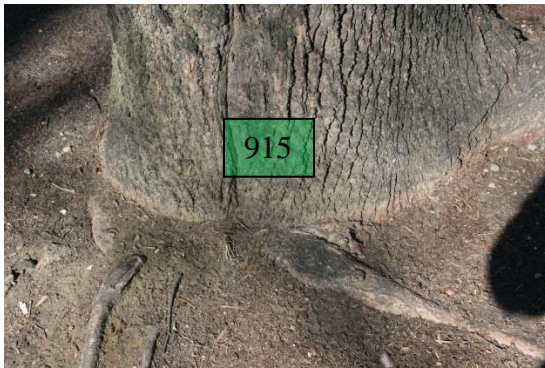
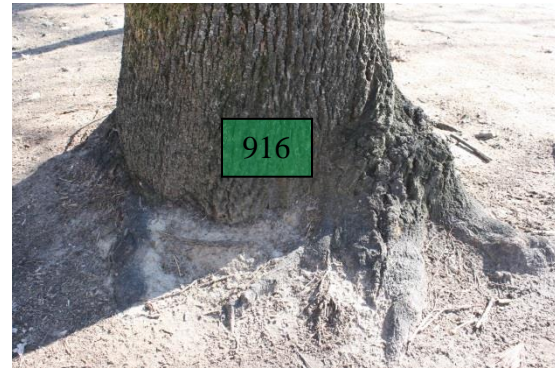
Both trees 915 and 916 exhibit problems with large girdling roots.

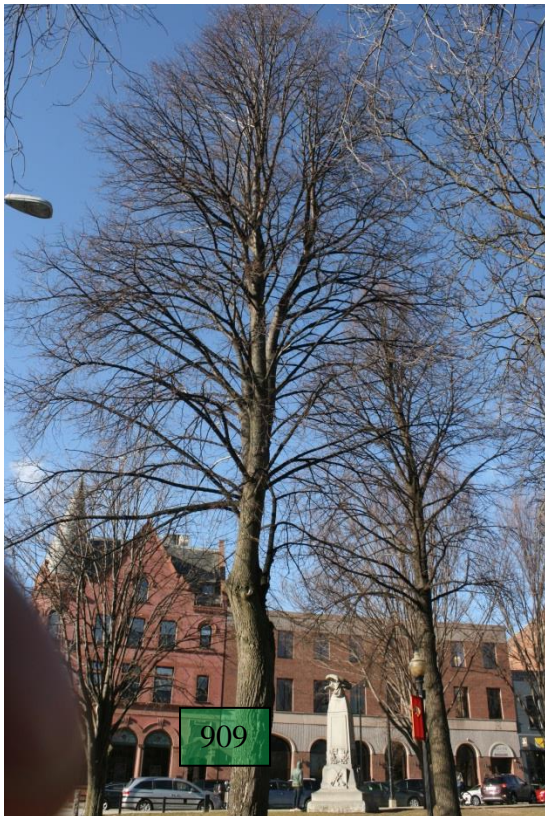
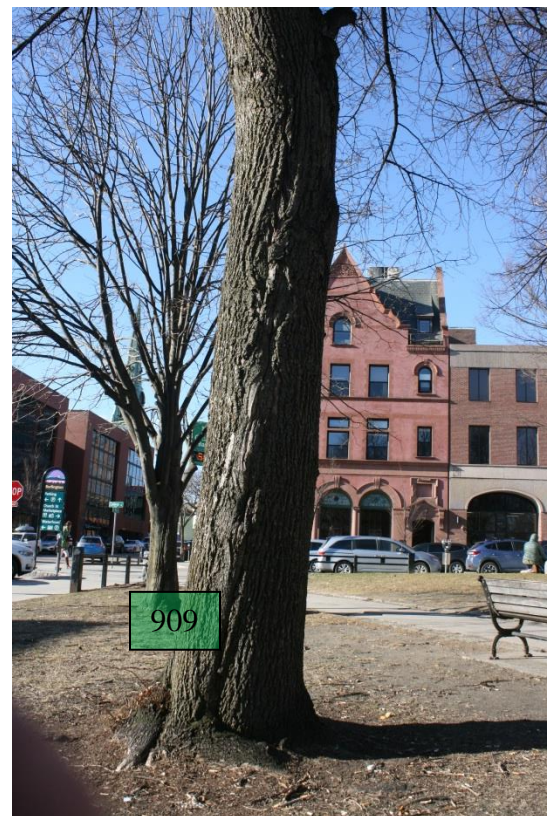
Tree 909 has a large lateral root associated with wounding running up the trunk.

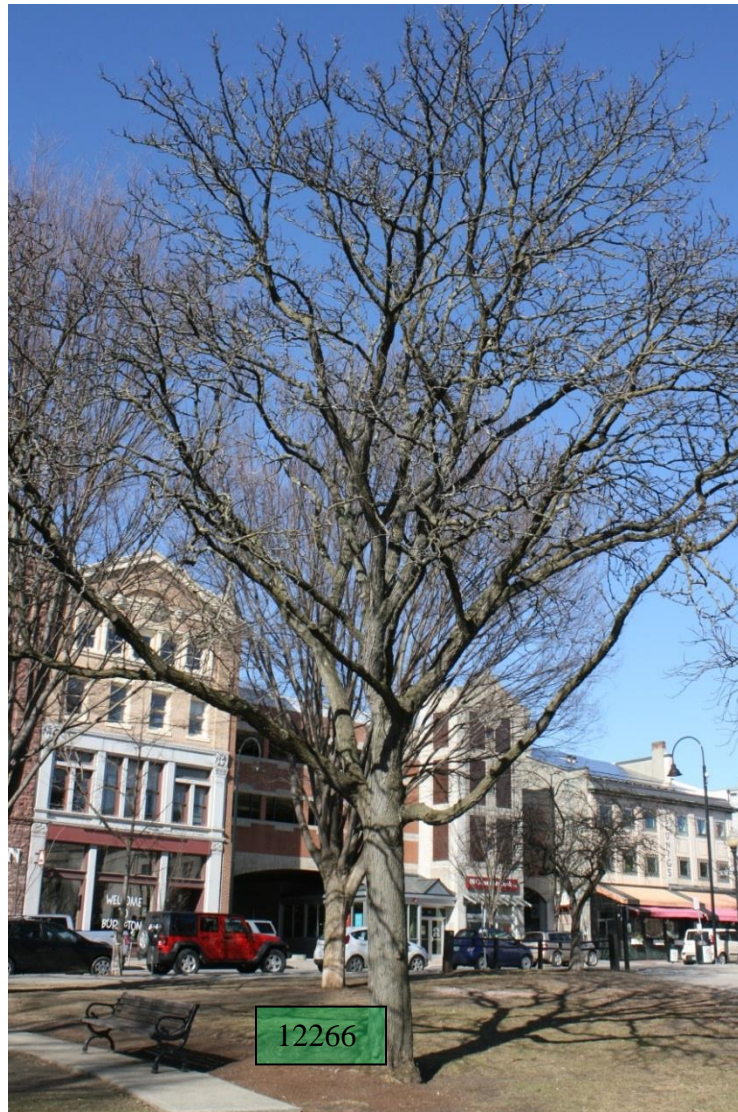
Tree 12266 shows good form, but compaction and root crown defects have stunted growth.

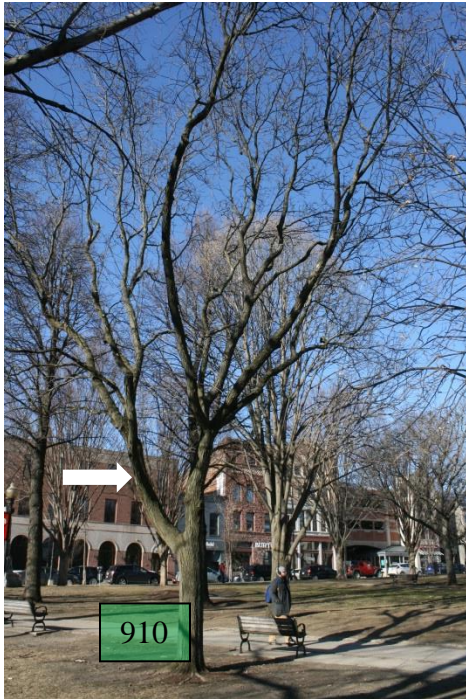
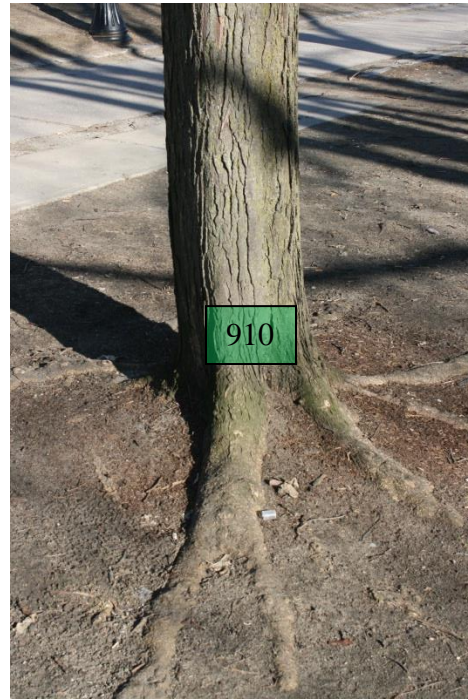
Tree 910 has good root crown structure and a strong trunk. The lower lateral limb is oversized and should be reduced (arrow). Crown is stunted, soil compaction is evident.

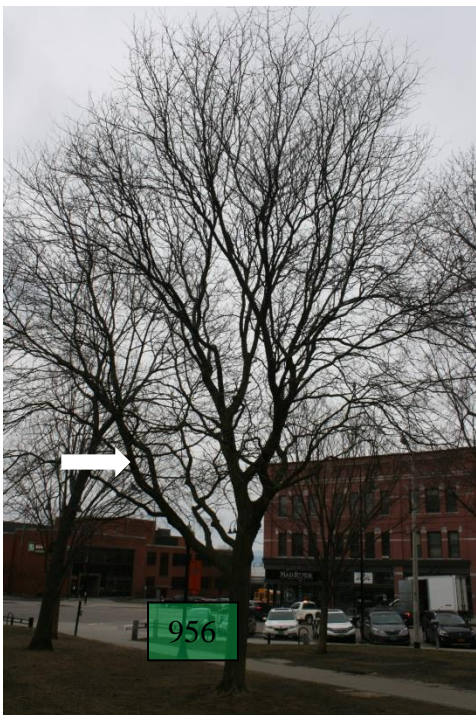
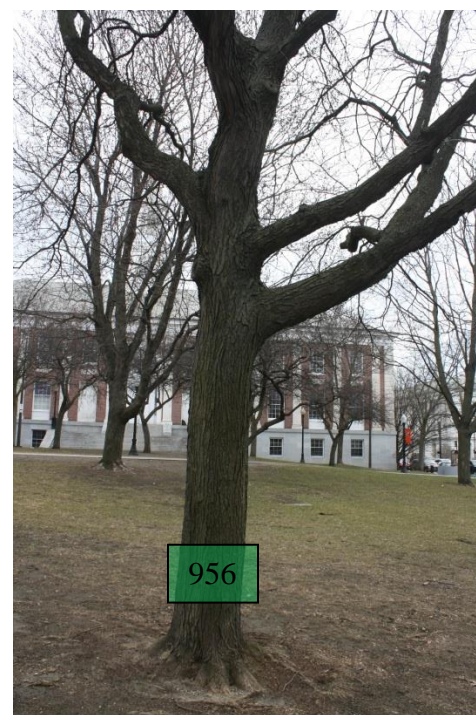
Tree 956 has fairly healthy crown with good structure, excepting the lower lateral that should be reduced (arrow). There are some root issues, but the root crown and trunk are solid.

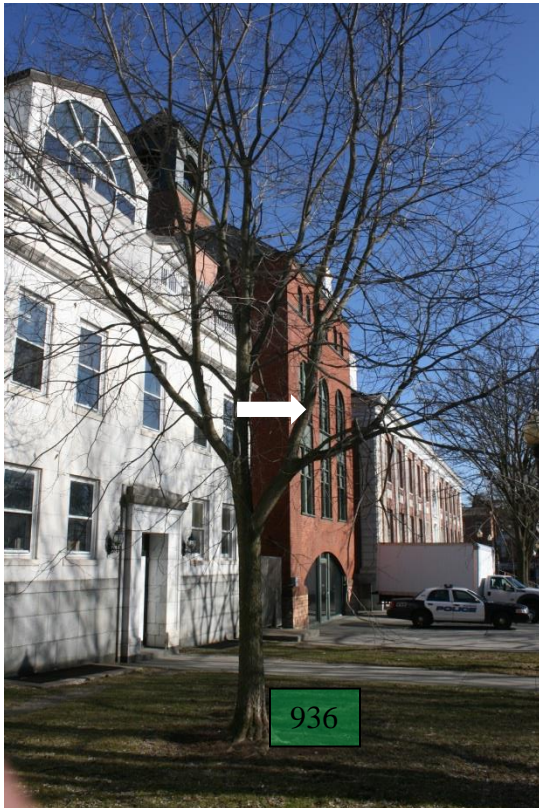
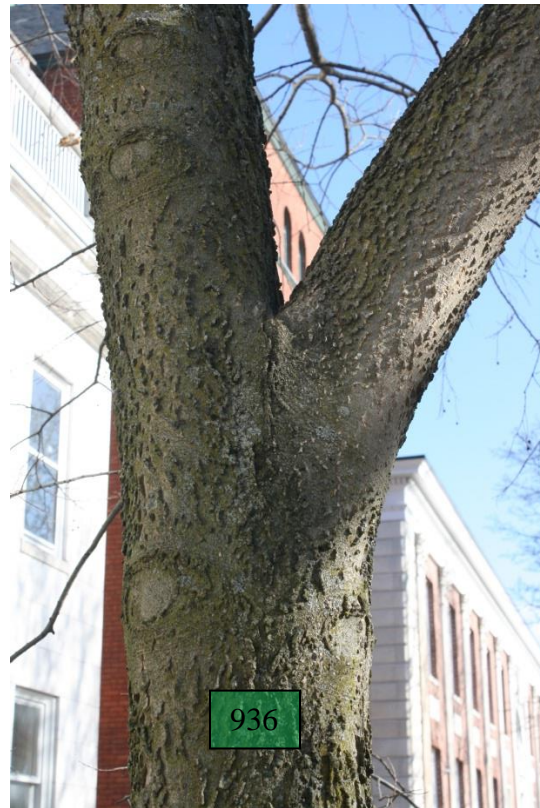
The lone Hackberry is a more recent addition to the park. An oversized lateral limb arises from a fairly good root crown and trunk. While experiencing the same stresses as the other trees, it appears to be doing well.

The Hackberry (#936) is doing well, but the oversized lateral limb (arrow) with included bark should be reduced to prevent future problems.

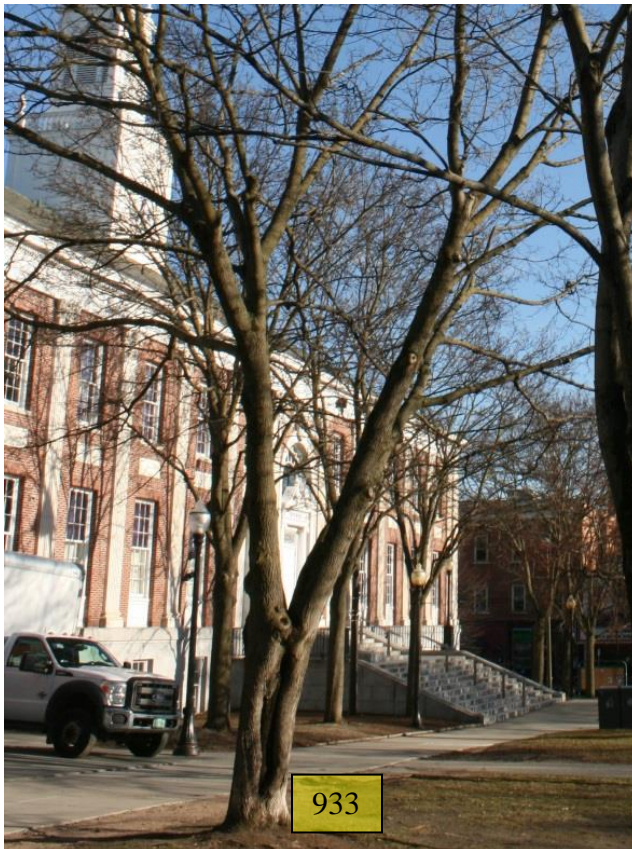
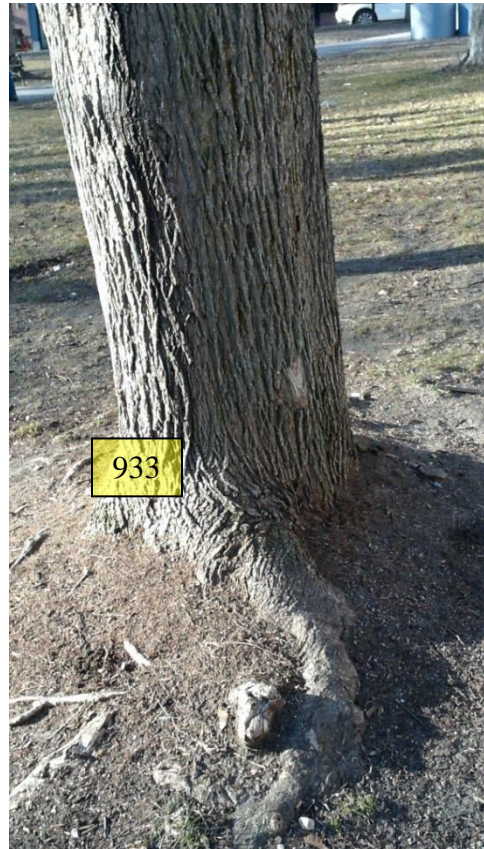
Tree 933 has a good root crown, but a large defect in the trunk and poor bud set make this another border line prospect.

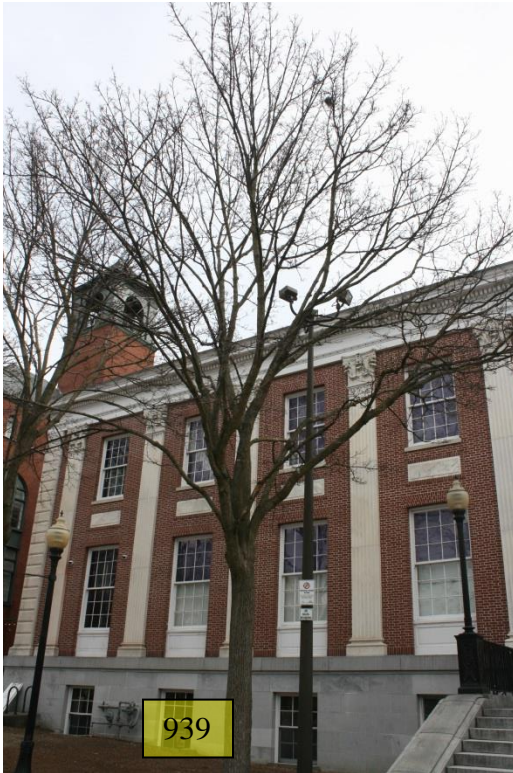
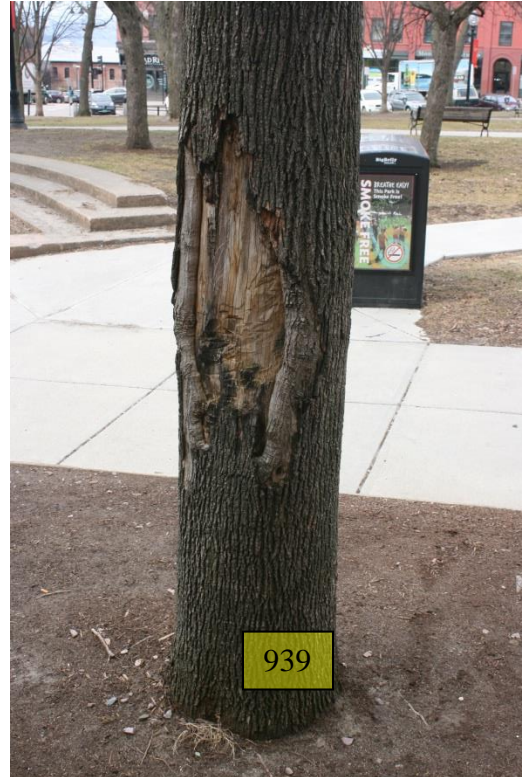
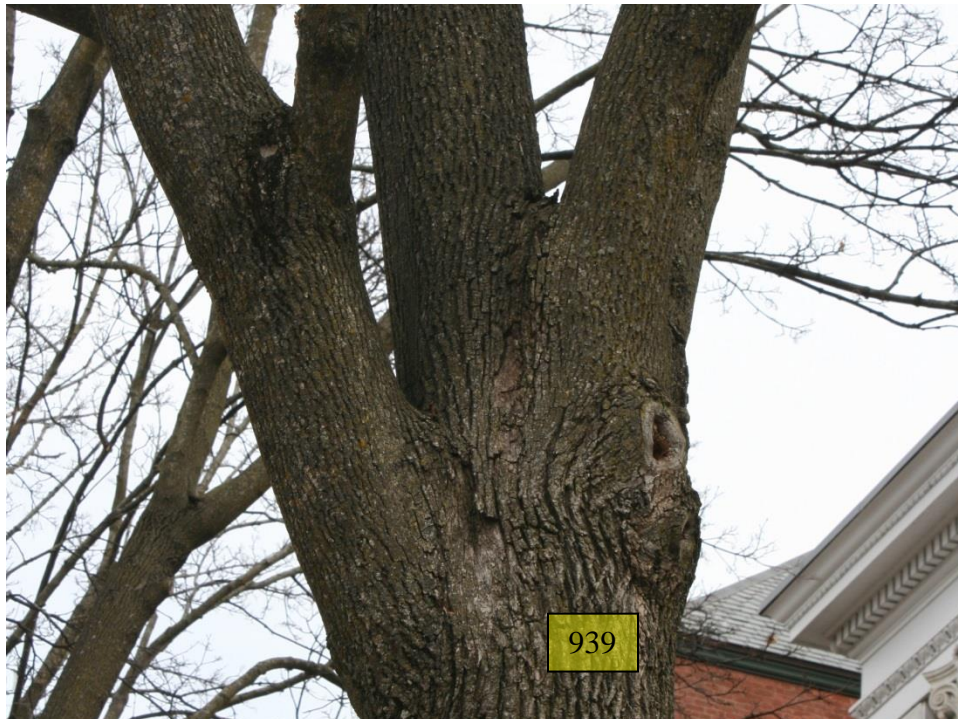
Tree 939 is a good representation of the Norway maples in front of City Hall. These trees may possibly be salvaged, but not likely worth the effort.

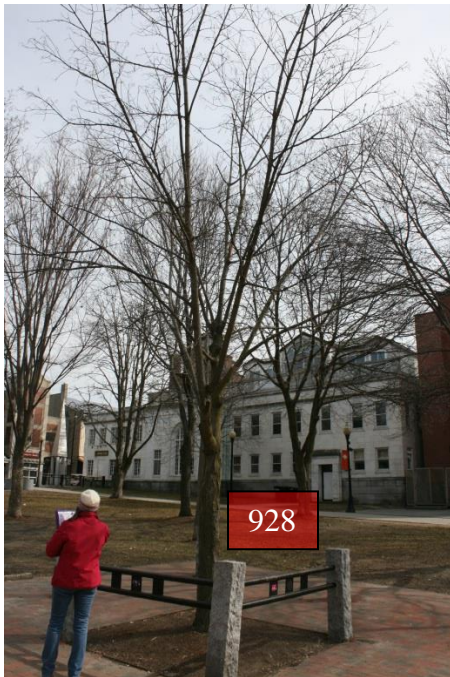
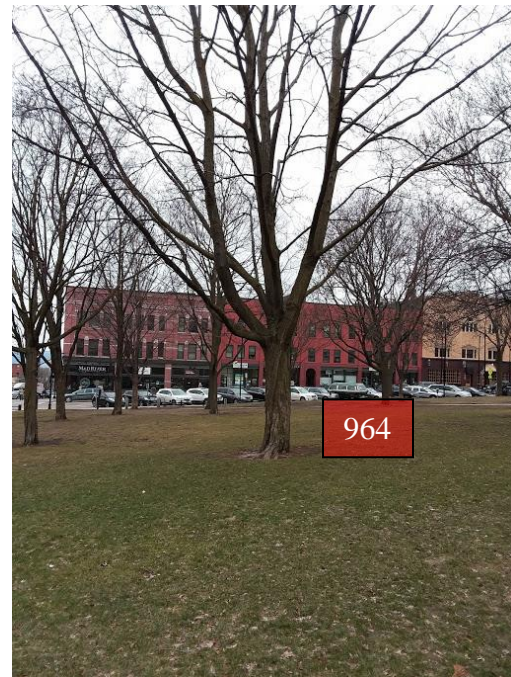
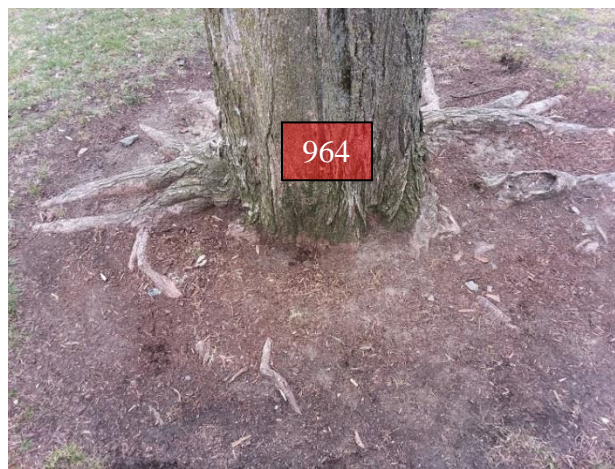
Upper left: Tree 928 struggles mightily in a small soil pit. Upper right: Tree 964, the best looking of a sorry lot. Bottom: No root flare is evident on the north side.

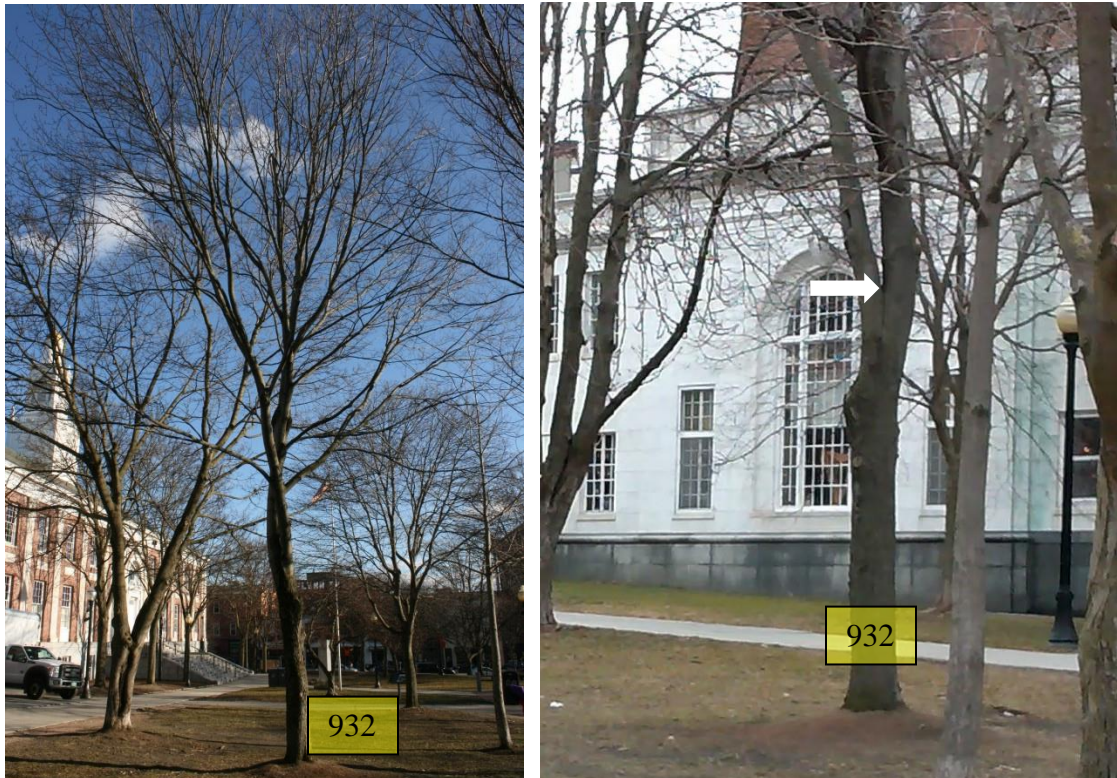
A mass of fibrous roots arise around the trunk of Tree 932. Large old wounds indicate decay cavities in trunk. Poor branch structure, included bark (arrow) and a weak crown make this tree a border line tree for preservation.

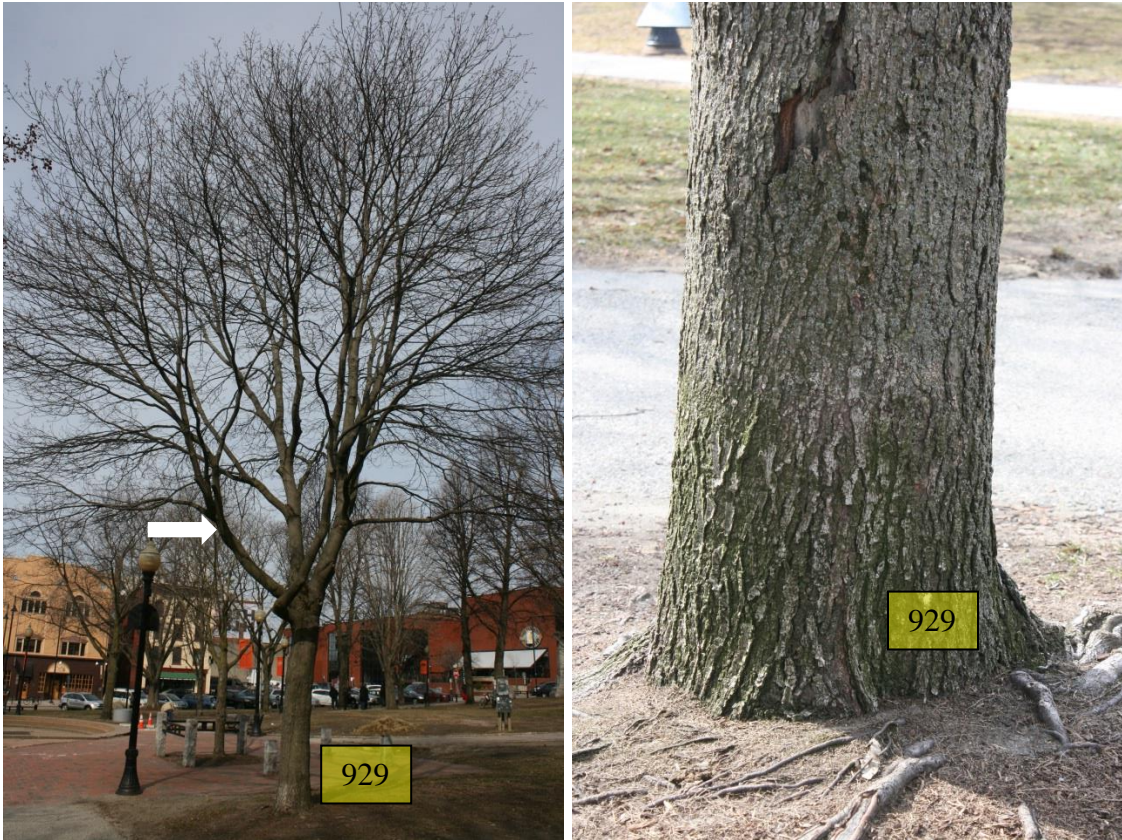
Tree 929 exhibits a fair crown structure and bud set. A wound in the trunk shows fair woundwood⁷ response. A reduction of the oversized lateral limb (arrow) is recommended. Compaction and girdling roots are of course an issue.

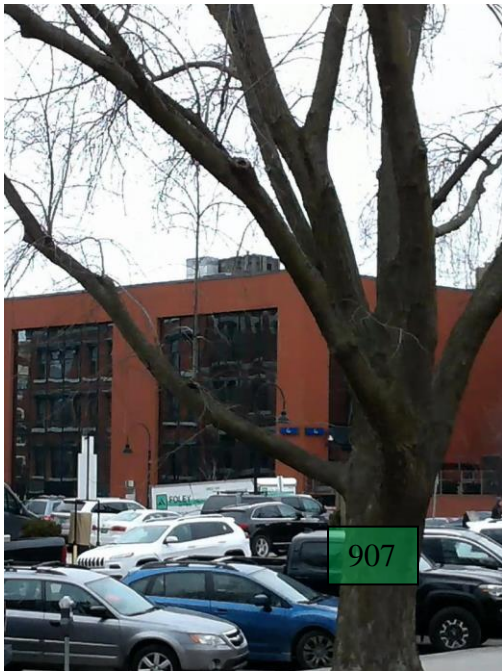
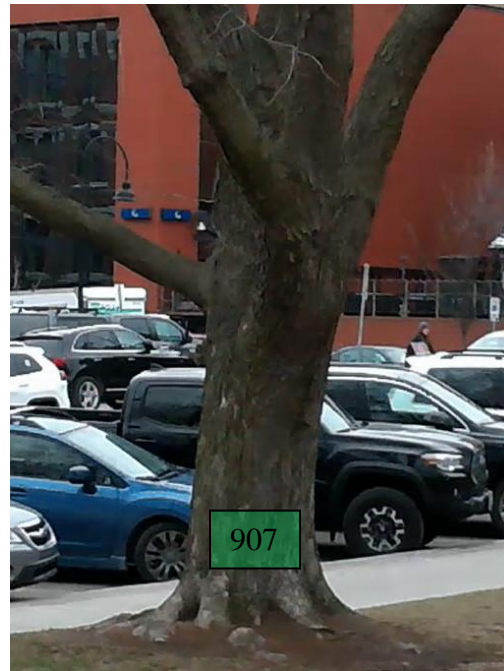
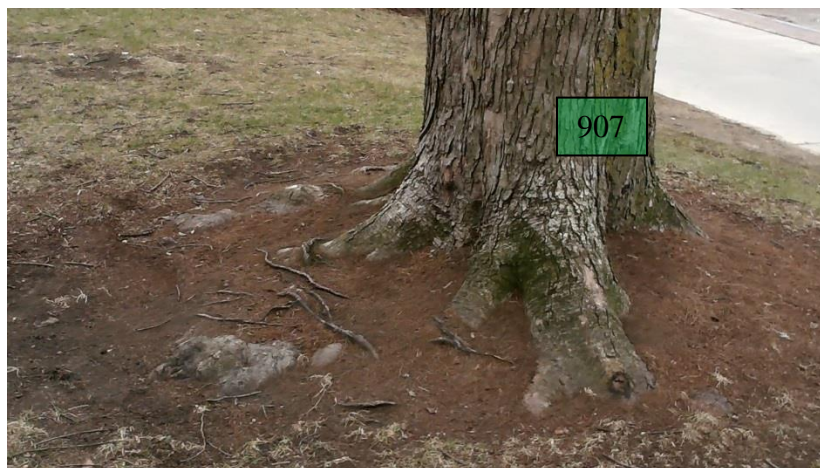
Silver maple 907

907	Silver Maple	30	Compacted soil. Some fibrous surface roots. Good root crown. Solid trunk arises to multi-stemmed crown. Good branch attachments. Well-formed crown
911	Silver Linden		Severely compacted. Girdling roots. Flattened area in trunk. Poor crown structure. Included bark.
978	Norway Maple	17	Compact soil. Girdling roots. Co-dominant stems at 20'. Large seam on east side of trunk. Recent wounding. Poor bud set, die back in upper crown
930	Ginkgo	8	Compacted soil. Surface roots. 50% of trunk wounded at base. Remaining trunk good. Good crown structure, fair bud set.
912	Red Oak	17	Compacted soil. Large girdling root to east. Flattened area to west. Solid trunk divides into v-shaped co-dominants at 18'. Old pruning wounds show fair closure. Weak, thin crown, bud set.
928	Sugar Maple	10	Limited, compact soil. Wounds on trunk. Poor structure. Severe crown die-back.
929	Red Maple	14	Compaction. Girdling roots. Surface roots. Wound in trunk at 3' with fair closure. 3 co-dominant stems arise from trunk at 10'. Fair-good scaffold limb structure. Fair bud set.

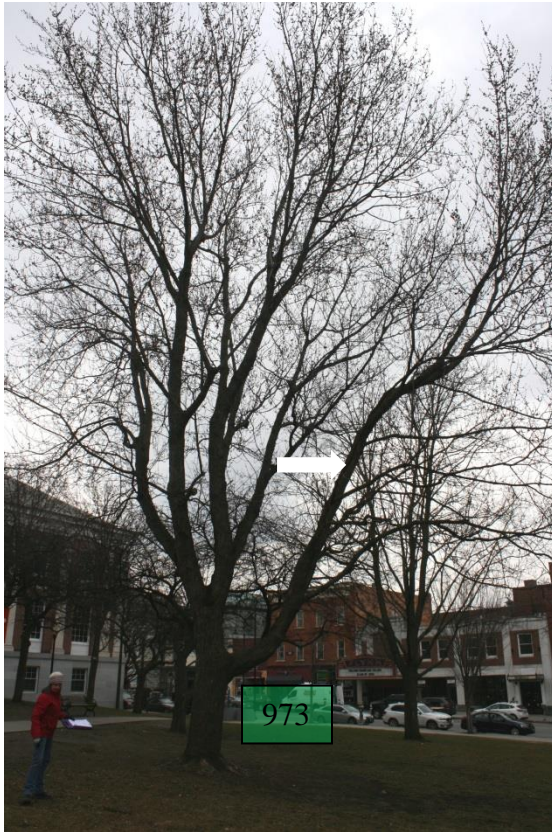
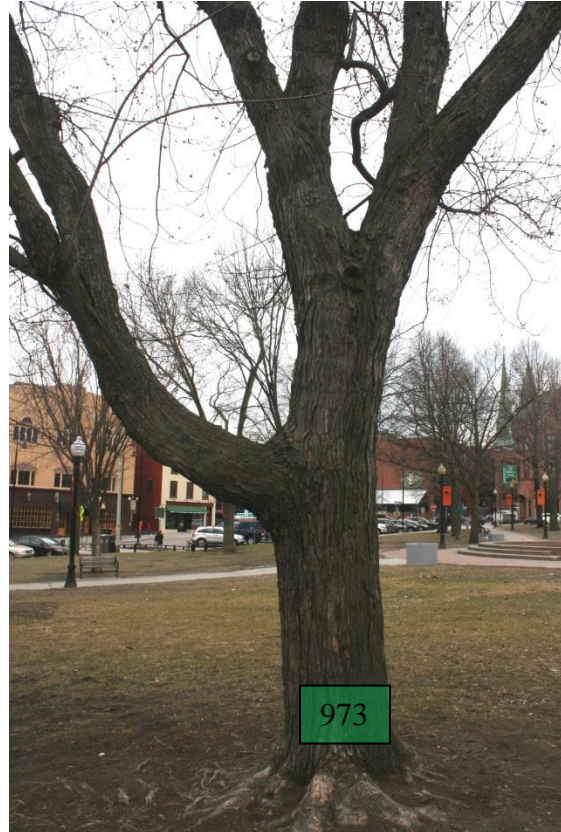
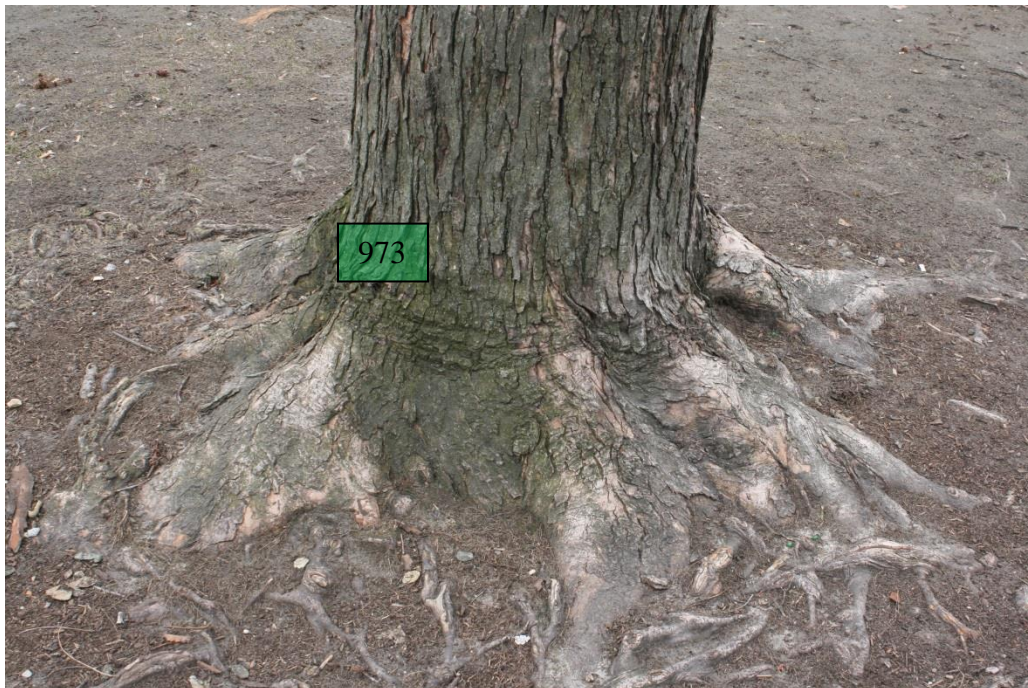
Silver maple 973 is one of the healthier specimens in the park. A reduction pruning on the large lateral limb (arrow) would be advised.

976	Crabapple		Not assessed.
975	Crabapple		Not assessed.
965	Crabapple		Not assessed.
973	Silver Maple	25	Compacted soil. Good root crown. Solid trunk divides into 3 major scaffolds Good branching attachment. Good bud set.
953	Zelkova	11	Compaction. Fair root crown, flat area on west side. Strong trunk. Fair crown structure for species. Some die-back. Weak bud set.
956	Honey Locust	17	Compacted soil. Some girdling roots. Flat side on trunk to west. Large lateral limb at 8'. Good branch structure and attachment. Good bud set.
954	Zelkova	11	Compacted roots. Fibrous surface roots. No visible root flare. Oversized lower lateral limb with poor attachment. Fair bud set.
957	Red Oak	19	Compacted soil. Surface roots. Good root crown. Strong trunk, slight lean to west. Good branch structure and attachments. Good wound closure. Fair bud set.
958	Zelkova	15	Compact soil. Good root crown. Multi-stemmed. Included bark. Oversized lower scaffolds. Fair crown structure, fair bud set.

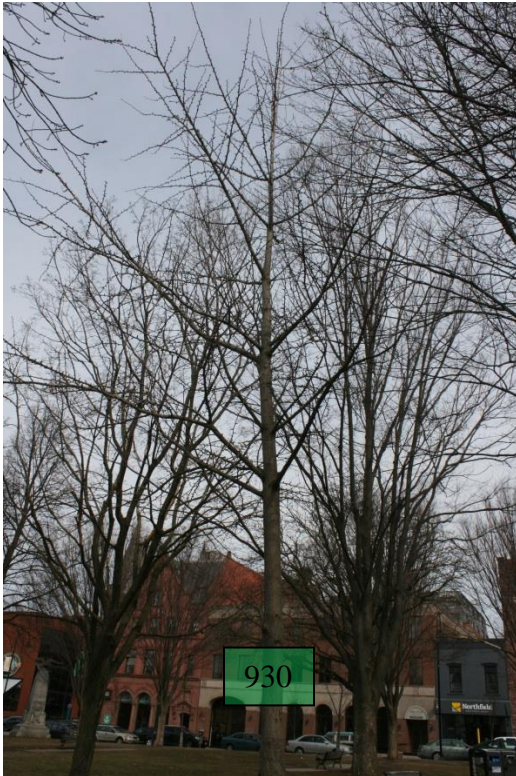
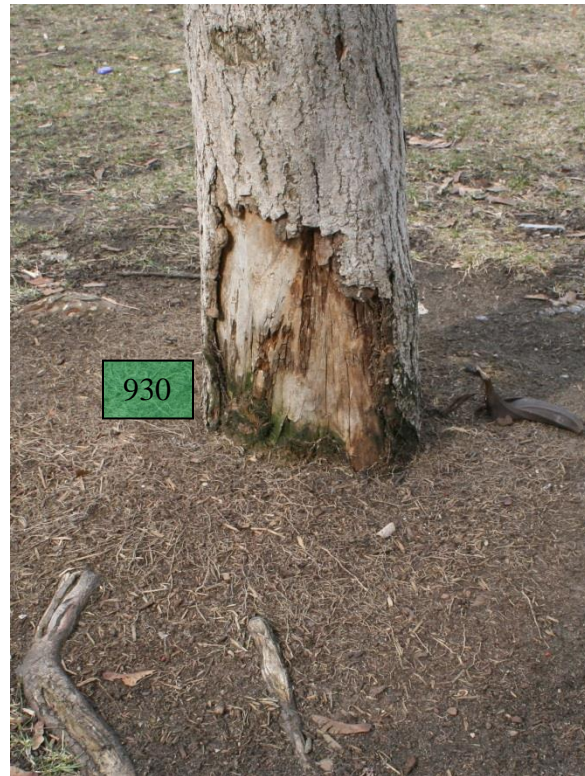
The lone Ginkgo in the park is suffering the same humiliations as the other trees, including a large wound at the trunk base. Despite it all, the tree still exhibits good form and a fair bud set.

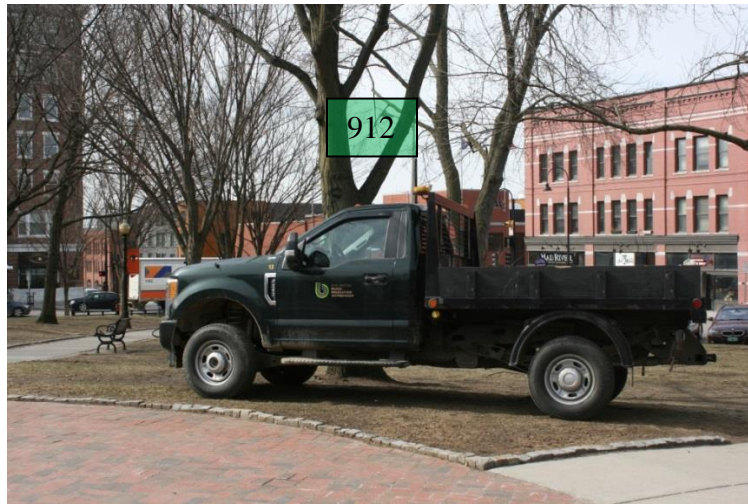
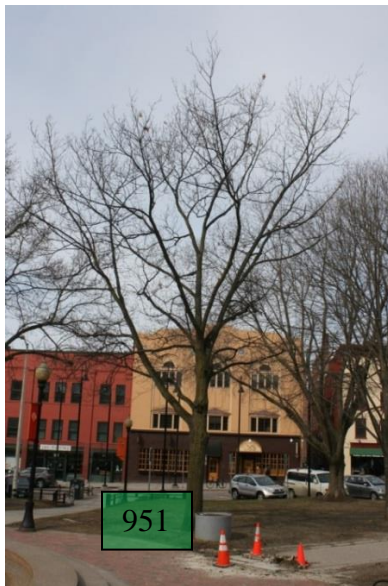
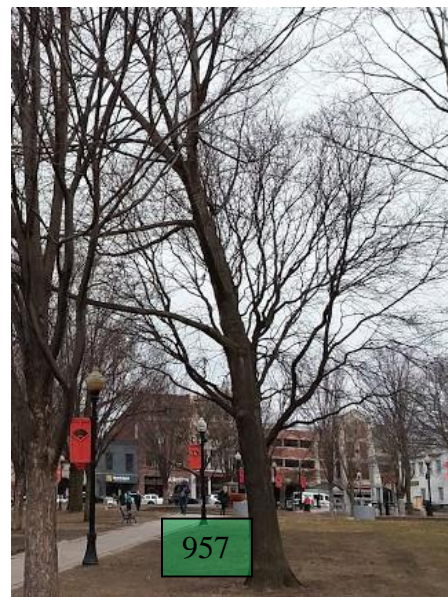
Above: A vehicle parked directly over the “Critical Root Zone”⁸ (CRZ) of tree 912 exemplifies the primary problem in the park; Compacted soil. Bottom left: Tree 951. Bottom right: Tree 957 displays a good root crown, but has a one-sided upper crown with a lean to the west.

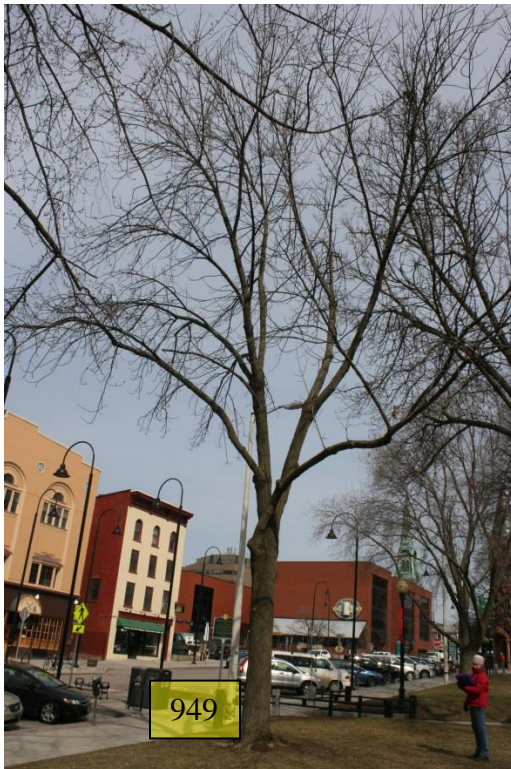
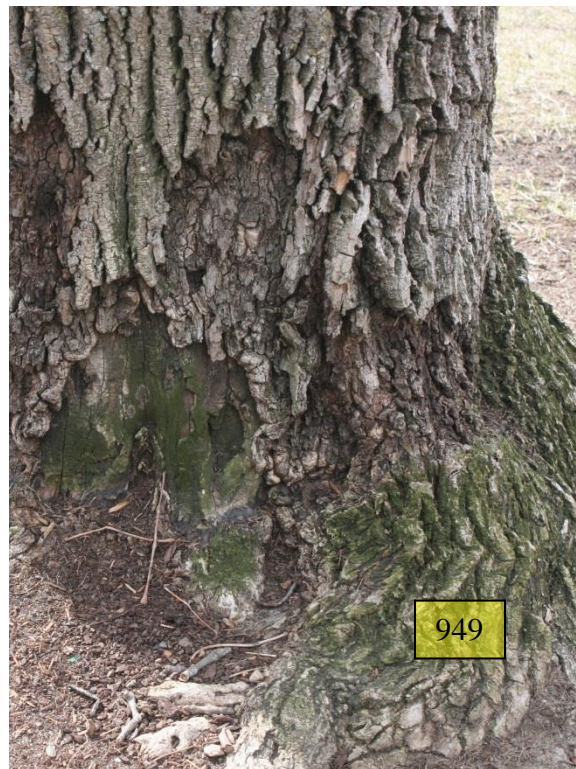
Tree 949

949	Green Ash	17	Compacted soil. Girdling roots. Mechanical wounding at trunk base. Good trunk. Good woundwood formation. Co-dominant stems at 18'. Fair crown, bud set.
950	Green Ash	22	Compaction. Girdling roots. Good root crown, solid trunk. Good woundwood formation. 3 major scaffolds arise 15' from base. Fair-good crown, bud set.
951	Red Oak	20	Compaction. Girdling surface roots. Flattened area on trunk to north. Strong trunk. 3 major scaffold limbs at 15'. Fair branch attachments. Good woundwood formation. Fair bud set. Sooty mold noted on trunk and limb bark.

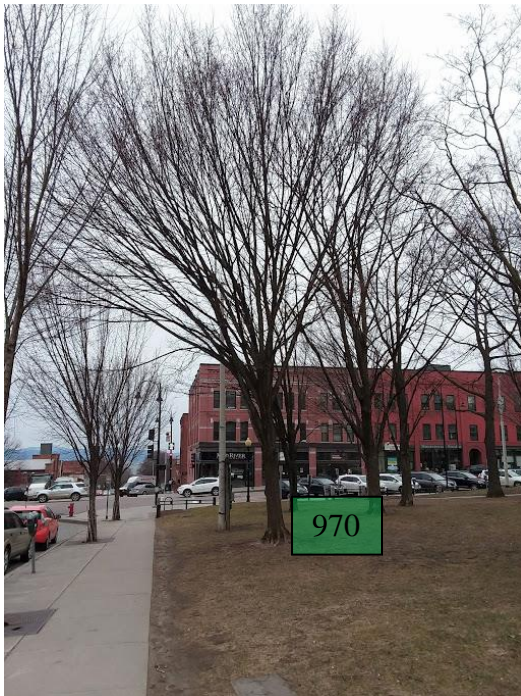
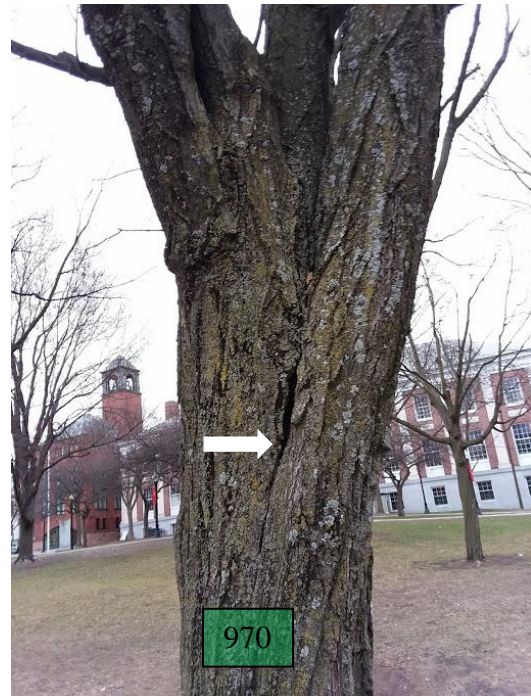
Growing in compacted soil, this lone Elm has a good root crown and solid trunk. The scaffold structure is fair. V- shaped multiple stem attachments with included bark arise from the trunk. The bud set and crown structure are good.

Tree 970 has a nice full crown, but displays typical structural defects (arrow) found on Elms.
