Silver Maple Assessments

Prepared for:
Tree Guy
2 Elm St
Treetown, MA

Prepared by:
Howard Gaffin
MCA #1468
BCMA # NE-0363B
RCA #458

December 11, 2018

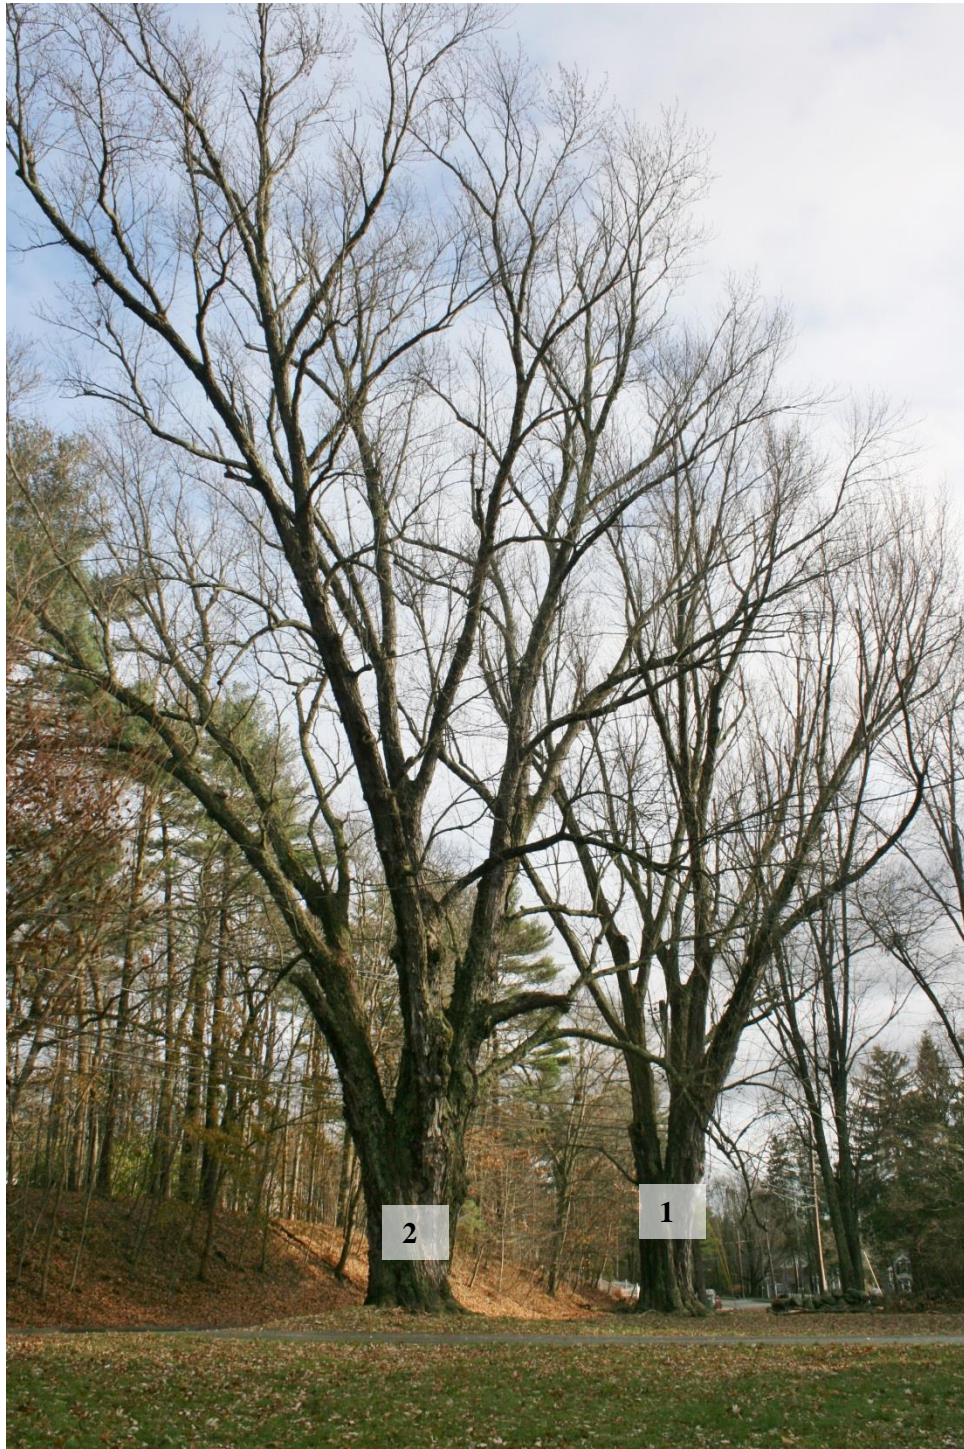
Image 1

These trees are in remarkable condition given their size and placement, enhanced by their proximity to open areas that have remained fairly undisturbed (image 1, pg. 9). Despite their size and advanced age, the relative health of the crown and quality of woundwood closure indicate these trees are still quite viable.

This image shows the trees looking north along Elm St.

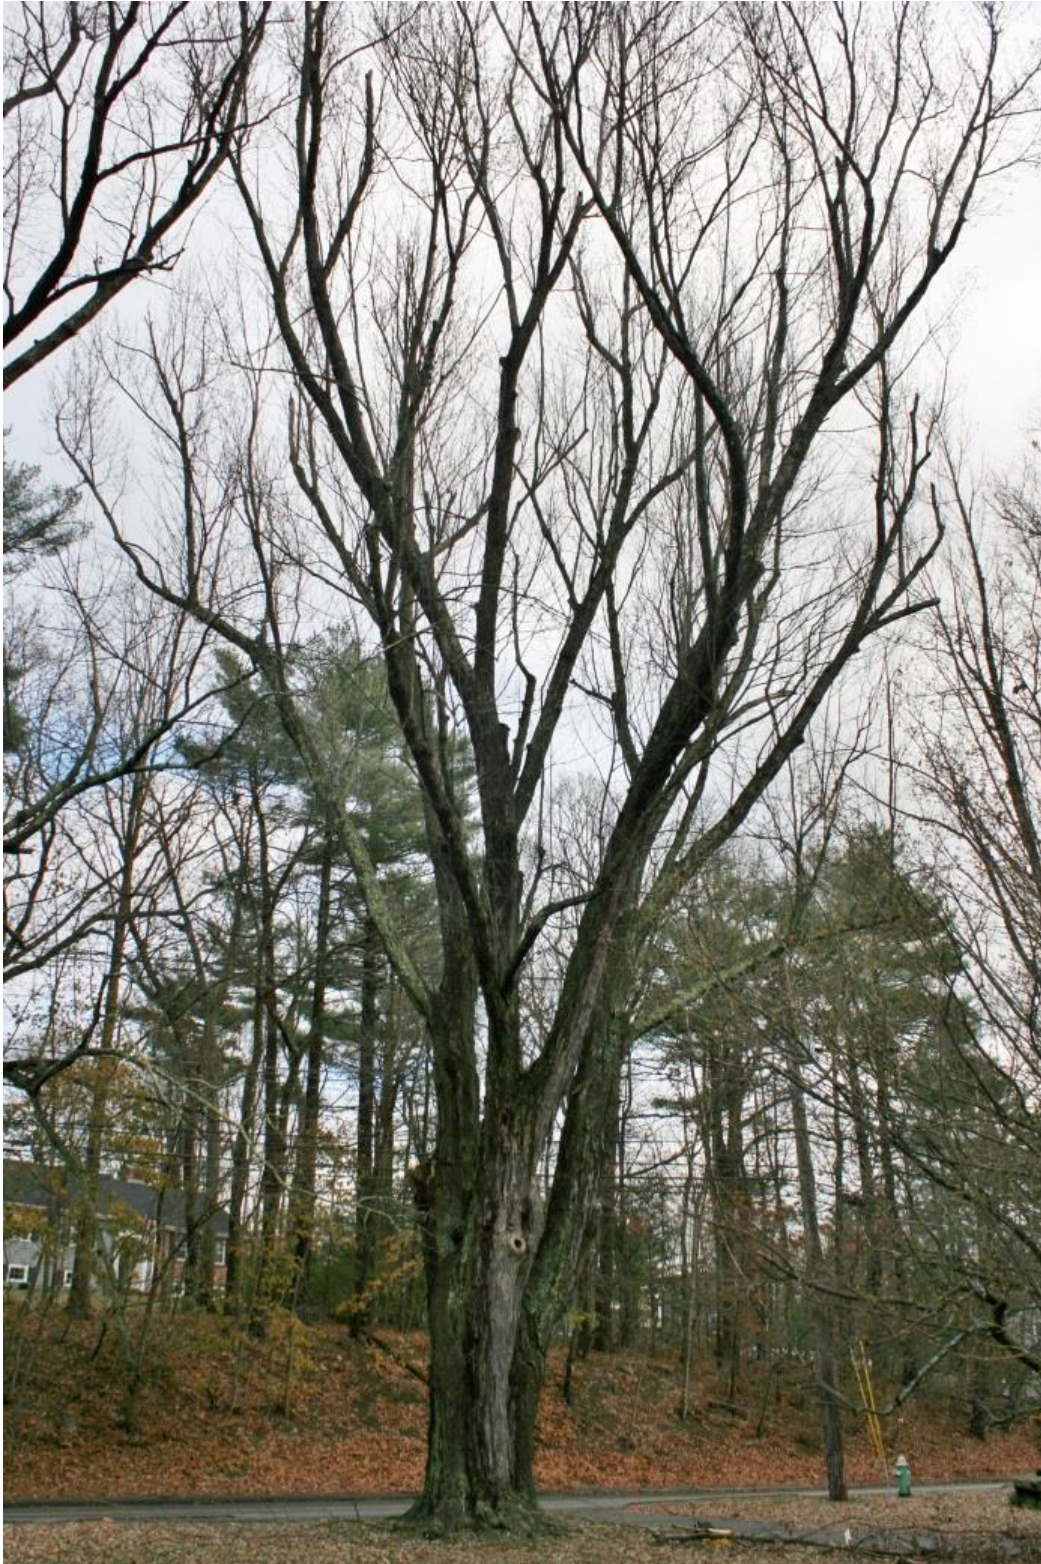
Image 2

Tree 1 will be most impacted. The driveway to the north will be extended and the utilities moved.

The majority of the root system of Tree 1 will remain undisturbed. Grades shall be carefully considered to avoid changes to current drainage patterns. Preserving the integrity of the roots growing under the existing driveway/proposed entryway however, will be a major challenge. Utilities will be moved and the pavement area extended to the south. Careful excavation and examination of this area will be required to make informed decisions regarding the driveway design.

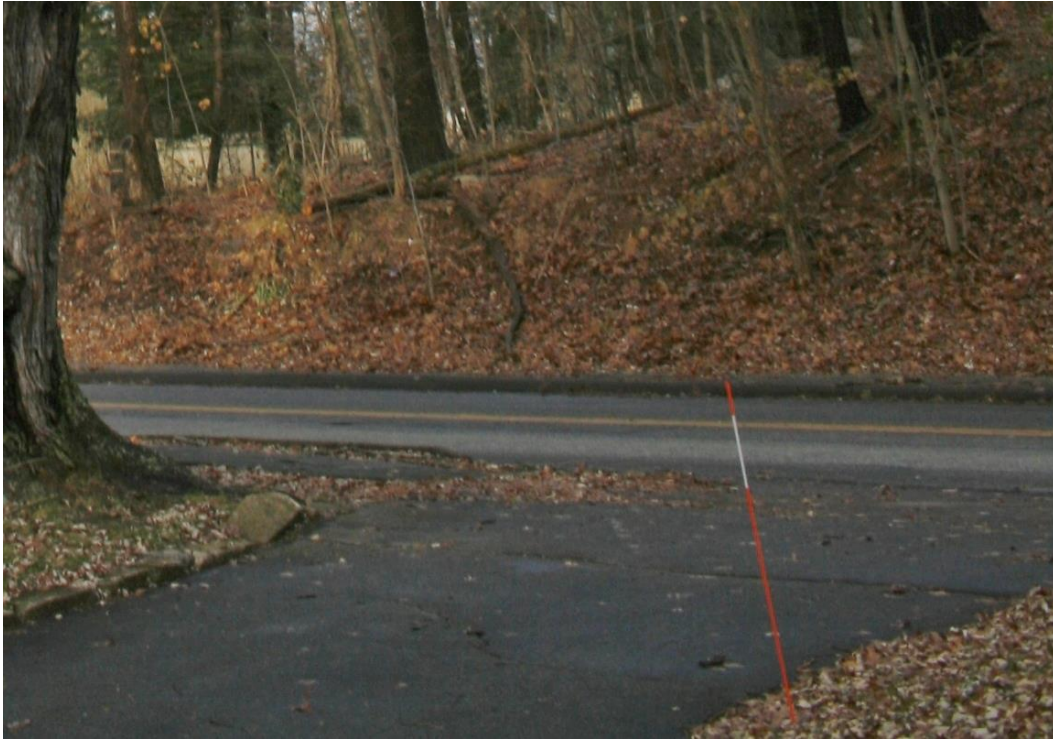
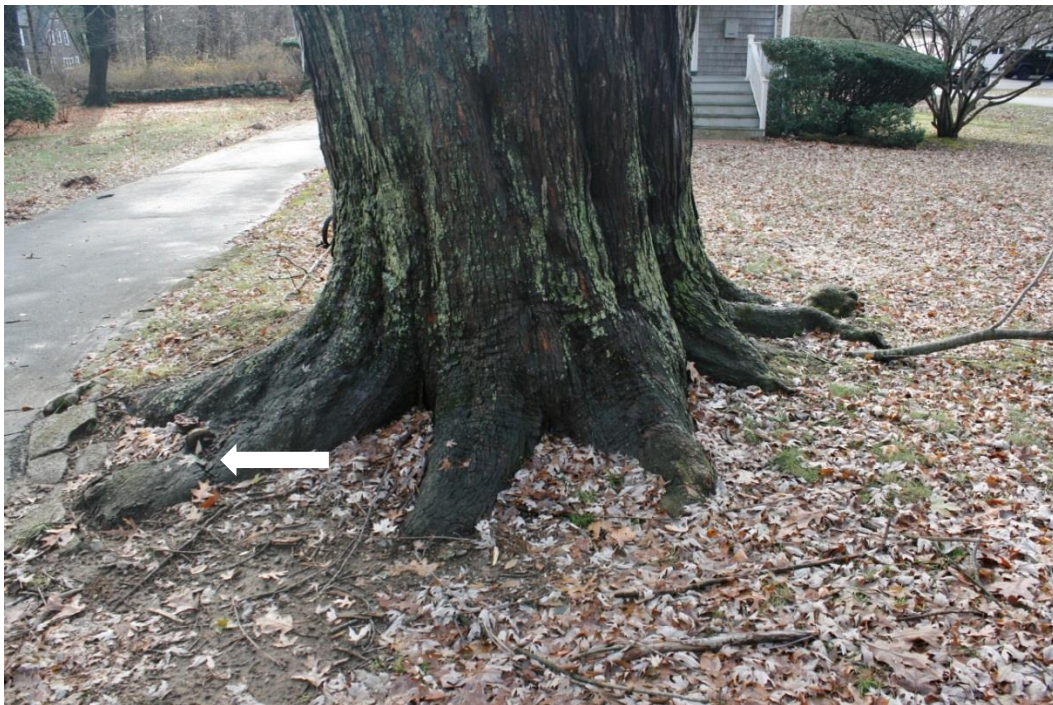
Images 3 and 4

The root crown and buttress roots appear solid. One area to the south-east exhibited a fungal bracket, and sounding with a mallet indicated an area of decay where it meets the pavement edging (image 4, pg. 11). The lower trunk immediately divides into 3 major stems. Two large cavities in close proximity are present on the lower portion of the scaffold growing to the west. The other major scaffolds grow to the east and south-east, over the road, driveway and utilities. The scaffold to the east extends over the road and has a large cavity at the base (images 5 and 6, pg. 12). The structure is fair and the branch unions appear sound, with minimal included bark observed at branch unions. Dozens of pruning wounds are visible throughout the crown, especially toward the road and utilities. Woundwood formation appears normal. Several dead limbs 4’ in diameter are present (image 7, pg. 13). No foliage was present, but the buds looked to be of normal size and density. No serious areas of die-back were evident in the upper crown. Satellite imagery from 2014 shows a fairly healthy crown with good foliage color and density (image 8, pg. 14).

Roots can be seen uplifting the driveway in the top image. The lower image shows the root crown and buttress roots, which appeared and sounded solid, except for the area indicated by the arrow.

- Remove existing asphalt. Expose roots using air excavation and hand tools.
- Document exposed roots and make determinations regarding root preservation and/or pruning
- Test the exposed sub-soil to determine suitability as a base material
- Adjust grade so pavement is built on top of natural grade
- Provide plans to either backfill with an acceptable base material or bridge roots using pier foundations
- Proposed plans shall optimize the distance from the trunk to the pavement edge.
- Use pavement types that require thinner sections

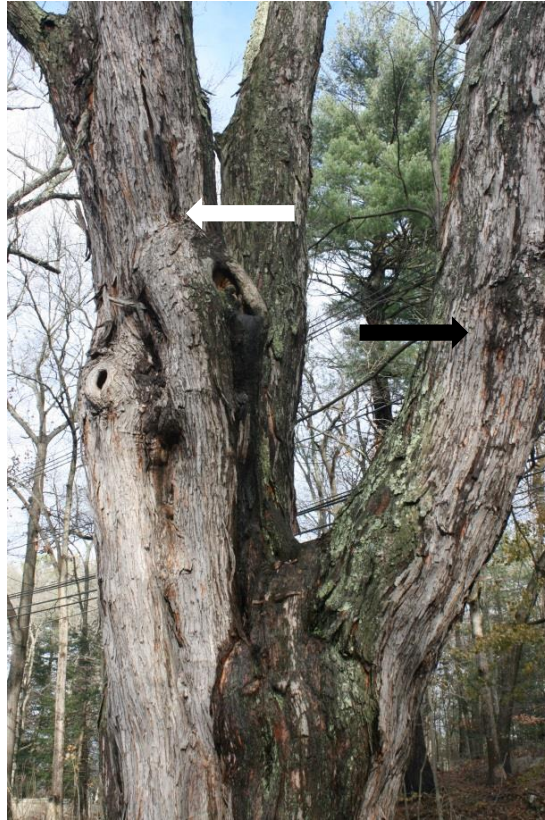
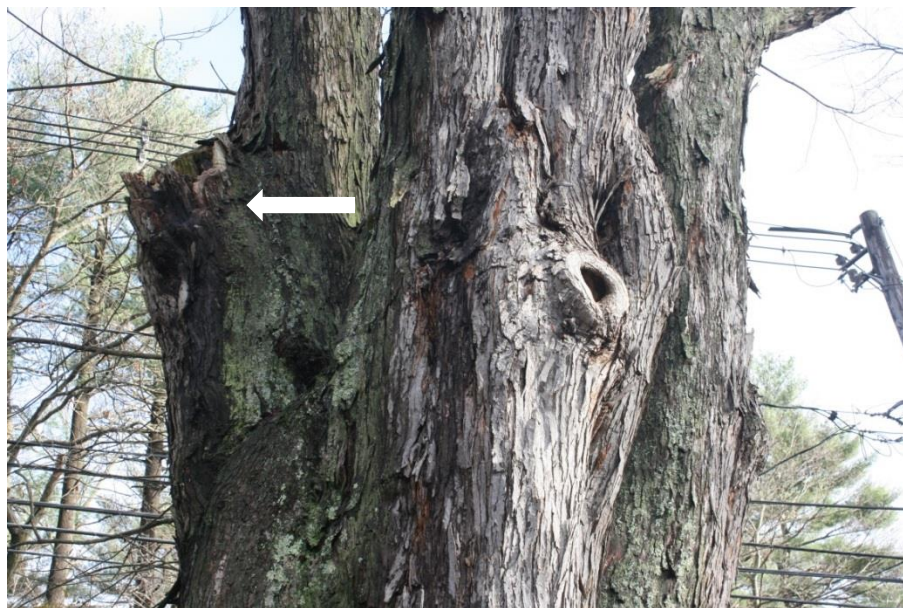
Images 5 and 6

The images show where the tree divides into 3 major scaffolds. The scaffold growing toward the west (arrow) has 2 major cavities in close proximity. The one growing toward the utilities (black arrow) has a strong union. The scaffold growing over the roadway to the east (arrow, lower image) also exhibits a large cavity at the base. Woundwood formation is good, but all these areas should be further investigated to determine the extent of decay.

Risk Rating: Moderate-High. Risk can be reduced to Low-Moderate by performing a crown cleaning and reduction pruning

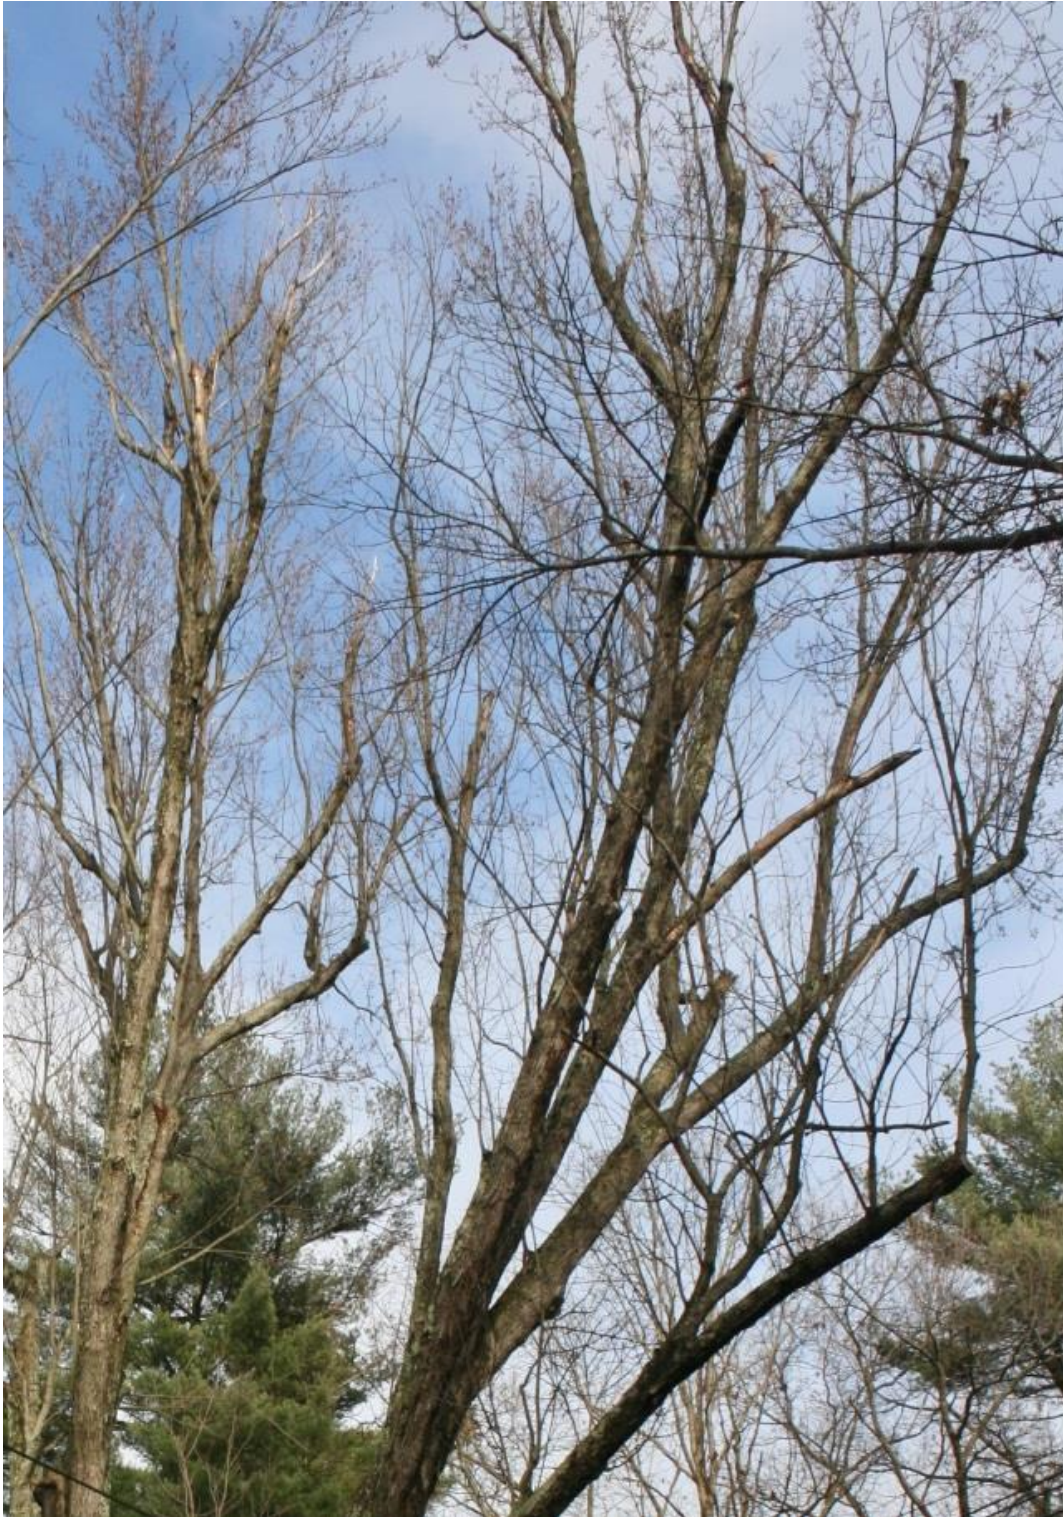
Image 7

The upper crown has a moderate amount of deadwood over 4 'in diameter growing over utilities and the roadway.

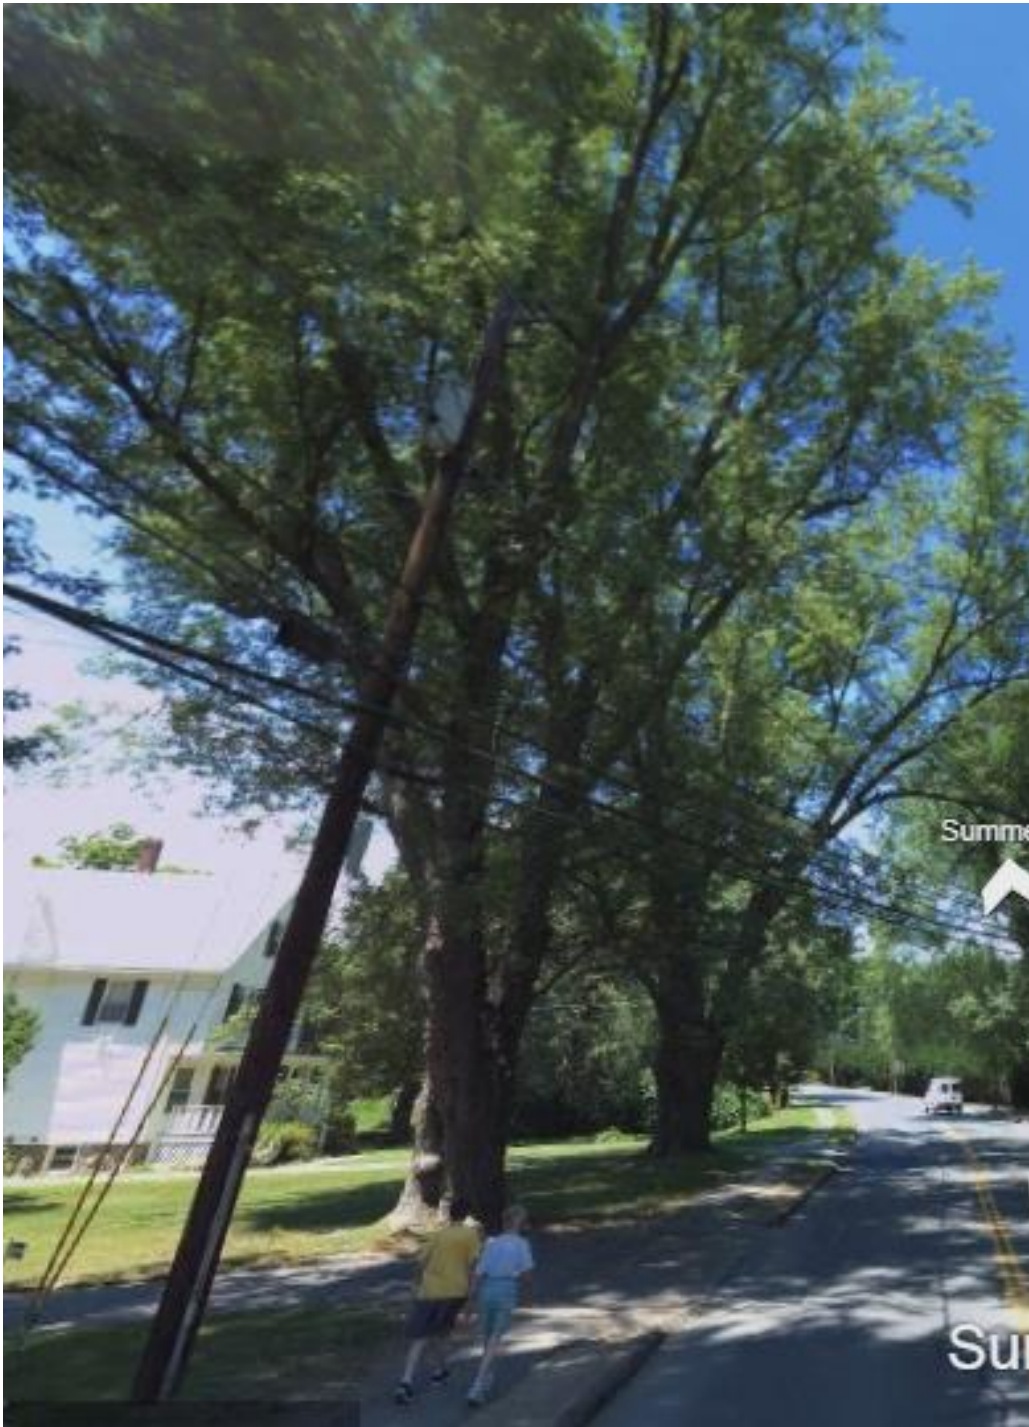
Image 8

This 2014 image from Bing Maps shows a view of Tree 1 looking south along Elm St. The foliage appears to be of normal density and color.

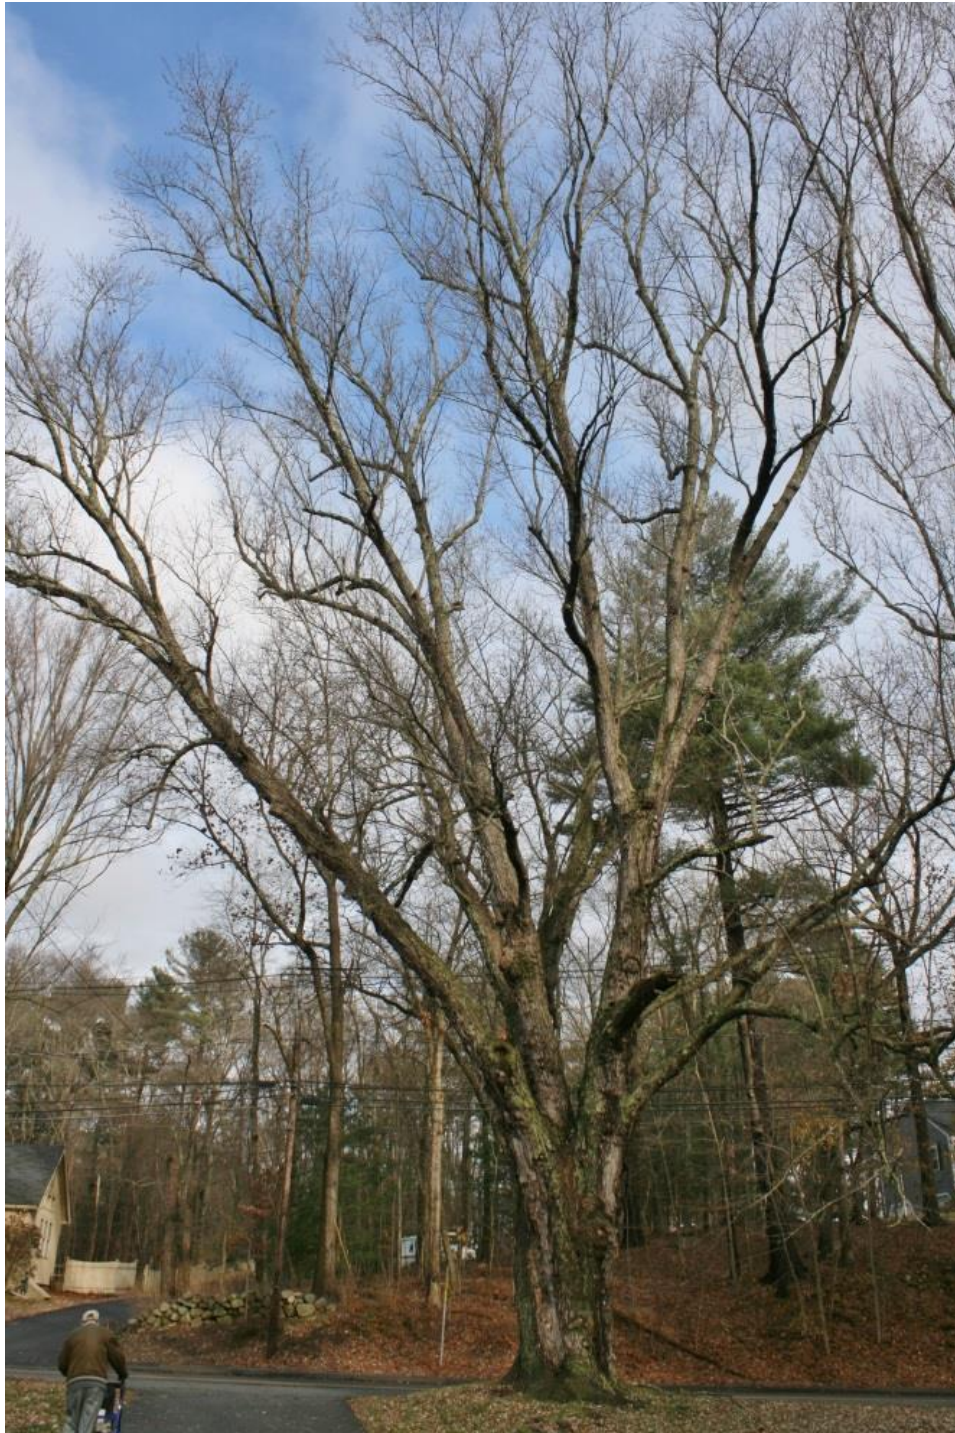
Image 9

Tree one’s partner is also located along the road near an existing driveway entry to the north of the trunk (image 9, pg. 15). The same open area is available for roots as Tree 1, as well as more open area available on the other side of the driveway. Surface roots abound a good distance from the trunk. The root crown is solid with no visible signs of wounding or decay (images 10 and 11, pg. 16). The lower trunk is solid and divides into 3 major scaffolds. A large cavity with good woundwood is present on the scaffold to the north growing over an existing driveway and house utility lines. The scaffold to the east grows over major utilities and the road. The remaining scaffold grows to the southwest, over the open lawn (image 12, pg. 17).

This image shows Tree 2 looking east toward the street.

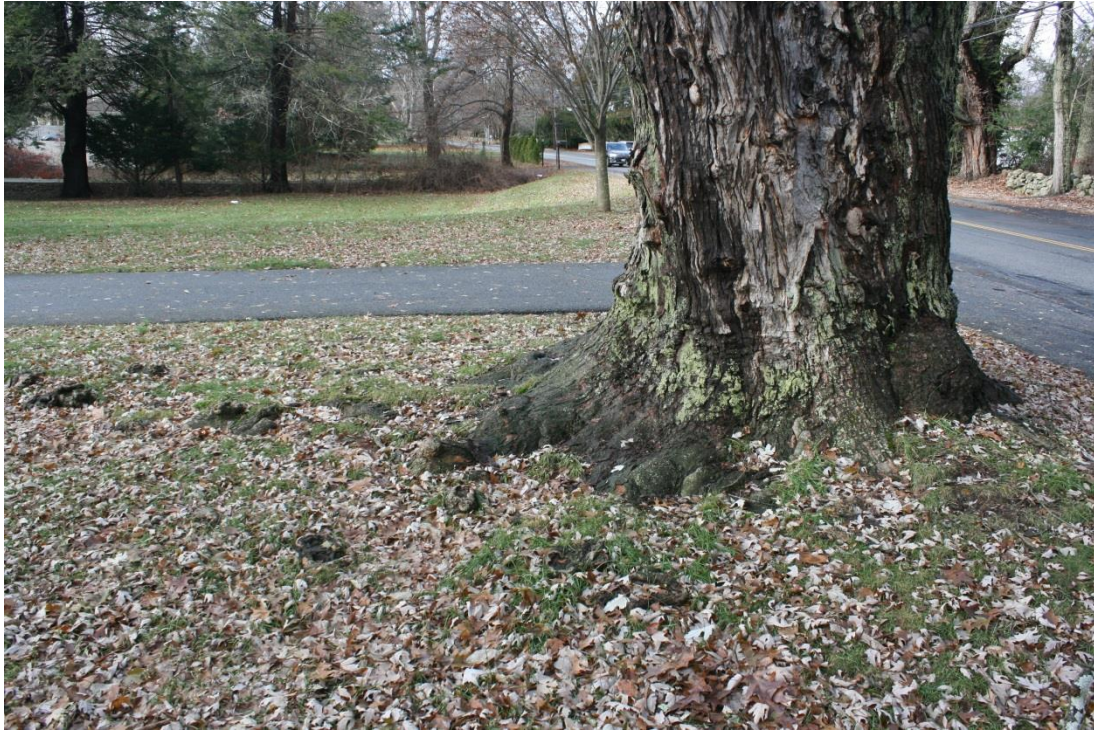
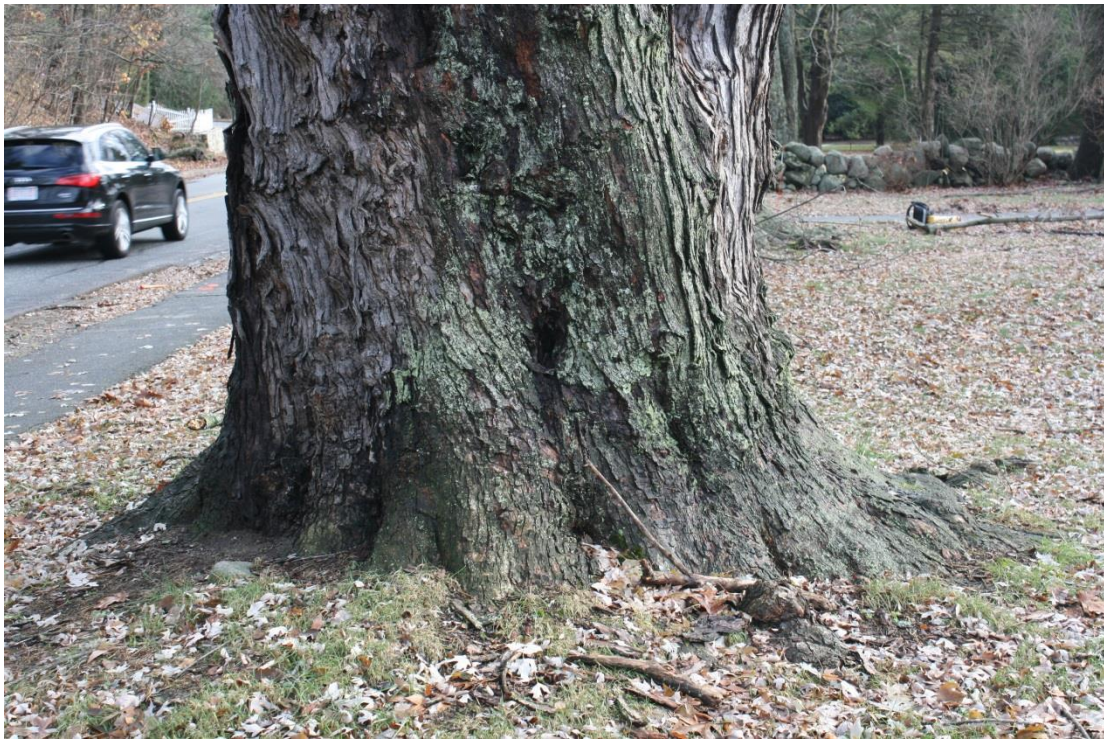
Images 10 and 11

The above image shows the root crown and large surface roots extending into the lawn area. Another image from the other side is shown below. The root crown appears and sounds solid. No external signs of decay were noted.

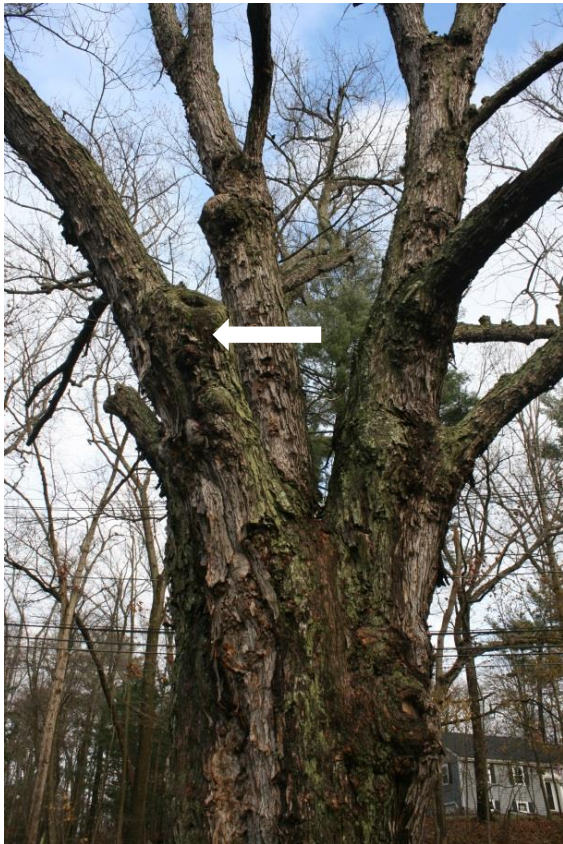
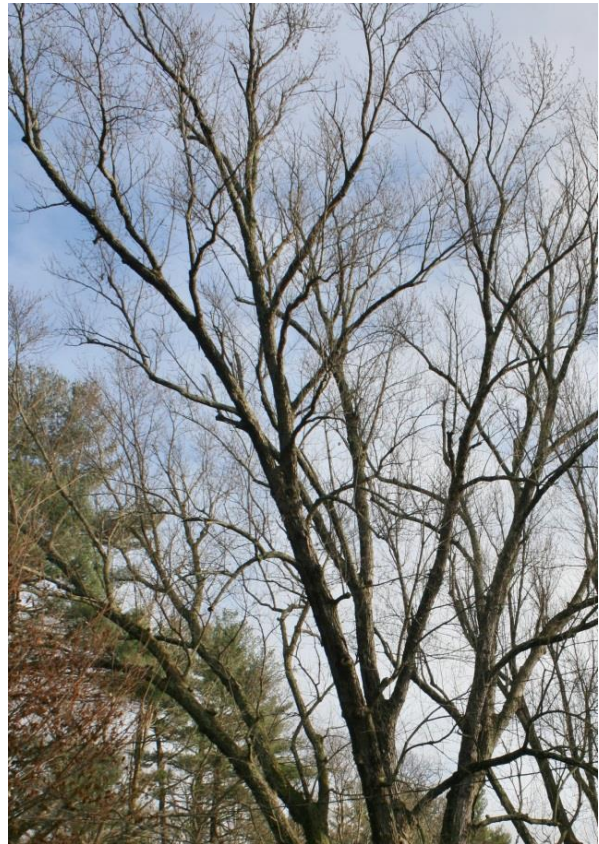
Images 12 and 13

The crown structure and branch unions are good, relatively free of v-shaped unions or included bark. Two long stubs remain where the limbs failed in the lower crown. Dozens of pruning wounds are visible throughout the crown, especially toward the road and utilities. Woundwood formation appears normal. Little to no deadwood was visible in the upper crown (image 13, pg. 17). Bud set looked to be of normal size and density. No serious areas of die-back were evident. Satellite imagery from 2014 shows a fairly healthy crown with good foliage color and density (image 14, pg. 18).

The top image shows where the tree divides into 3 major scaffold limbs. The scaffold to the left has a large cavity near the base (arrow) and grows over a house utility line and driveway. The middle scaffold grows over the roadway. The scaffold to the right grows primarily over the open lawn. The upper crown exhibited little deadwood, good branch structure, and good bud set.

Risk Rating: Moderate. Risk can be reduced to Low by performing a crown cleaning and reduction pruning

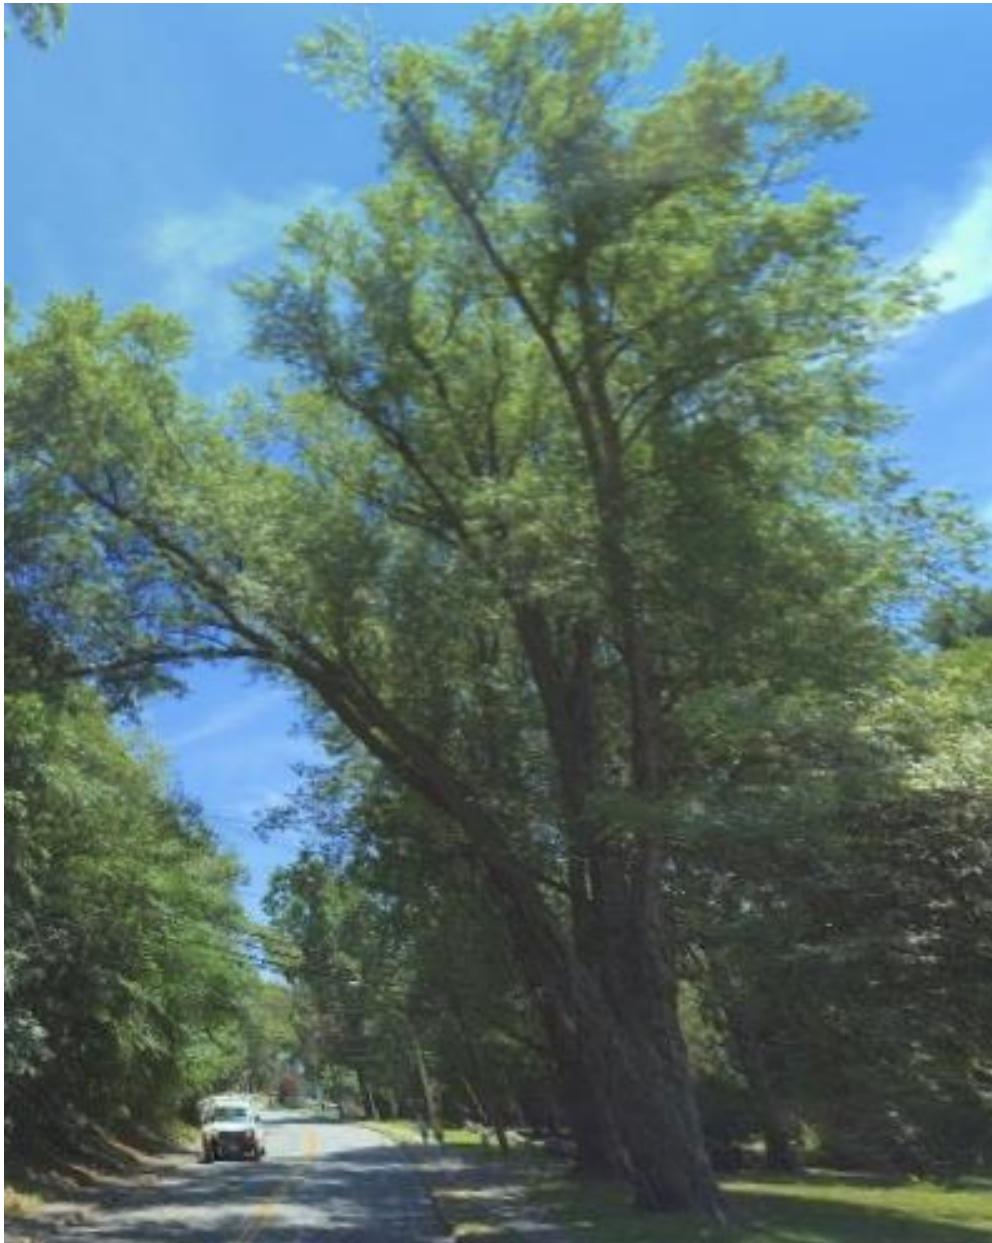
Image 14

This 2014 image from Bing Maps shows a view of Tree 2 looking north along Elm St. The foliage appears to be of normal density and color. No obvious die-back is visible.
