BREAKOUT SESSION

Autothrottle Use with Autopilot Off

Bill McKenzie
Flight Crew Operations
Boeing Commercial Airplanes
May 2004

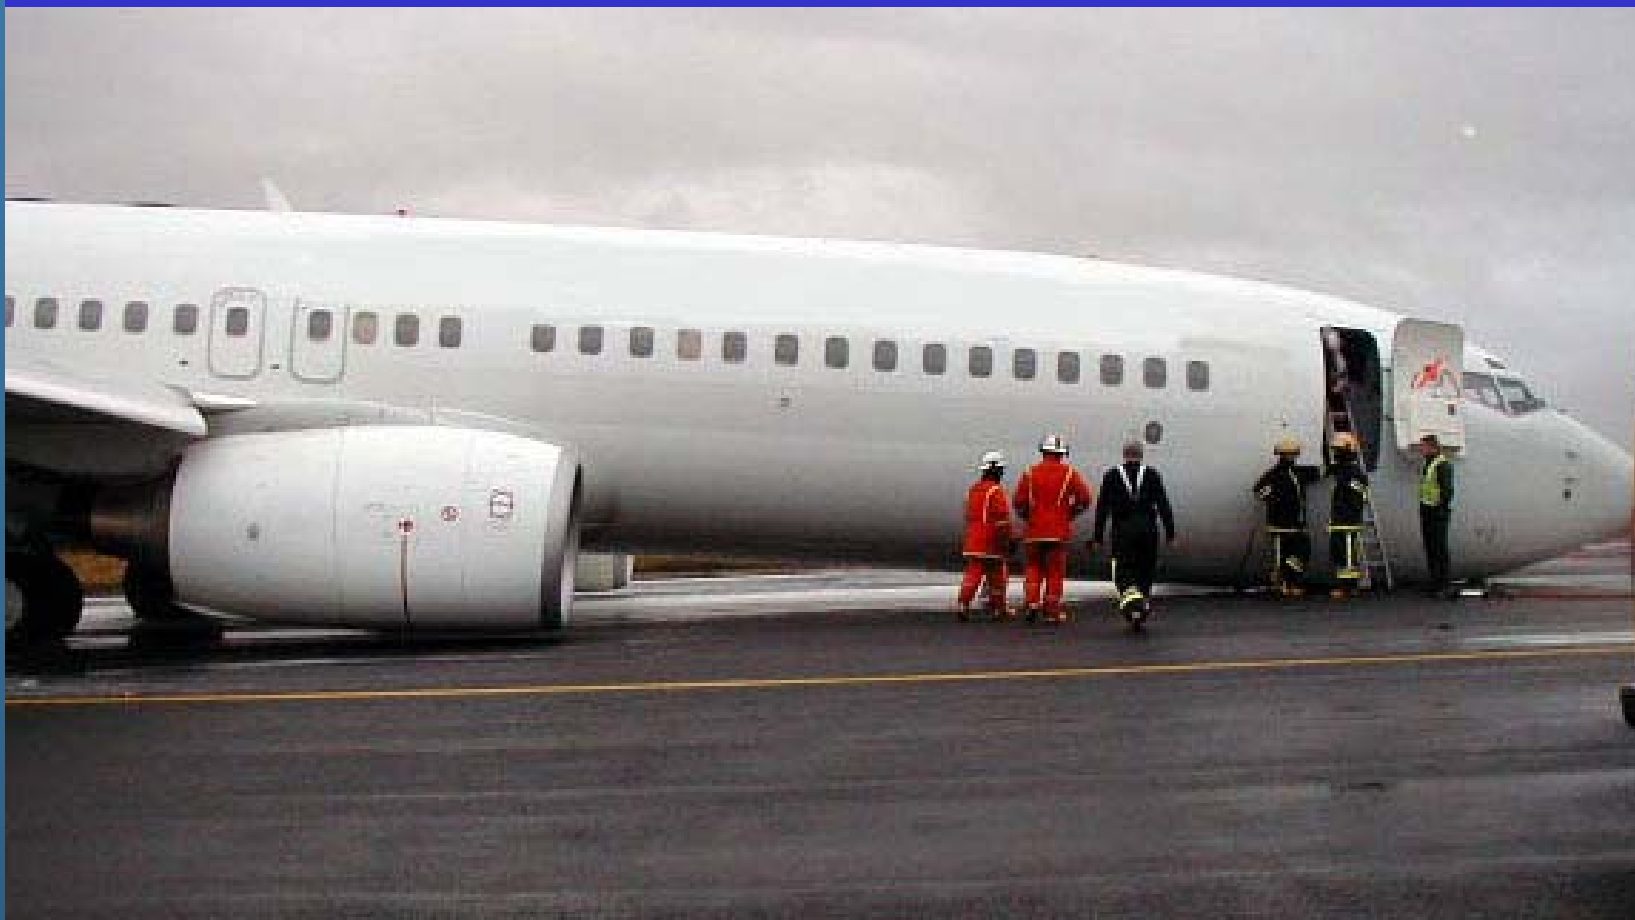
737 NG Incident

- The gusts, turbulence and autothrottle engagement contributed to an unstabilized manual final approach.
- At 0.6 miles and 14.4 seconds to touchdown, the “glideslope” warning sounded.
- Over control of pitch attitude started after a high rate of descent occurred at 100 ft at 0.25 miles and 5.4 seconds from touchdown, causing a “sink rate” warning.
- Over control continued throughout the flare. Nose landing gear collapsed.

737 Nosegear Collapsed on Landing

- 3.1.8 The autothrottle remained engaged after manual control was initiated on the approach, and remained engaged until after the touchdown, when it disconnected.
- The gusts and turbulence contributed to over control of the pitch attitude during the flare resulting in a hard touchdown. The aircraft pitched down. This caused the aircraft to contact the ground nose gear first, with a longitudinal deceleration of 0.4 G. Shortly thereafter, the main gear contacted the ground coincident with a vertical load factor of 3.8 G.

- Use manual thrust control when in manual flight due to potential “pitch coupling”
- Unable to provide NTOs due to accident & incident history
