CDR BULLETIN

MASONRY EFFLORESCENCE

August 2007

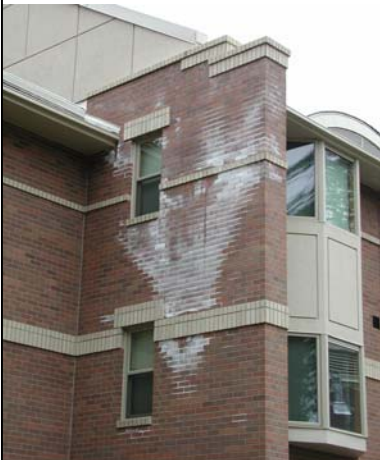
Efflorescence and calcium carbonate staining can occur during or after construction is complete. Both are white in color and are the direct result of moisture in the wall. Efflorescence appears as a powdery salt residue, while calcium carbonate appears in hard, crusty stains and in some extreme instances forms stalactite-like features.

Excessive efflorescence or calcium carbonate staining on the face of the masonry wall usually is the result of one of the following:

1. Too high a water content in masonry units and/or mortar during construction.
2. Lack of physical protection of the building during construction in wet weather
3. Ineffective flashing and coping assemblies to prevent rain water from entering the wall.
4. Lack of cleaning and sealing of the veneer following the curing of the mortar.

If the masonry veneer is applied over a wood frame wall, continued efflorescence or calcium carbonate staining could signal deterioration in the structural framing.

While efflorescence and calcium carbonate involve a different process and result, the cure for each is proper construction, cleaning, sealing and maintenance of proper weather proofing assemblies to minimize water penetration into the masonry wall.
