Midcoast Community Council

Date: June 28, 2017

Subject: **PLN2016-00327 after-the-fact CDP to legalize remediation performed in spring 2017 for unpermitted grading and vegetation removal that occurred in spring 2016.**

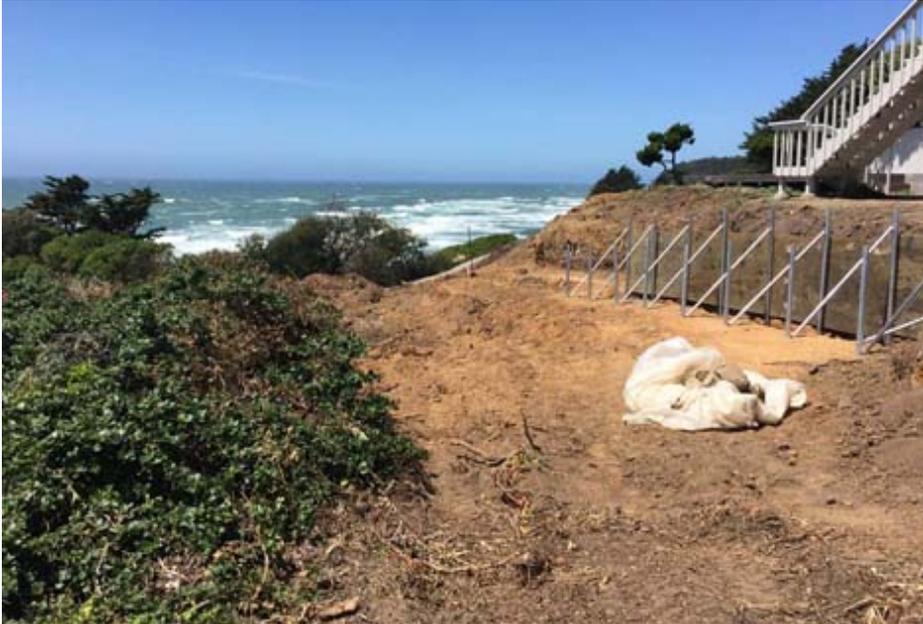
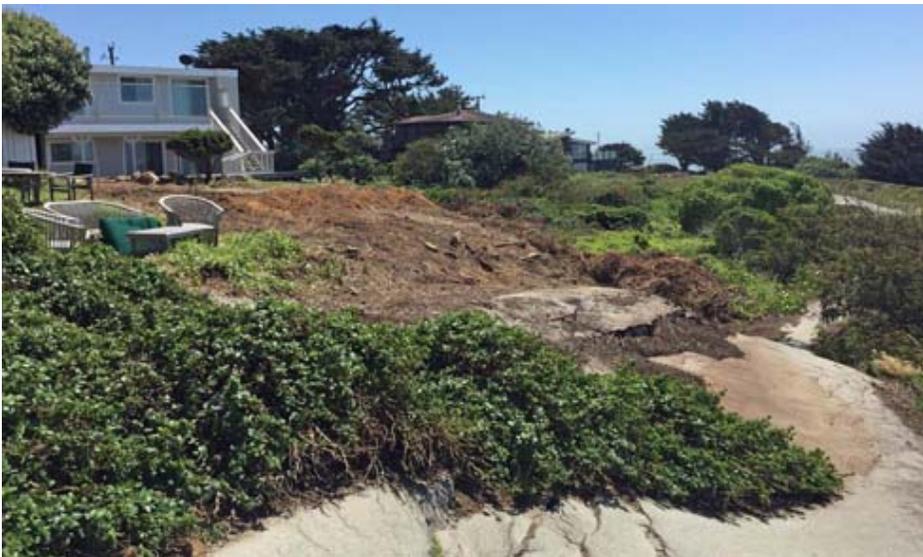
Attached photos show the remnants of the low-growing Ceanothus shrubs on neighboring lots after the initial destruction in April 2016. Also included is photo from project referral showing mass of cape ivy in foreground.

Ceanothus on left

Please include Condition of Approval for a landscape restoration planting and maintenance plan which must include the entire disturbed area (Ocean Blvd and adjacent parcel), in order to succeed. Beyond the initial infertile seed cover crop, the plan should include replanting of appropriate native coastal shrubs including the Ceanothus that was so successful there.

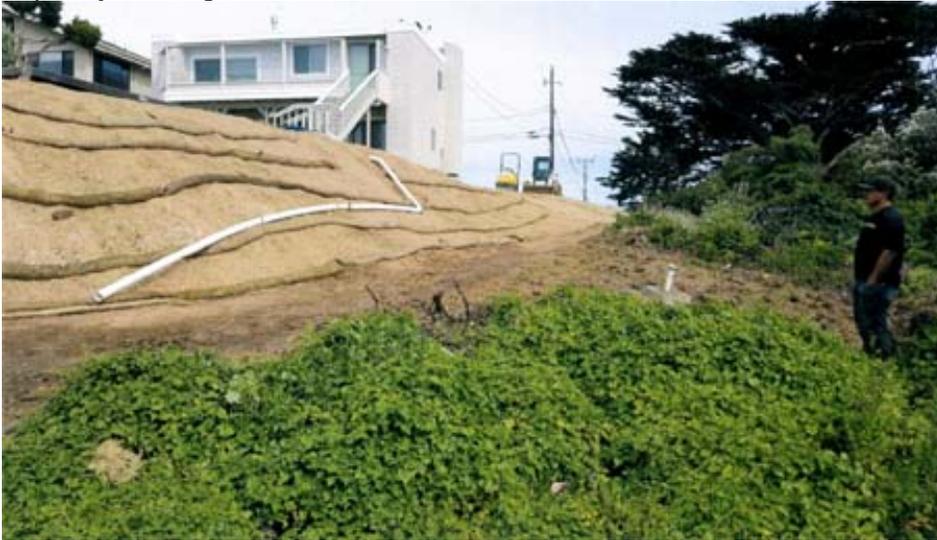
In April 2016 the site was cleared of all vegetation out to the center of Ocean Blvd right of way and across about half the adjacent undeveloped parcel to the west (APN-037-258-100, under separate ownership). The mature ground-cover species of native Ceanothus shrubs that previously covered the area provided deep-rooted slope soil stability, weed suppression and natural beauty along this informal much-loved section of coastal trail, even growing out across the distorted abandoned asphalt. The disturbed area is now infested with annual weeds and perennial cape ivy, an alien invasive perennial vine/ground cover that blankets and kills all other plants. Cape ivy propagates from any stem or root segment so the clearing/grading process likely spread it all around in the soil and debris.

Cape Ivy in foreground
