ISSF 2010: Session 6

**Integrity Inspection of Dry Storage Casks
and Spent Fuels at Fukushima Daiichi
Nuclear Power Station**

Yumiko Kumano

Tokyo Electric Power Company

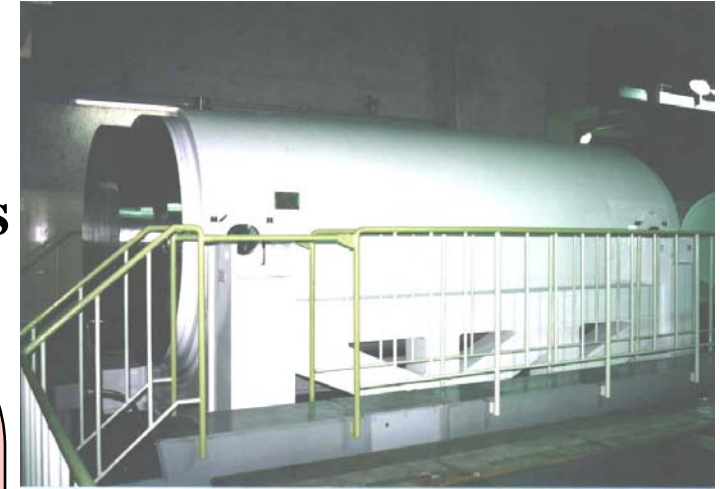
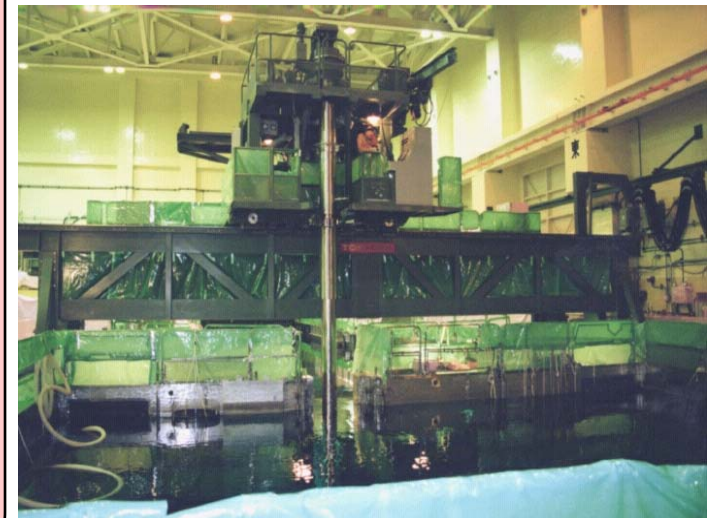
**Storage Status of spent fuel (as of Mar. 2010)
(Assemblies)**

Storage method	Storage Amount	Capacity (existing facilities)
Spent fuel pool at each reactor unit	3,450	8,310
Dry cask	408	408
Common pool	6,291	6,840
Total	10,149	15,558

Approx. 450% of the total core capacity of 6 plants

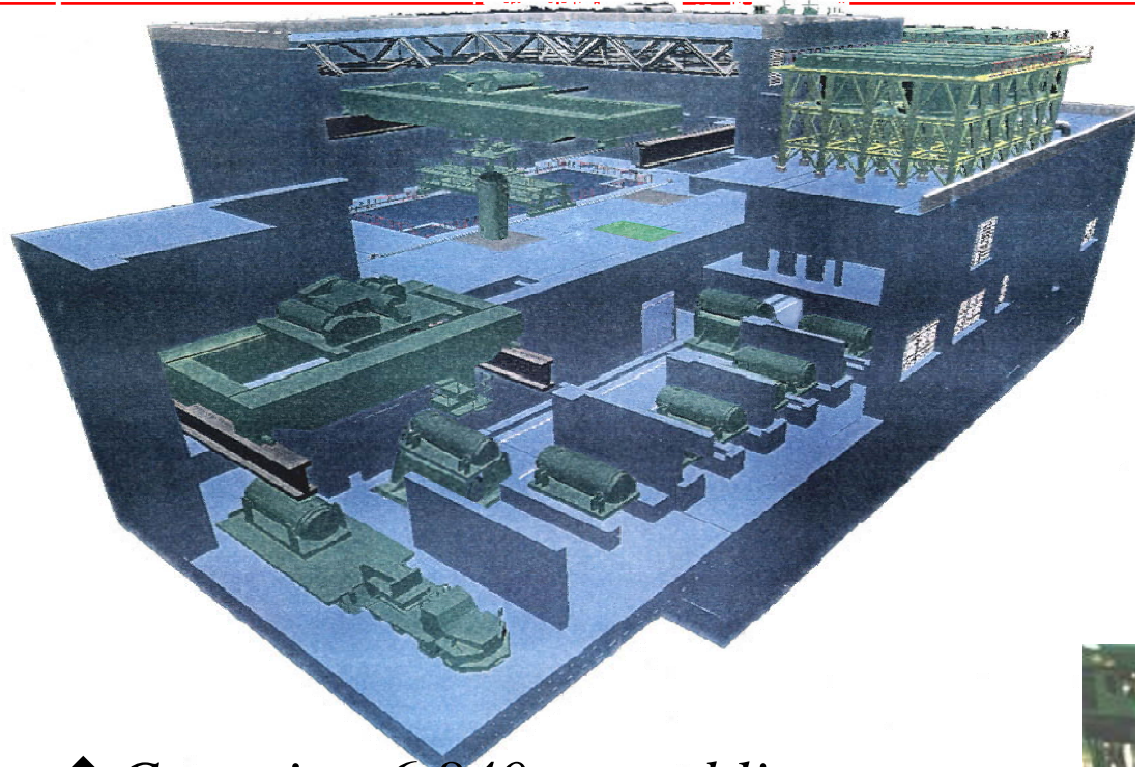
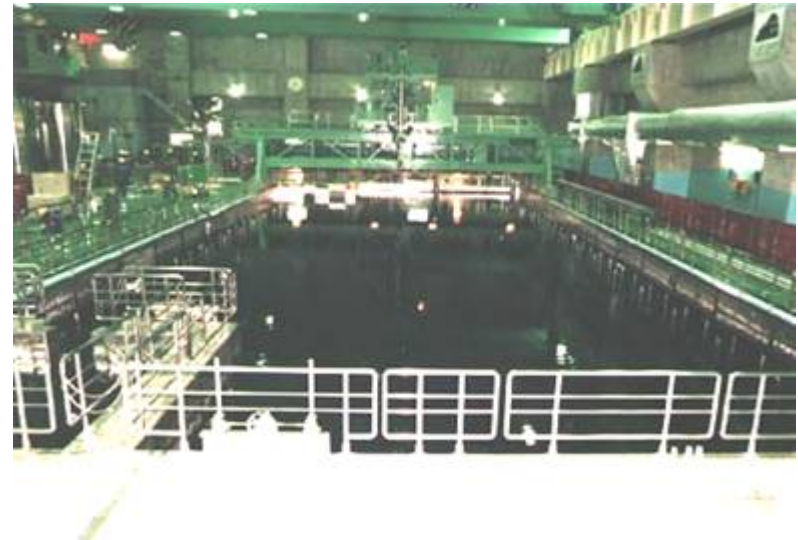
Outline of Common Spent Fuel Storage Pool (1)

- ◆ *In operation since 1997*
- ◆ *A large-scale pool
12m x 29m x 11m(depth)*
- ◆ *fuels more than 19-month
cooling*

- ◆ *Capacity: 6,840 assemblies
⇒ corresponds to 200%
of total core capacity*
- ◆ *Storage amount: 6,291 assemblies
⇒ corresponds to 90%
of the pool capacity*

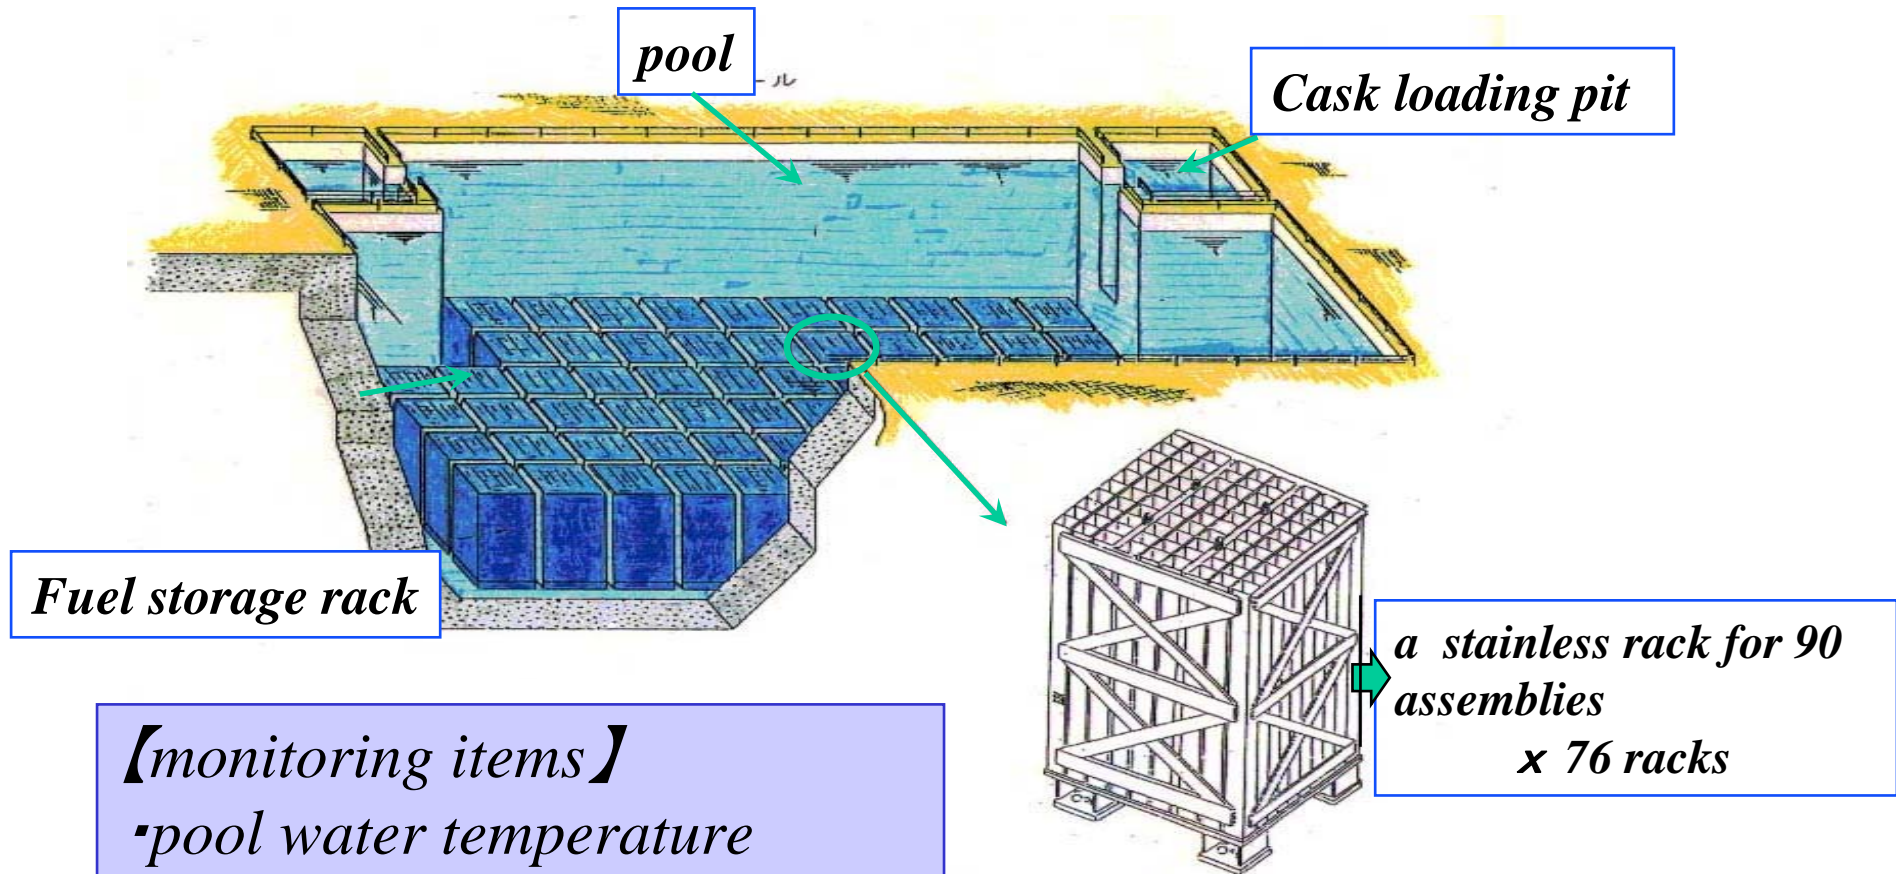
Outline of Common Spent Fuel Storage Pool (2)

- 【monitoring items】**
- pool water temperature
 - water level of the pool
 - area radiation in the building
 - radioactivity in the air dust

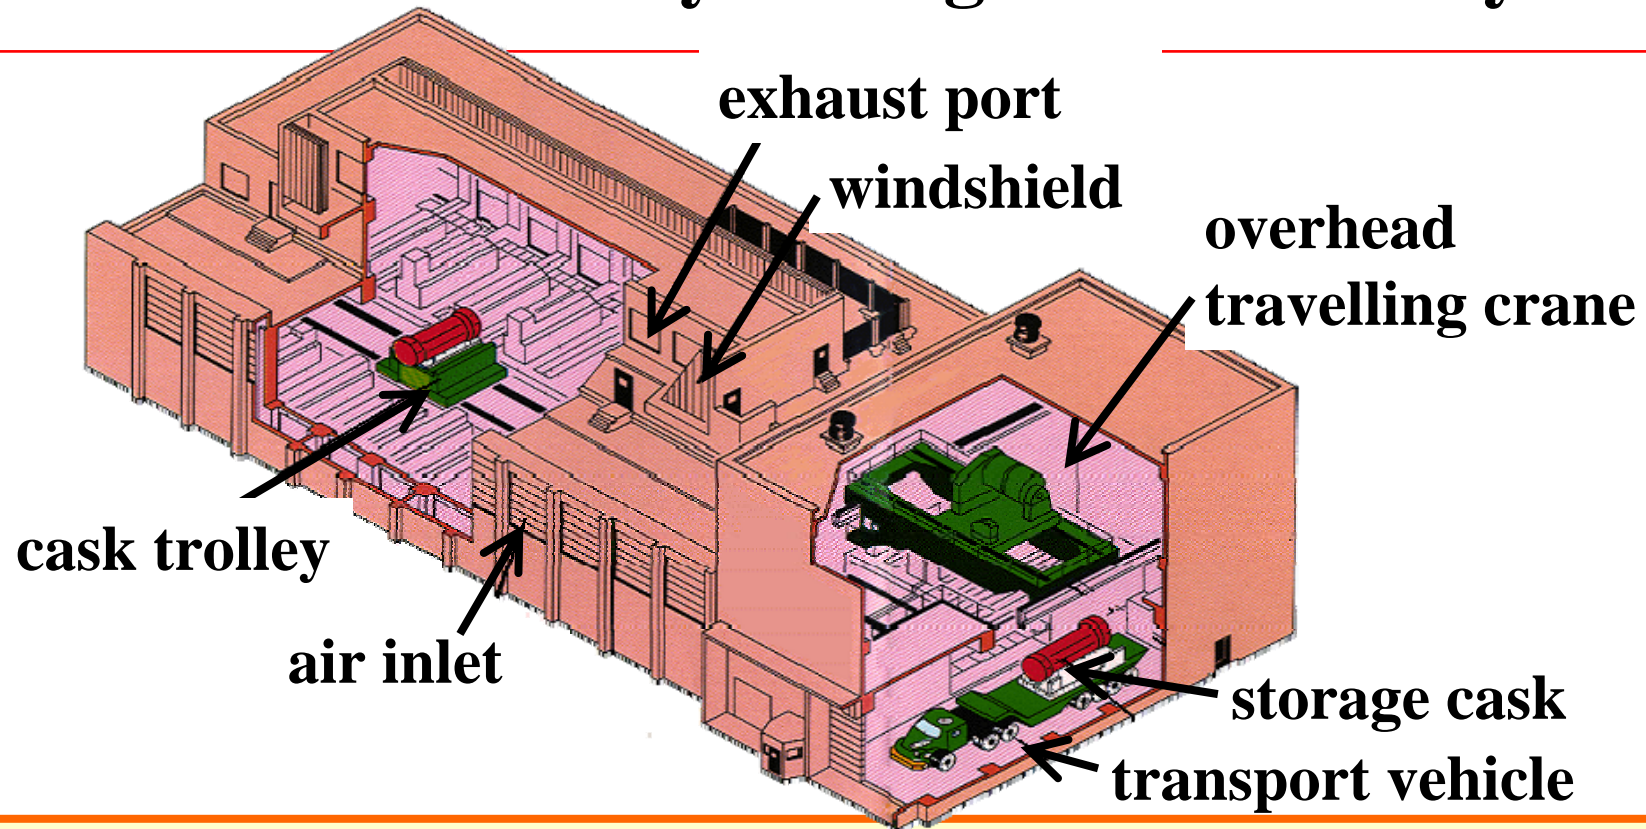
Outline of Dry Storage Cask Facility

- ◆ *Originally designed for transport casks*
 - *Modified the license in 1994 / dry cask storage since 1995*
- ◆ *Permission for the storage of 20 casks*
 - *9 dry casks are in operation, 11 casks are to be installed.*
- ◆ *Efficient use of existing building → Casks are laid down in horizontal*
- ◆ *Natural-convection cooling*

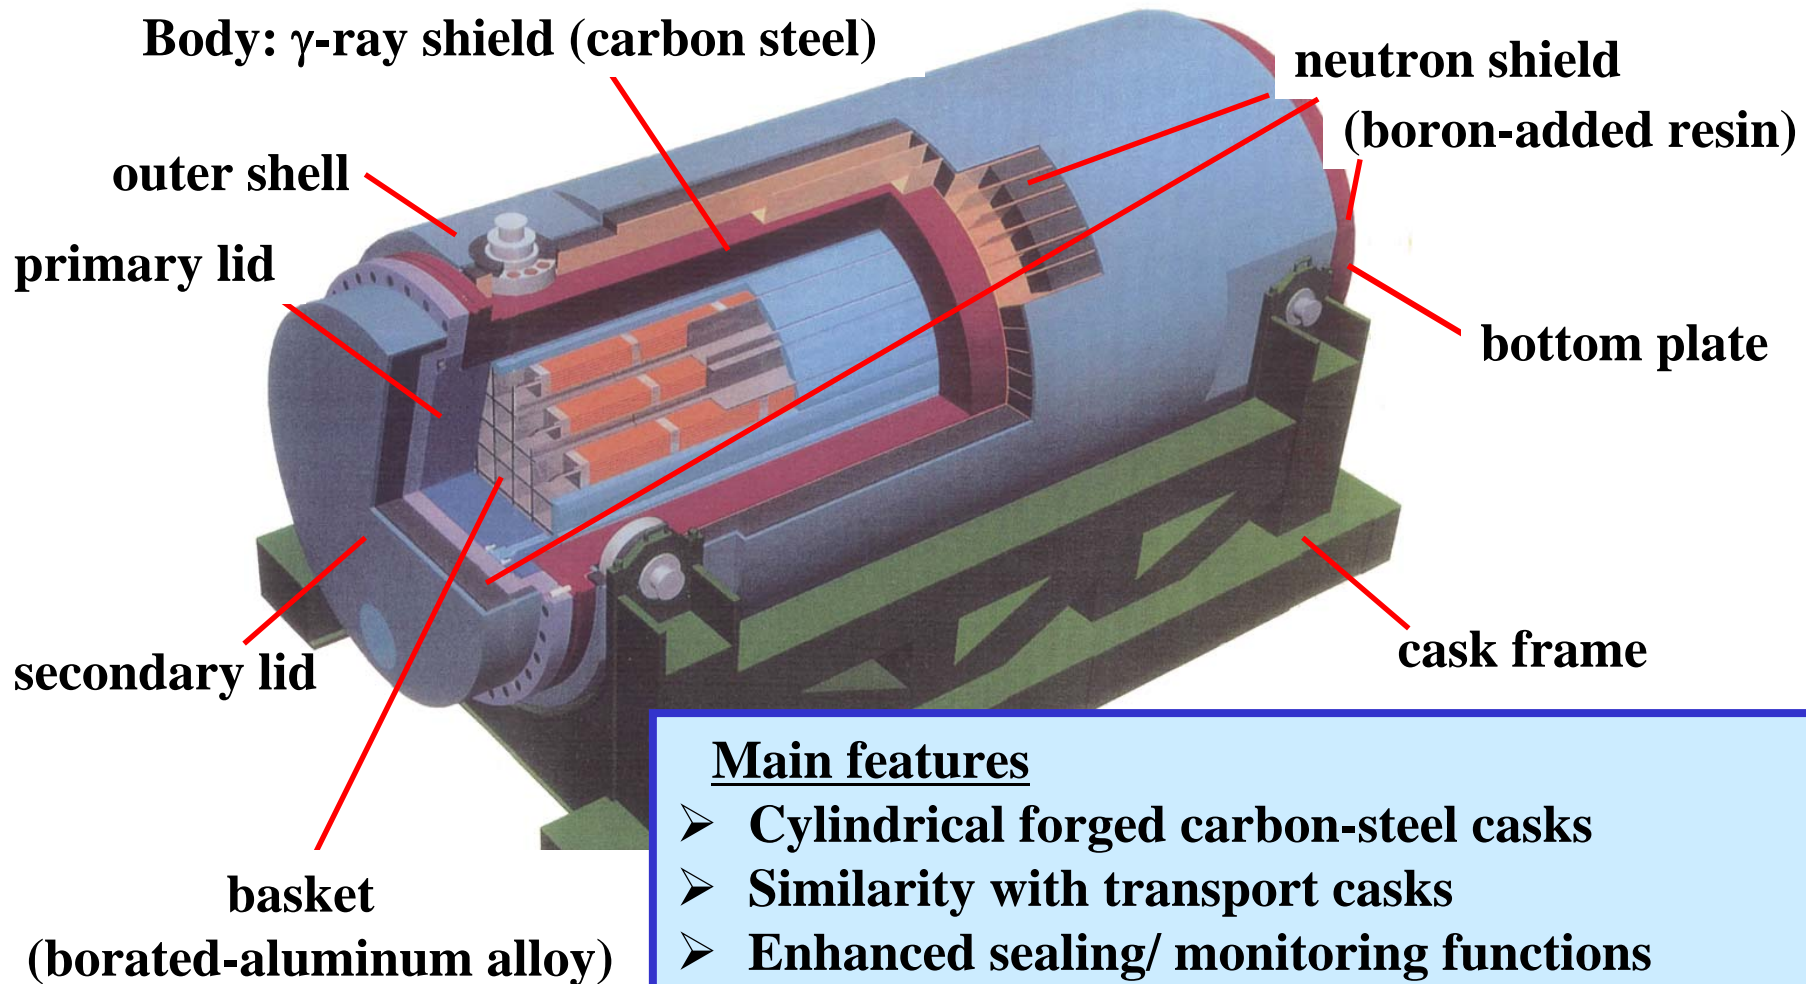
Structure of Dry Cask

- Cylindrical forged carbon-steel casks
- Similarity with transport casks
- Enhanced sealing/ monitoring functions
- Inner gas substituted with helium
- Steel for γ -ray shield/ resin for neutron shield
- Borated-aluminum alloy basket for sub-criticality

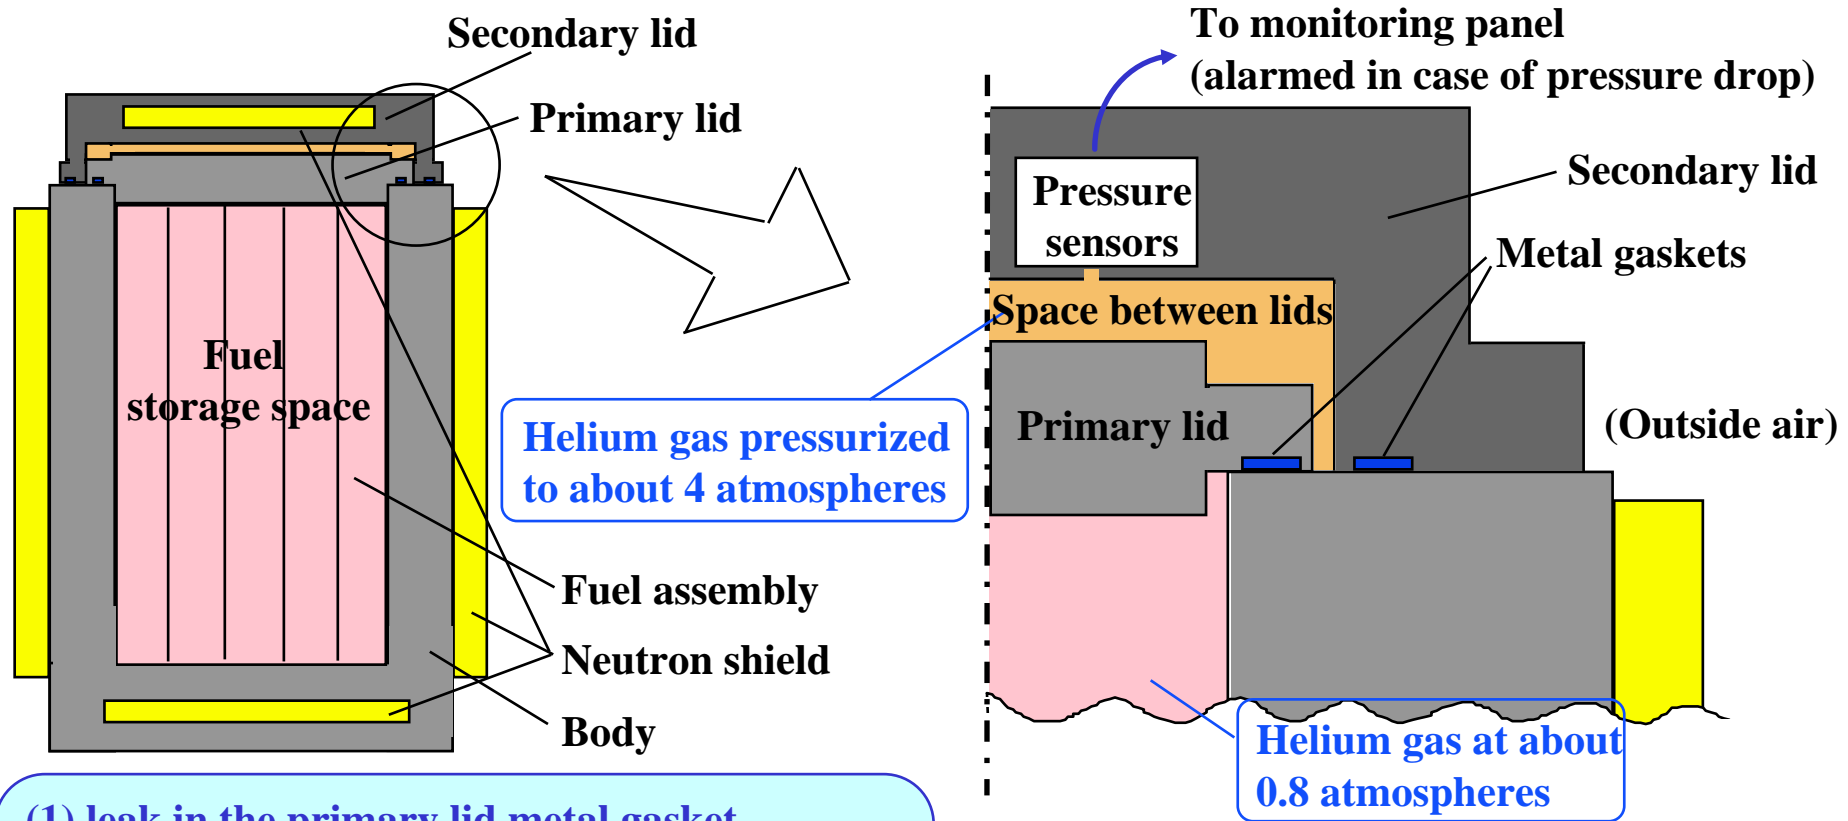
Design Features Concerning Containment

- (1) leak in the primary lid metal gasket
 - Space between lids → Helium gas → Fuel storage space
- (2) leak in the secondary lid metal gasket
 - Space between lids → Helium gas → Outside air

➔ **Alarmed in case of pressure drop**

Even if a leak in a metal gasket occurs, no radioactive material inside the cask (in the spent fuel storage space) is released outside the cask.

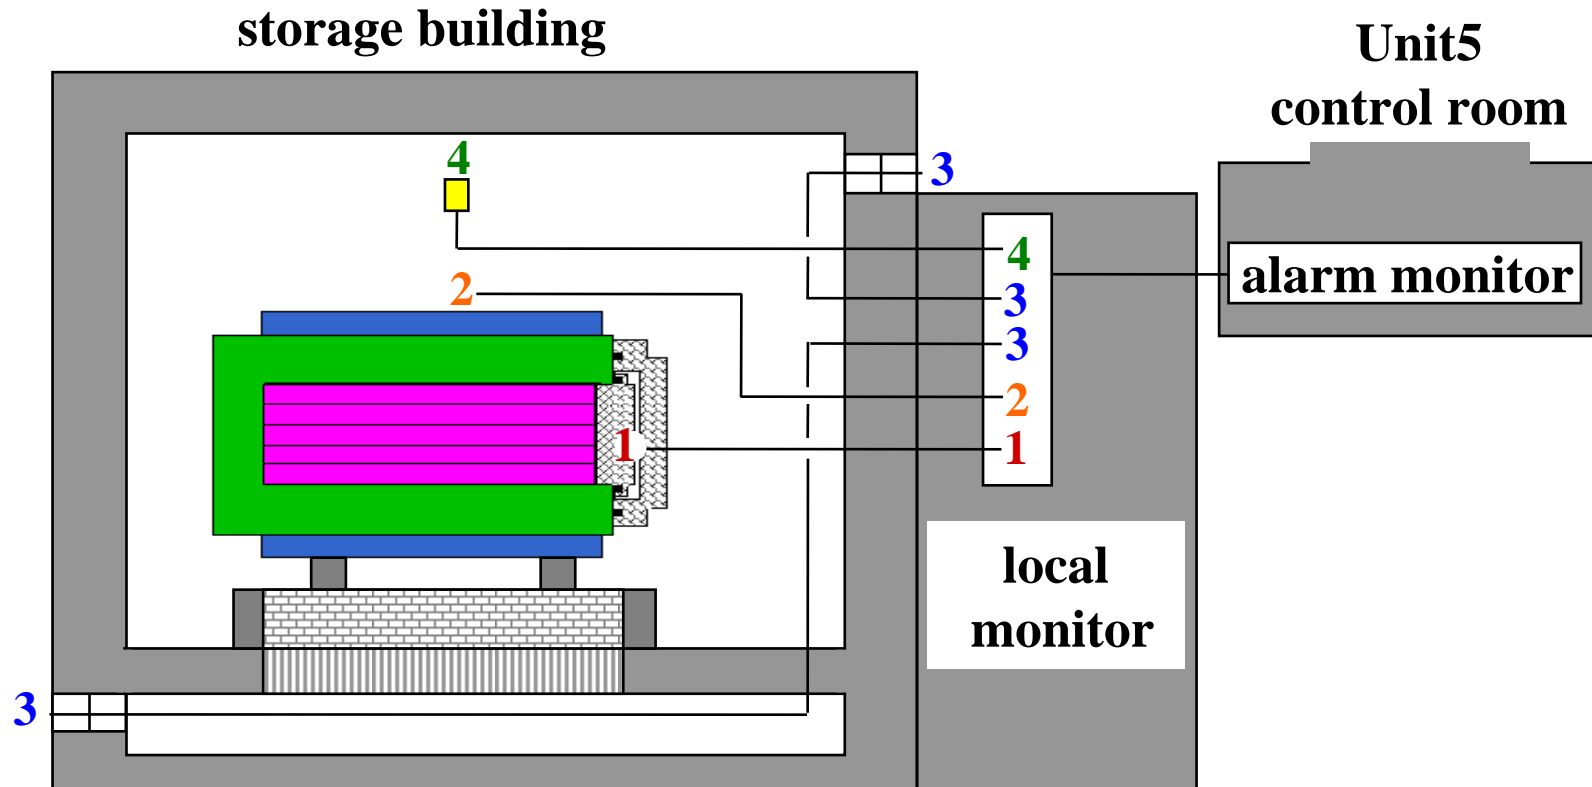
Monitoring System at Normal Conditions

1. pressure between primary /secondary lids
2. surface temperature
3. inlet and outlet air temperature / temperature difference
4. area radiation in the building

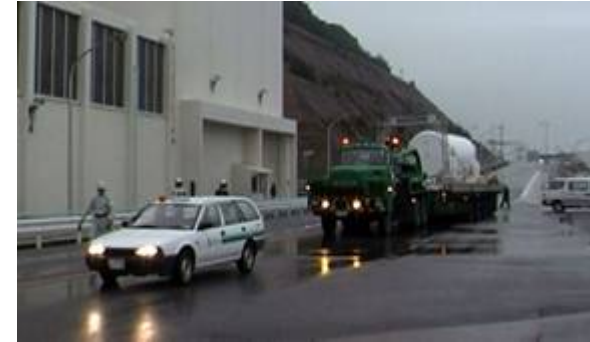
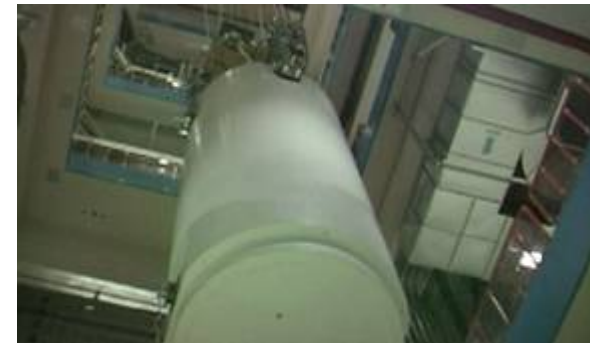
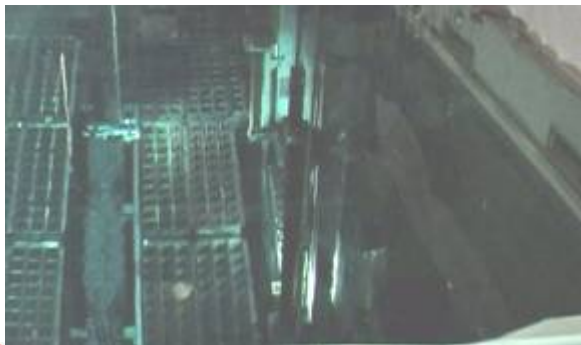
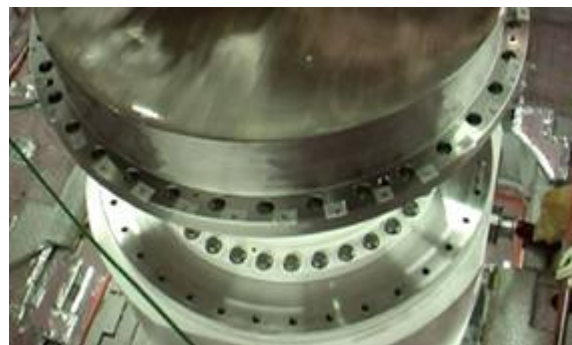
Procedure of the Inspections

- 1) Transportation of a cask from the cask storage building to a reactor building
- 2) **Leak test of the secondary lid**
- 3) **Secondary lid opening / visual inspection**
- 4) **Leak test of the primary lid**
- 5) **Inner gas sampling for Kr-85 detection**
- 6) Reflood / removal of bolts
- 7) Transportation into fuel pool
- 8) **Primary lid opening / visual inspection**
- 9) **Lift up of a fuel bundle / visual inspection**

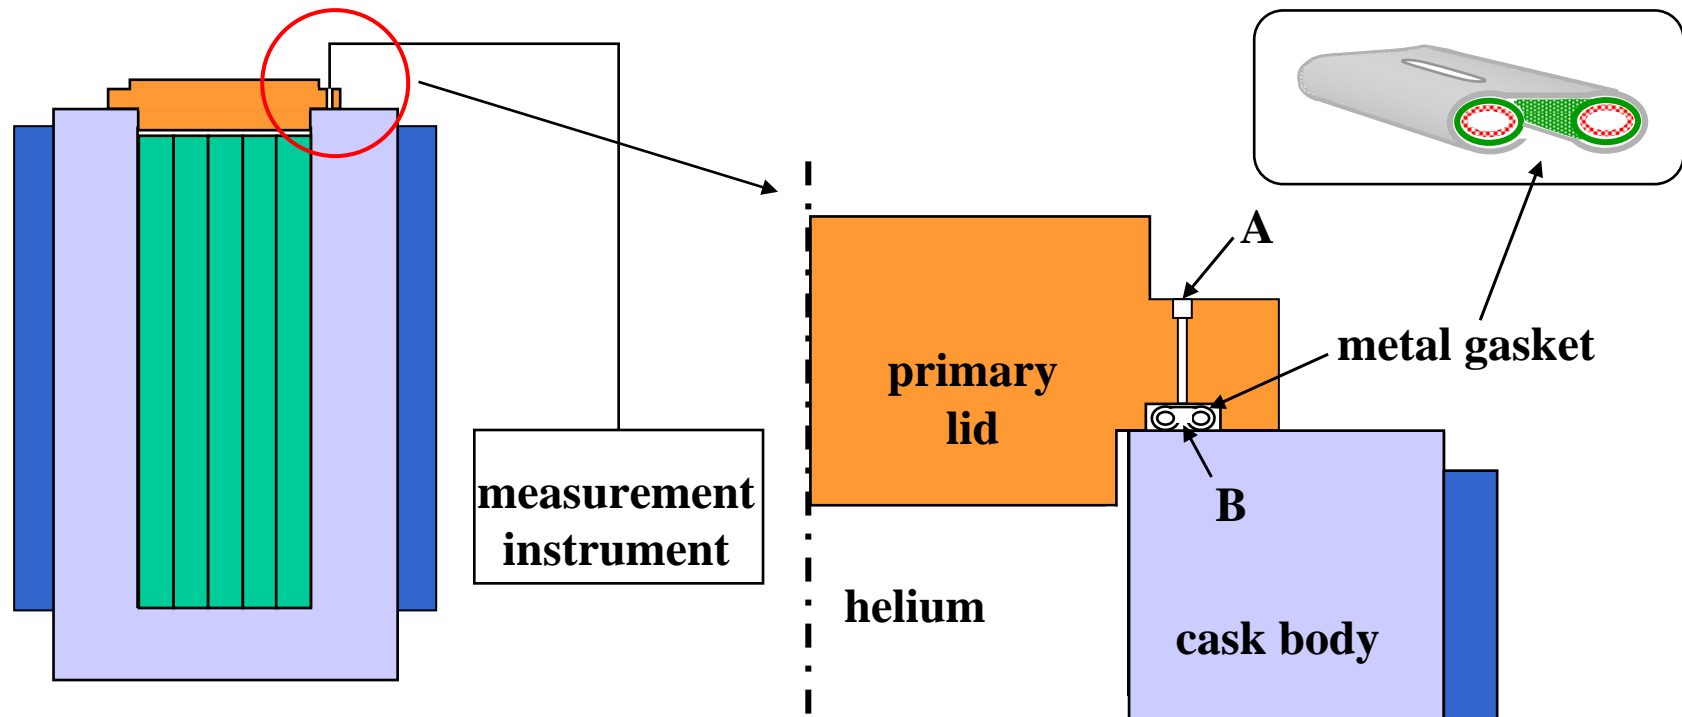
Leak Test for a Primary Lid

1. A flexible pipe is connected to a detection hole (A).
2. The other end of the pipe is connected to the measurement instrument.
3. Helium among the doubled layer of a metal gasket (B) is vacuumed by a vacuum pump which is installed in the measurement instrument.
4. Flow rate of helium gas passing through the metal gasket is measured.
5. The measured amount is converted into leak rate.

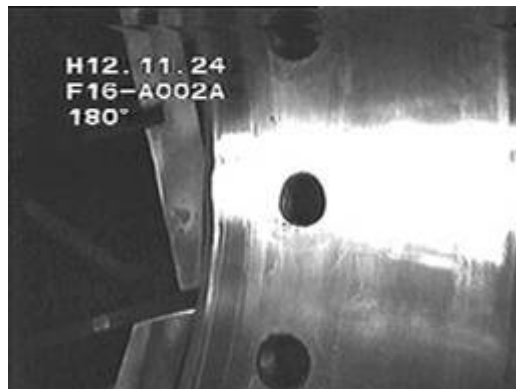
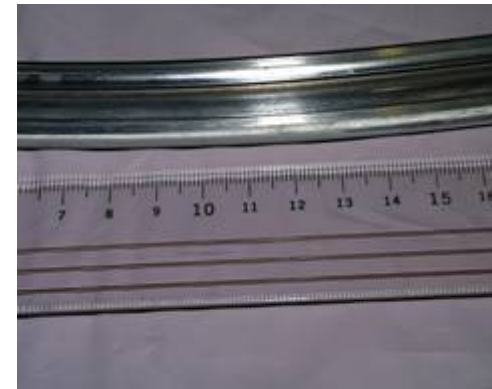
➤ Visual inspection of the primary lid

measured value: $5.3 \times 10^{-8} \text{ Pa} \cdot \text{m}^3/\text{s}$

required criteria: $<1 \times 10^{-6} \text{ Pa} \cdot \text{m}^3/\text{s}$

⇒ **No problem found in the confinement performance**

← Flange surface
of the cask

Metal gasket
of the primary lid →

⇒ **Nothing abnormal occurred on confinement, but white coloring was observed on the gasket's surface due to residual water.**

➤ All metal gaskets were replaced.

➤ Procedure manual was updated so that residual water could be completely removed.

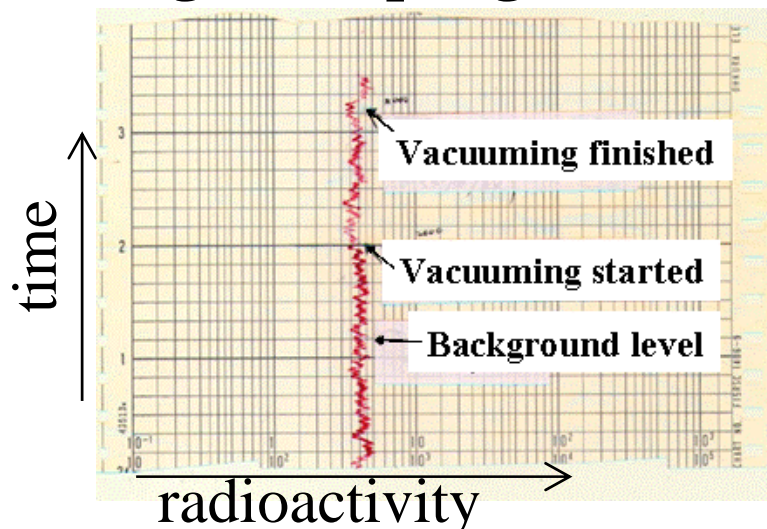
➤ Inner gas sampling for measuring Kr-85 concentration

⇒ No leak of Kr-85 from the spent fuel was observed based on the measurement of radioactivity of the sampled gas.

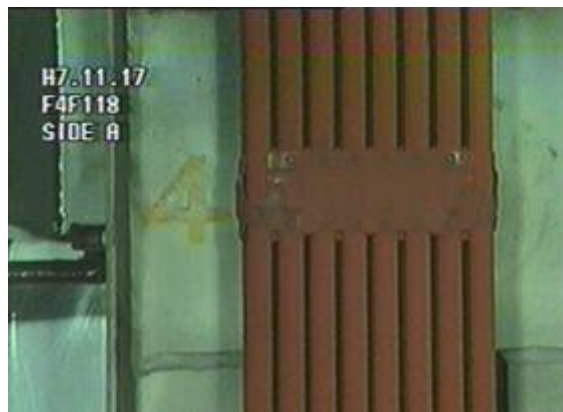
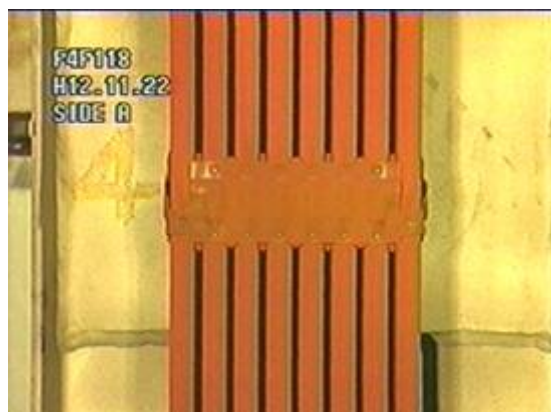
➤ Visual inspection of a fuel assembly

17/Nov/1995

22/Nov/2000

⇒ No signal of any defect was observed.

Target: New 8X8 BWR assembly (approx.32 GWd/t)

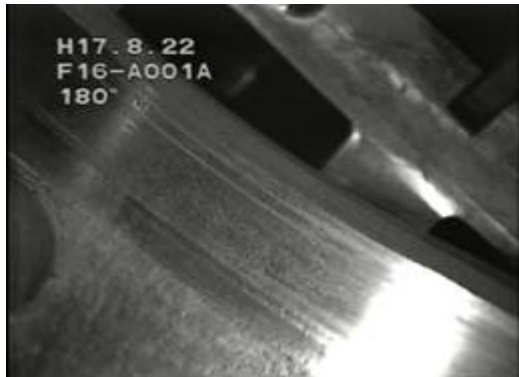
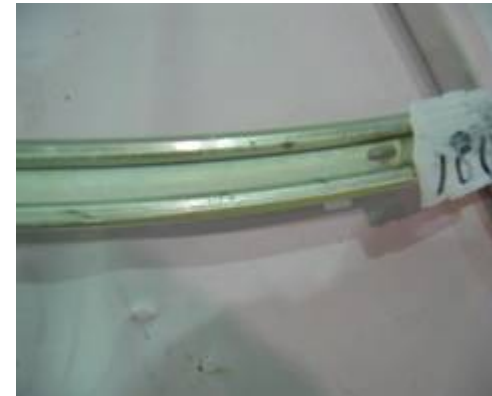
➤ Visual inspection of the primary lid

measured value: $1.6 \times 10^{-7} \text{ Pa} \cdot \text{m}^3/\text{s}$

required criteria: $<1 \times 10^{-6} \text{ Pa} \cdot \text{m}^3/\text{s}$

⇒ **No problem found in the confinement performance**

← Flange surface
of the cask

Metal gasket
of the primary lid →

⇒ **Nothing abnormal occurred on confinement, but white color change was observed on the surface of the gasket due to immersion to reactor pool water for several days before opening the primary lid.**

➤ **Procedure manual will be additionally updated in order to reduce the immersion duration.**

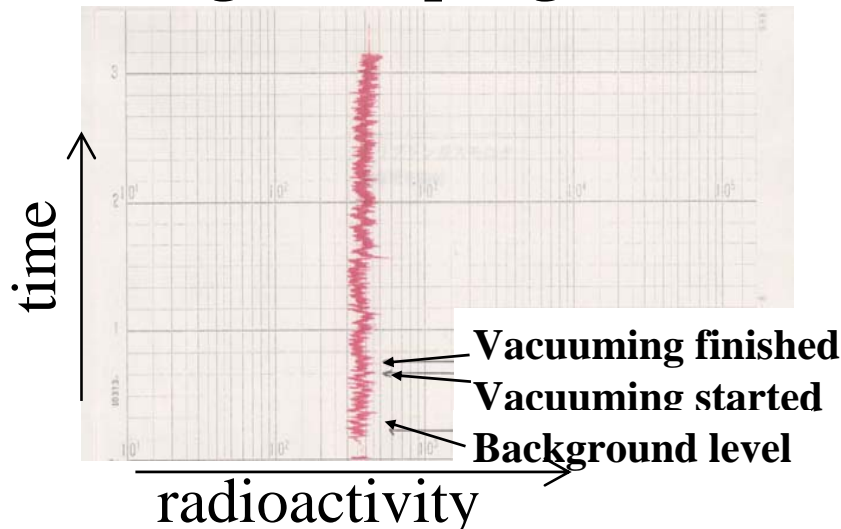
➤ Inner gas sampling for measuring Kr-85 concentration

⇒ No leak of Kr-85 from the spent fuel was observed based on the measurement of radioactivity of the sampled gas.

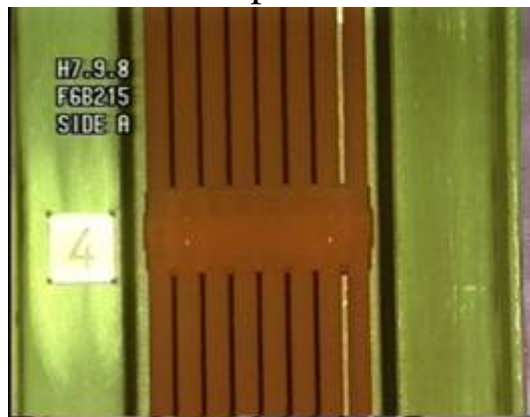
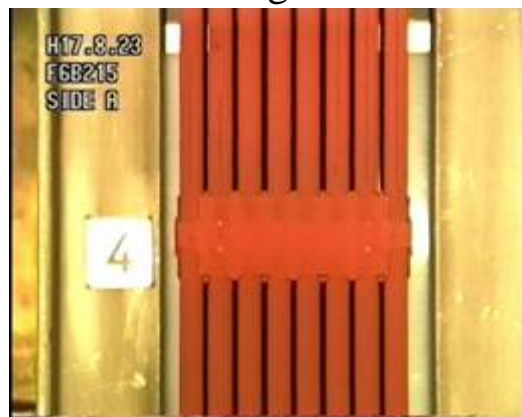
➤ Visual inspection of a fuel assembly

8/Sep/1995

23/Aug/2005

⇒ No signal of any defect was observed.

Target: 8X8 BWR assembly (approx.28 GWd/t)
