## DAVIS-BESSE NUCLEAR REACTOR

Ohio Sierra Club Nuclear Free Committee  
[www.ohiosierraclub.org](http://www.ohiosierraclub.org) Oct. 2014  
Pat Marida, chair [marida@wideopenwest.com](mailto:marida@wideopenwest.com)

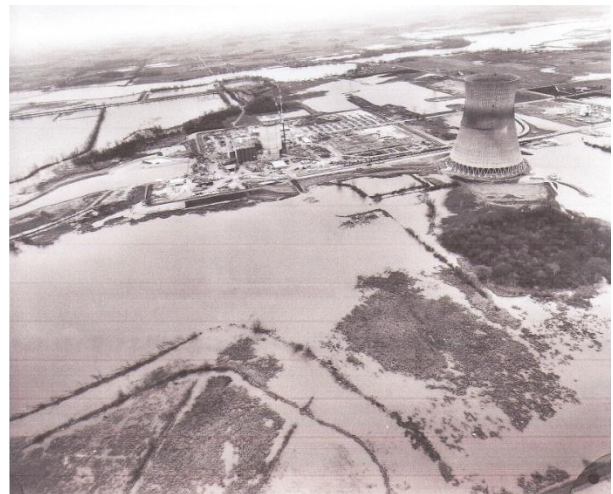
**Davis-Besse construction site floods in 1972.**

- In 1972 a strong wind caused lake water to flood the construction site for a month.
- Davis-Besse has had six “significant accident sequence precursors” out of 34 total in the U.S.

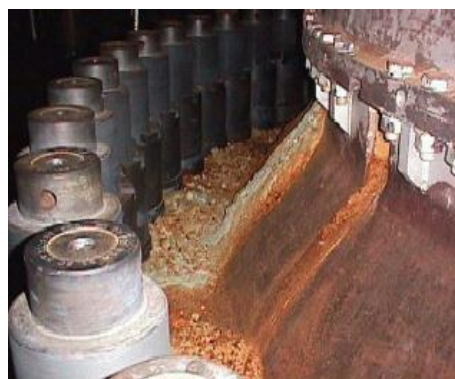
**This is what inspectors ignored.**

- In 2002 a delayed inspection found that boric acid had eaten through 7 inches of the steel reactor lid, with only a bulging 3/16-inch steel liner preventing a radioactive catastrophe. A photo was found, taken earlier, that showed major corrosion on the outside of the vessel, but this was ignored. This “Hole-In-The-Head” fiasco resulted in the largest fine in NRC history – \$33.5 million. The plant was idled for 2 years, costing ratepayers \$600 million.

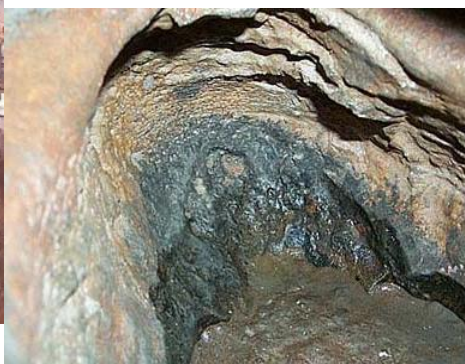
**Later, this football-sized hole was found in the head of the reactor.**
