# Successful Stainless Swimming Pool Design

by Catherine Houska, CSI and James Fritz, Ph.D  
(Extracted from Construction Specifier Magazine, December 2005)

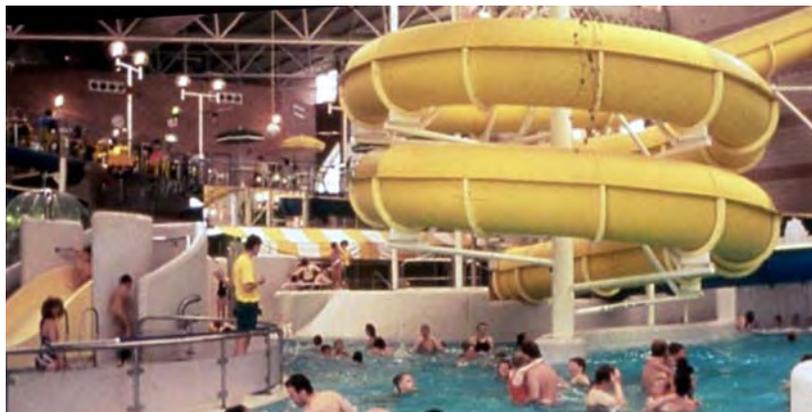
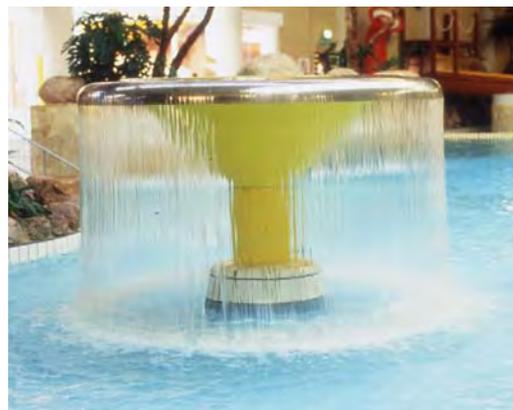
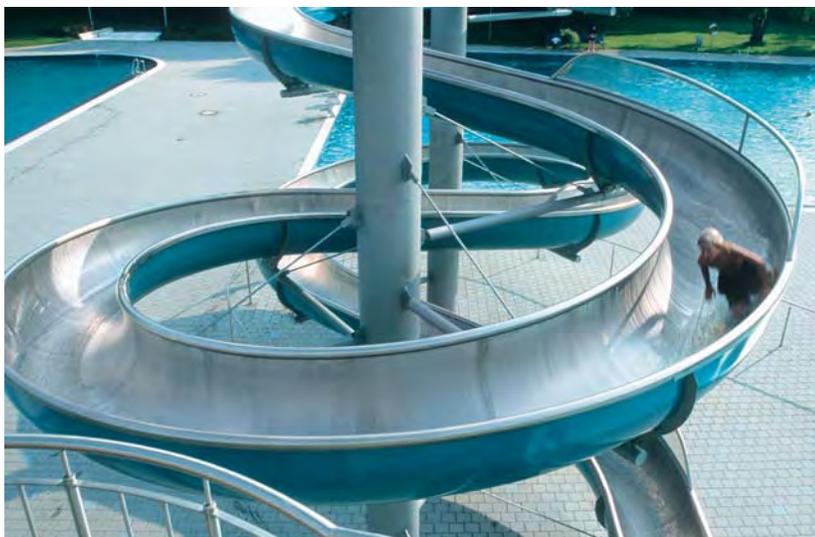
Figure 1

Figures 1, 2 and 3: Stainless steel swimming pool slide and water feature.

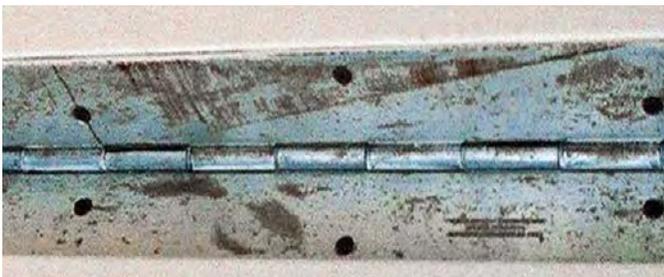
**Figure 5:** Carbon steel brushes were used by a cleaning contractor on this stainless steel door hinge that was installed beside an indoor swimming pool. The areas with carbon steel contamination are rusting. Photo courtesy of TMR Consulting

Poor maintenance and the use of inappropriate cleaning compounds can be another factor in corrosion performance. Carbon steel wool and wire brushes should never be used for cleaning or 'refinishing' stainless steel since particles can become embedded in the surface. These carbon steel particles corrode at the same rate as unprotected carbon steel and cause unsightly surface damage.

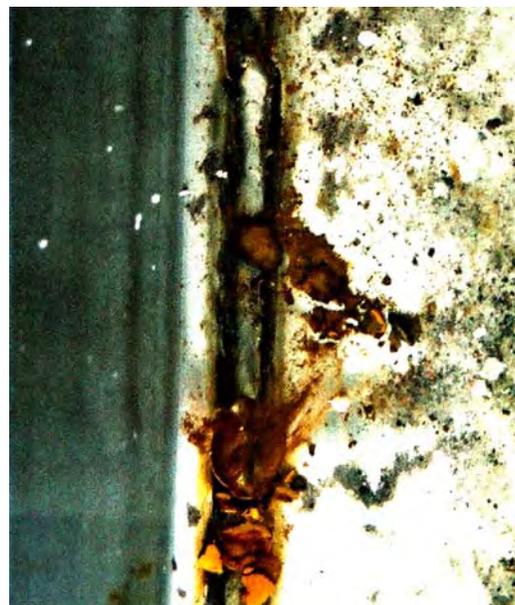
**Figure 6:** This weld within a swimming pool gutter was not cleaned properly and pitting corrosion is occurring along the weld seam. Photo courtesy of TMR Consulting

In cases where stainless steel components have welded joints, the welds should provide the same level of corrosion performance as the surrounding metal. Therefore, corrosion on and around welded stainless steel joints is unacceptable. Grinding and pickling joints is the best means of restoring a weld's corrosion resistance.

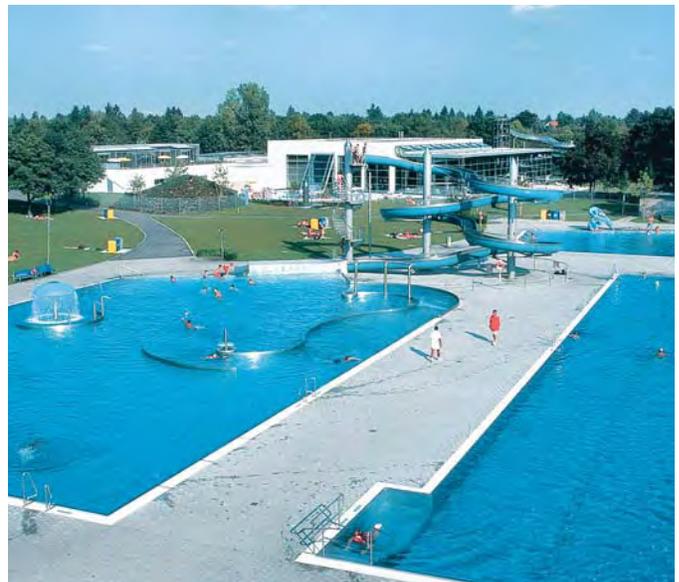
**Figure 8:** This swimming pool in Munich, Germany was relined with Type 316 stainless steel panels that were welded together. Photo courtesy of Martina Helzel

Bare Type 316 stainless steel has been used for pool linings, particularly in Europe.<sup>8</sup> In relining applications, stainless steel has replaced plastic and ceramic tiles, while in new pools, self-supporting structures composed of stainless steel sheet and structural framing are typically used for water depths up to about 2 m (6.5 ft). Deeper pools typically require a secondary support structure or heavier wall panels due to water pressure loads. The stainless steel panels are welded together, producing a watertight structure, and the seams are pickled to restore corrosion resistance. Pool lane markings can be applied in advance using electro-chemical coloring, which eliminates maintenance painting.

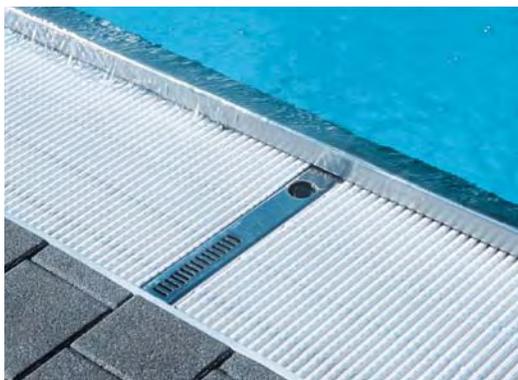
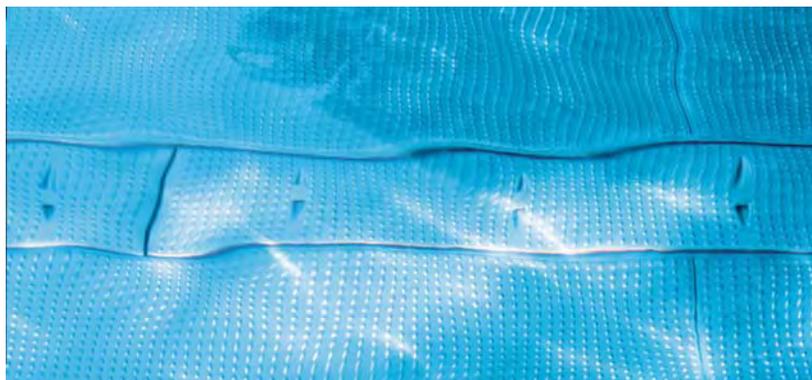
**Figure 10 and 11:** Type 316 pool gutters and water jet openings in the floor plates. Photos courtesy of Martina Helzel

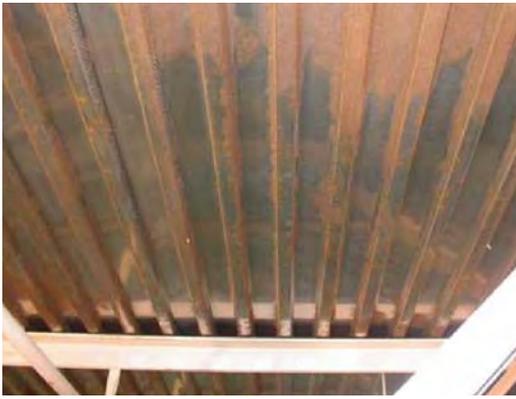
**Figure 12:** Corrosion of a Type 304 stainless steel roof deck above an indoor swimming pool.  
Photo courtesy TMR Consulting

SCC is a concern in load-bearing applications that are not splashed with pool water or cleaned, such as ceiling hangers, fasteners, brackets, supports, bolts, wires, cables, and hooks. Figures 12 and 13 depict an example of SCC attack. This North American Type 304 stainless steel natatorium roof deck was never inspected or cleaned. After a decade of exposure, there was significant brown staining on the roof panels above the diving platforms. Samples were removed from the roof deck and close examination revealed shallow pitting and extensive cracking with some fissures penetrating 80 percent of the cross-section. This cracking resulted because of the following factors:

- The stainless steel was susceptible to SCC.
- There were relatively high residual stresses from the cold working the roof panels and high roof service stress loads, particularly with winter snow loads.
- There was no cleaning to remove the accumulation of aggressive chloride compounds.
- It was a poorly controlled pool environment.
