Inspection Report

Property Address:
10,000sf House
Parkville MO 12345

ESI Property Inspection

Date: 5/17/2011	Time: 08:40 AM	Report ID: 10,000sf house
Property: 10,000sf House Parkville MO 12345	Customer: Sample Customer	Real Estate Professional: World's Best Realtor

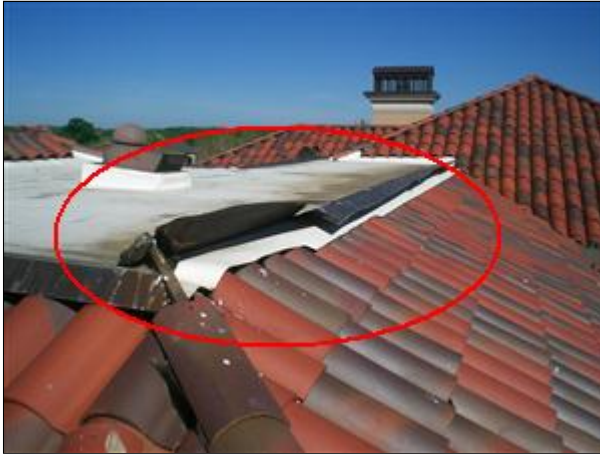
1.0 Picture 1 damaged flashing & missing tiles

Overall tile roof and upper rubber membrane area is in very good condition. The roof just needs some maintenance to fix a few small issues like damaged flashing, several missing tiles and several cracked tiles.

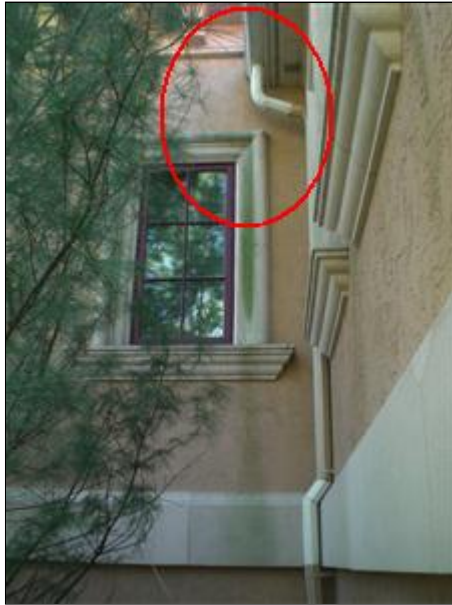
1.3 Picture 1

It appears that water is overflowing gutter near the north west corner of the house. There is evidence of excessive moisture in the area and some erosion at the ground. It is important for water to be properly diverted away from the foundation. Recommend a qualified gutter contractor investigate further. I am guessing that the gutter in this area just needs a larger splash guard. The mildew on the house in this area should be removed with lite pressure washing.

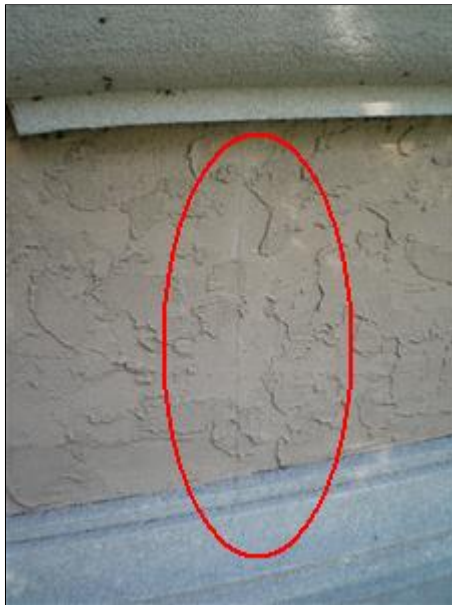
2.0 Picture 1

(1) Several small cracks were found in the stucco. Both were on the north side of the house at the garage. Cracks should be sealed by a qualified contractor to prevent water from entering.

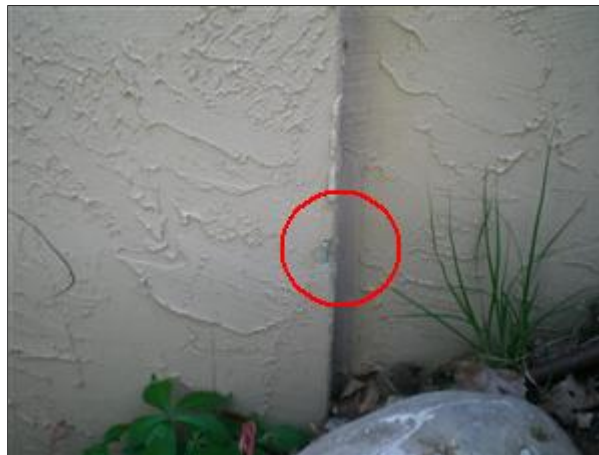
2.0 Picture 3

(2) Small ding at stucco on south side. Needs to be sealed by qualified contractor.

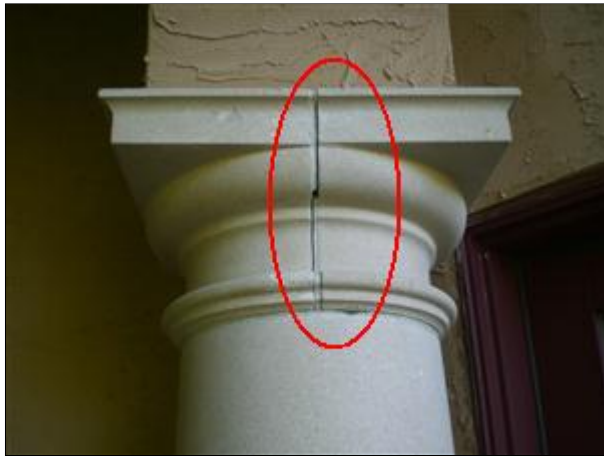
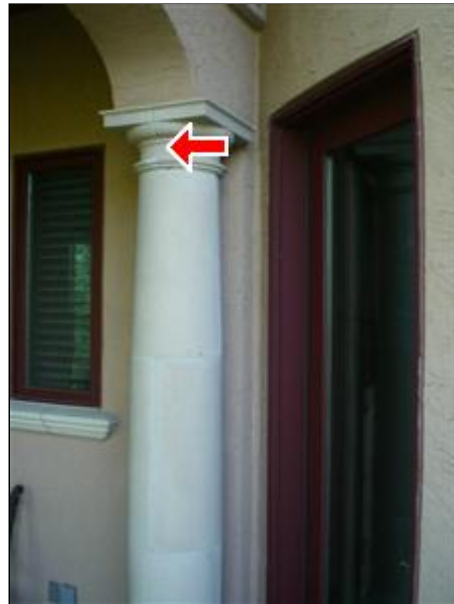
2.0 Picture 4

(3) Seam at one of the rear pillars needs re-sealing.

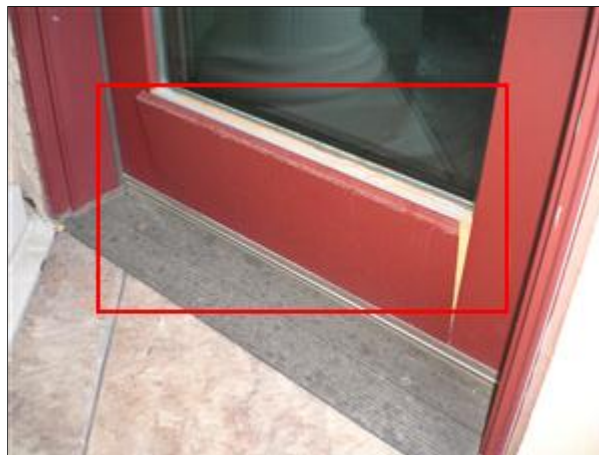
2.1 Picture 1

Comments: Inspected, Repair or Replace
Metal panel at rear door needs to be reglued.

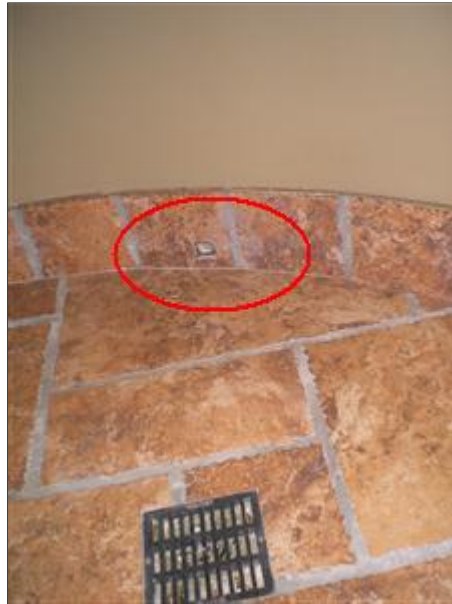
4.1 Picture 1

(1) There is a hole in the (not sure what this area is - I am going to call it the dog washing station) tile wall at the bottom of the stairs. The hole leads into the data room. Recommend repair by qualified contractor.

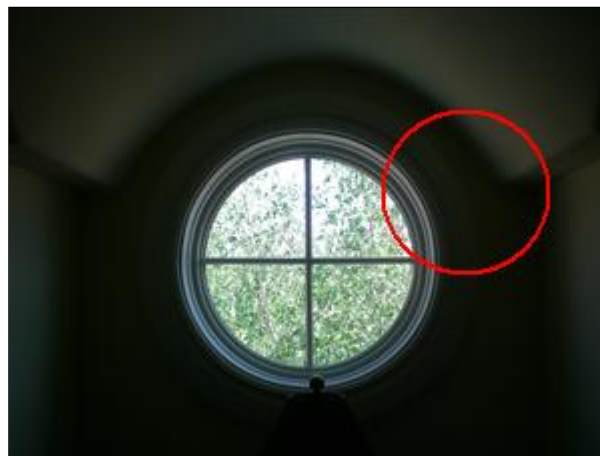
4.1 Picture 2

(2) There is a small settlement crack at the window in the upstairs bedroom. Recommend qualified contractor repair as needed.

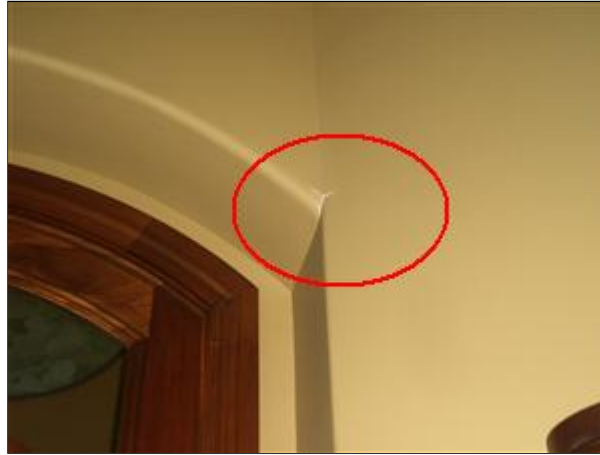
4.1 Picture 3

(3) There is a small settlement crack adjacent to the door in the first floor office. Recommend qualified contractor repair as needed.

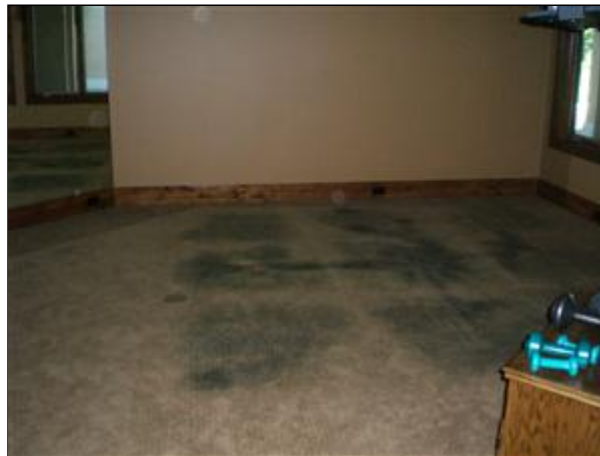
4.2 Picture 1

Comments: Inspected, Repair or Replace
Carpet in the downstairs workout room is stained.

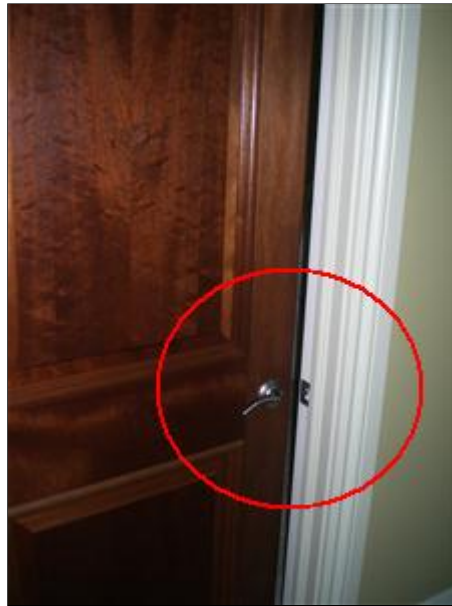
4.5 Picture 1

Door at upstairs bedroom does not latch

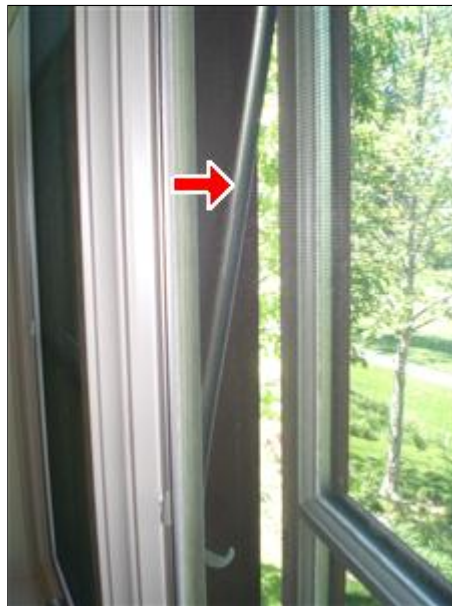
4.6 Picture 1 damaged seal

(1) A representative number of windows were opened and tested. Overall they are in good working condition. Because many appear to have not been opened in some time, several of the seals are damaged and need to be repaired or replaced. Recommend Pella authorized service technician service & correct as needed.

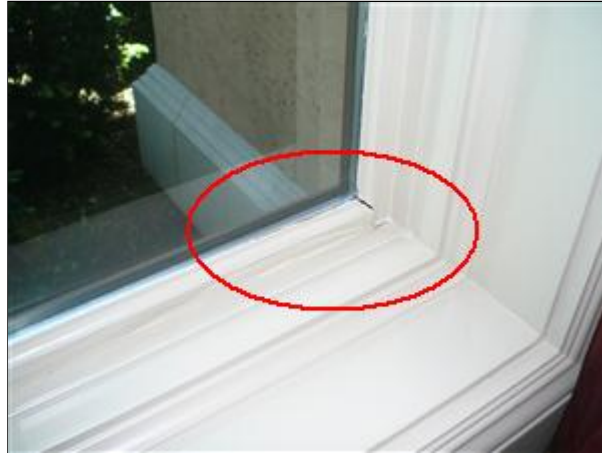
4.6 Picture 2

(2) There was a small area of deteriorated trim at a window in the dining area at the front of the house. Recommend qualified contractor repair.

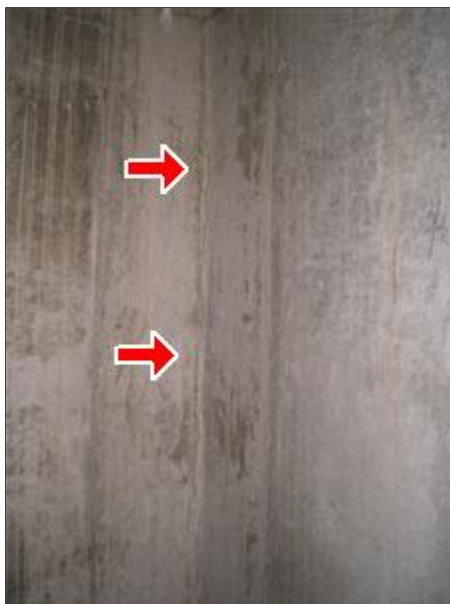
5.0 Picture 1

All visible areas of the interior foundation looked very good. There are a few vertical cracks, but this is normal and acceptable. All concrete will crack a little as it dries and shrinks.

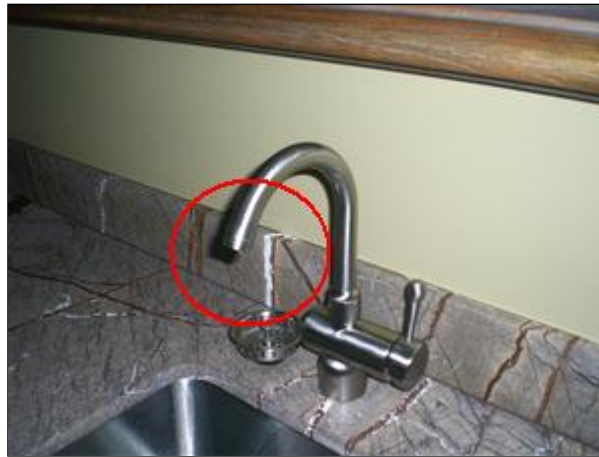
6.1 Picture 1

(1) Bar sink at second floor just needs discharge filter cleaned or replaced.

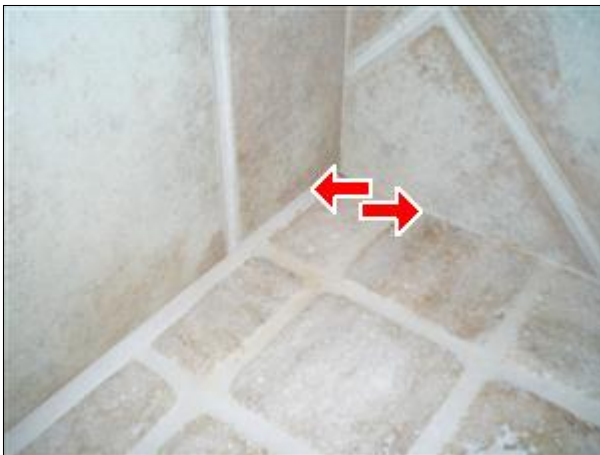
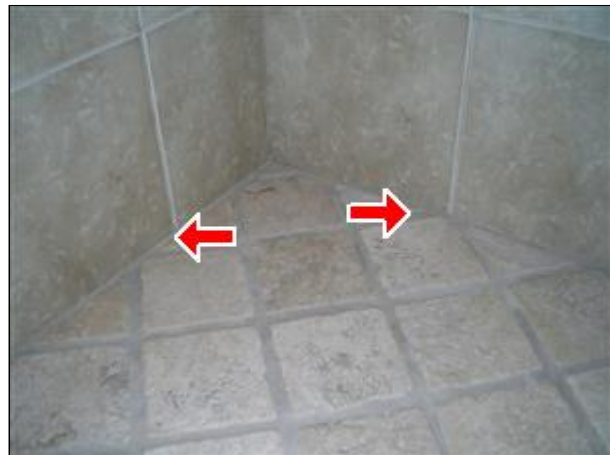
6.1 Picture 2

(2) There is some minor cracking at the shower base / grout joints in two of the showers. first floor guest room and second floor bedroom. Recommend qualified contractor seal around base of showers to prevent leaking.

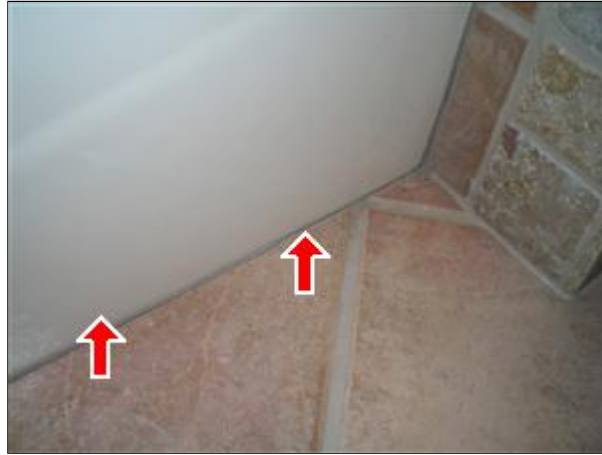
6.1 Picture 4

(3) Base of tub needs to be sealed at bathroom to prevent leaking into structure. Recommend qualified contractor repair as needed.

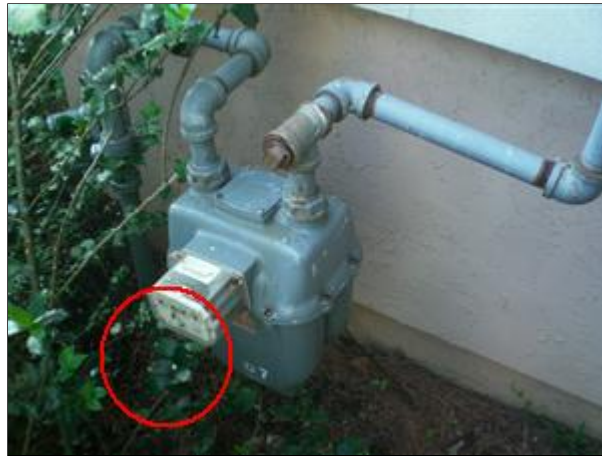
6.5 Picture 1

Main natural gas shut off is at meter on the west side of the house.

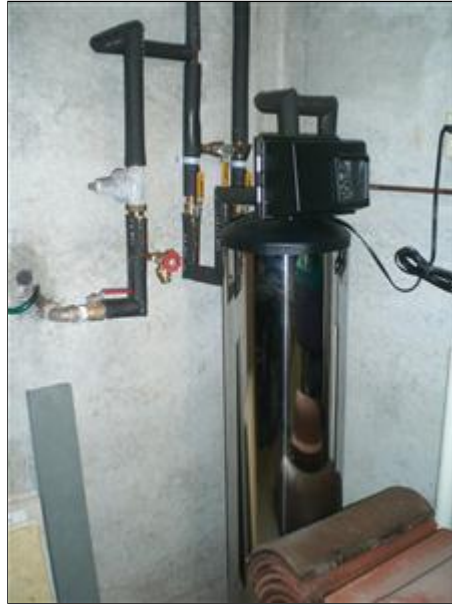
6.6 Picture 1

There is a whole house water filtration system. Recommend following the manufactures recommendation for maintenance.

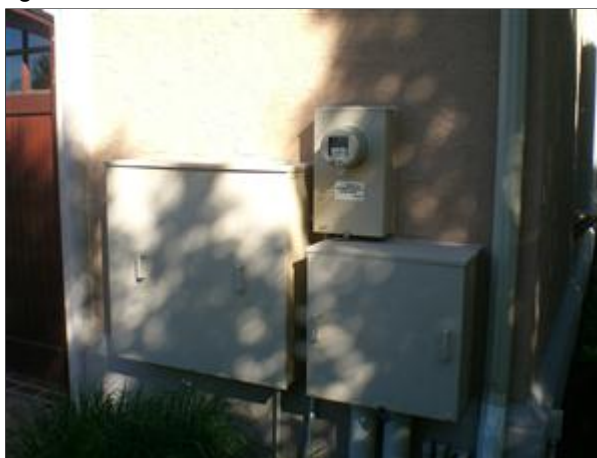
7.0 Picture 1

Service entrance is next to the garage

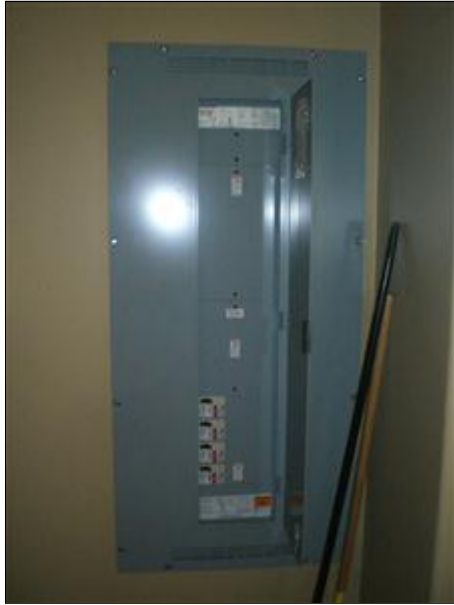
7.1 Picture 1

(1) Main panel is located in the garage. Sub panels are located in the basement storage room, mechanical closet off the basement play room and mechanical room in the attic.

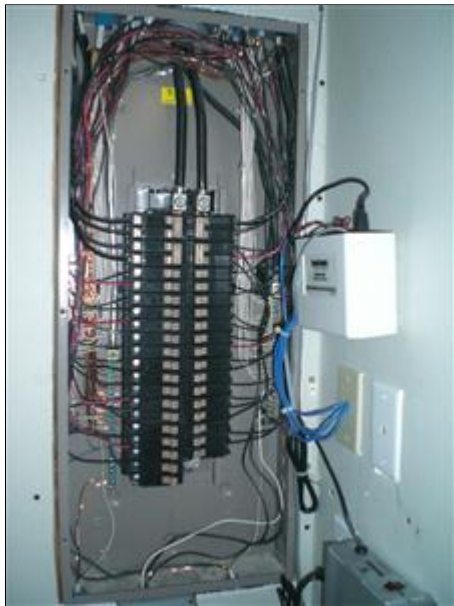
7.1 Picture 3 closet off playroom

(2) One of the panels in the basement storage room and the panel in the basement mechanical storage room off the play room had an issue with a double tapped breaker. This is where two sets of wires are connected into one circuit breaker. This has the potential to overload the breaker and create a fire hazard. In both cases there is room in the panel for additional breakers to accommodate extra wires. Recommend qualified electrician preform all electrical work.

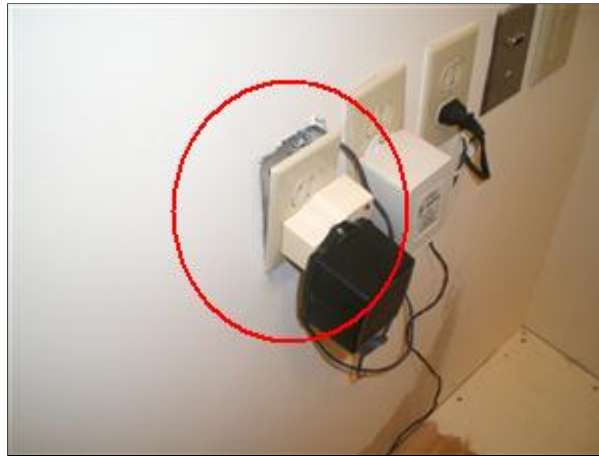
7.3 Picture 1

(1) There is an outlet in the data room that needs to be reattached.

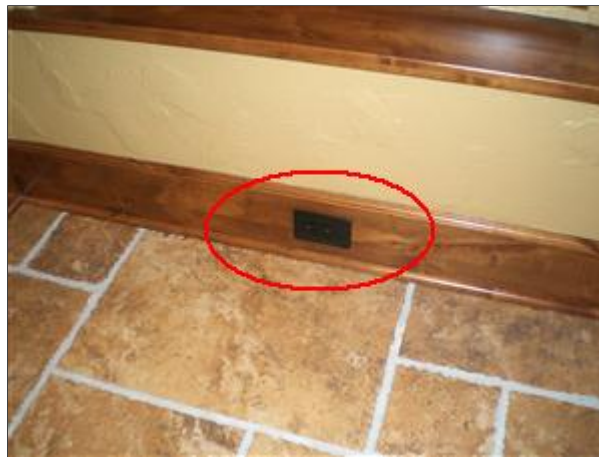
7.3 Picture 2

(2) There is an outlet by the bar in the basement that was not working at the time of the inspection.

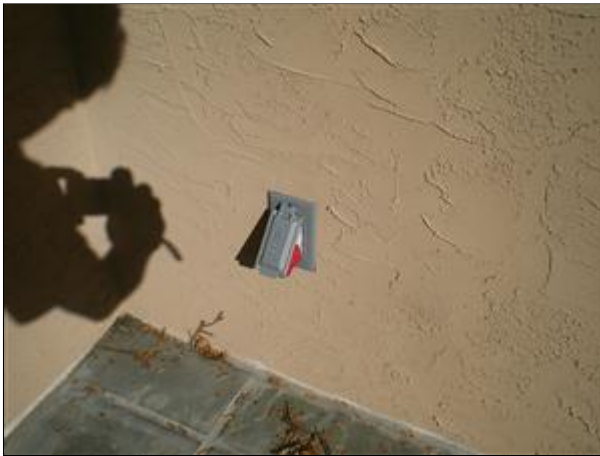
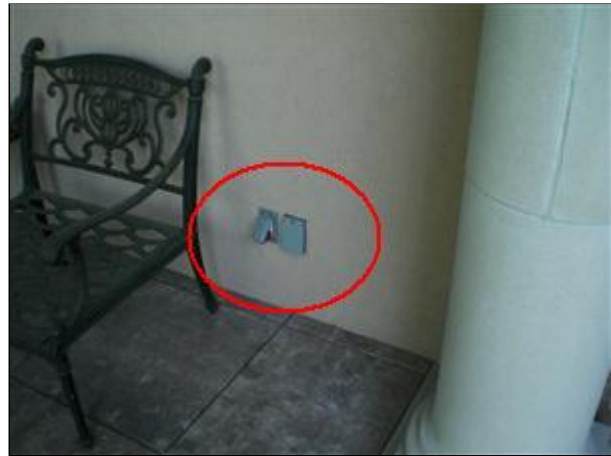
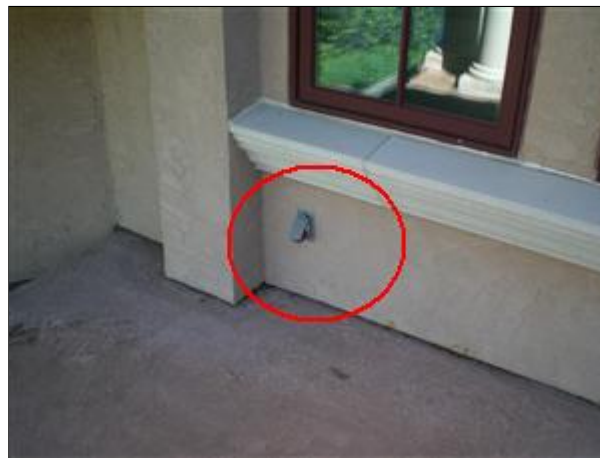
7.5 Picture 1 front door

There are several exterior GFCI outlets that are not working. Recommend qualified electrician service & correct.

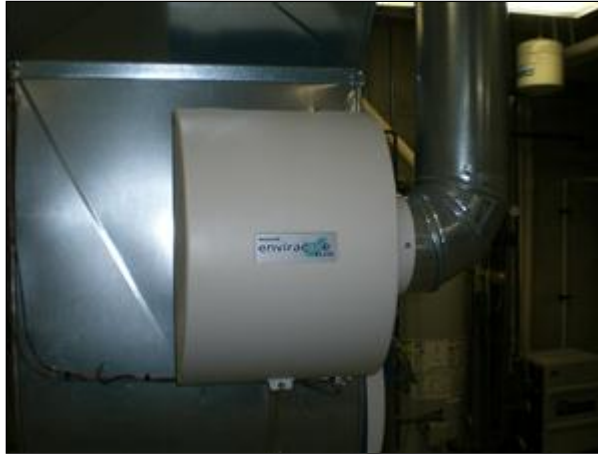
8.10 Picture 1

(1) ESI does not inspect humidification systems. Note that these systems need to be turned on in the winter and off in the summer. On & off is located at the unit. I suggest changing the filters.

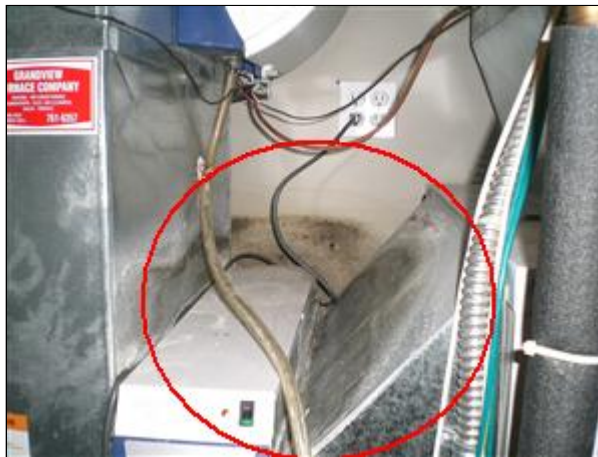
8.10 Picture 2

(2) There is mold / mildew like substance located in the mechanical room off the playroom in the basement. I can not determine the cause for the water leak for sure, but it looks like the humidifier might be clogged and backing up. I recommend a mold remediation contractor investigate further and make suggestions for abatement. Also recommend hv/ac contractor take a look at the surrounding equipment to determine the cause for the water leak.

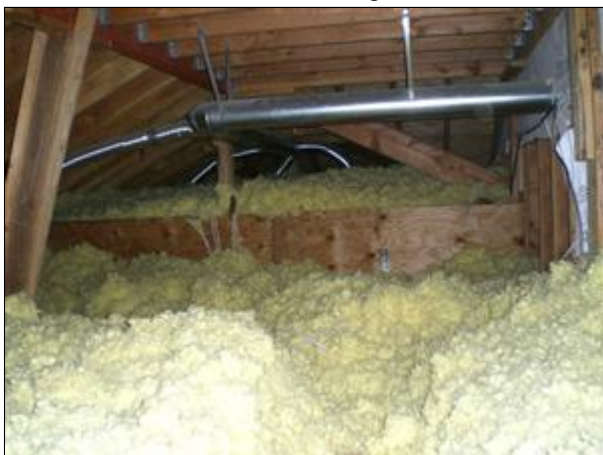
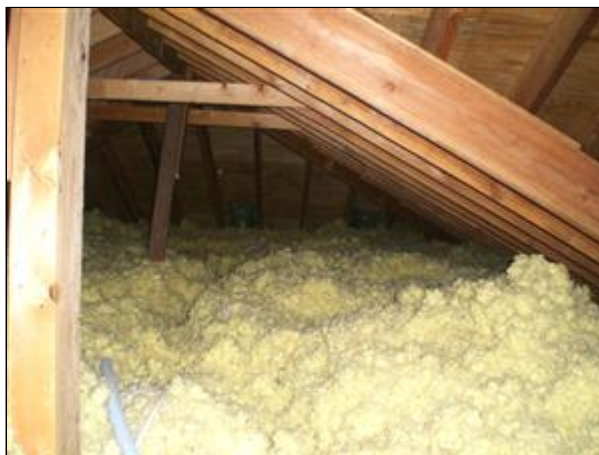
9.0 Picture 1

Attic is well insulated. Thickness averages about 14"
