Inspection Report

Townhouse
Lenexa KS 12345

ESI Property Inspection

Date: 6/15/2011	Time: 09:00 AM	Report ID: Townhouse
Property: Townhouse Lenexa KS 12345	Customer: Sample Customer 3	Real Estate Professional: World's Best Realtor

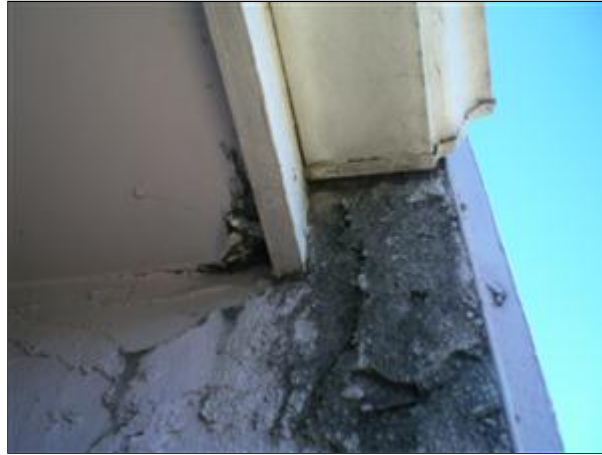
1.3 Picture 1

(1) Gutter at front of house is leaking and needs to be sealed. There is a mold like substance at this area that needs to be cleaned.

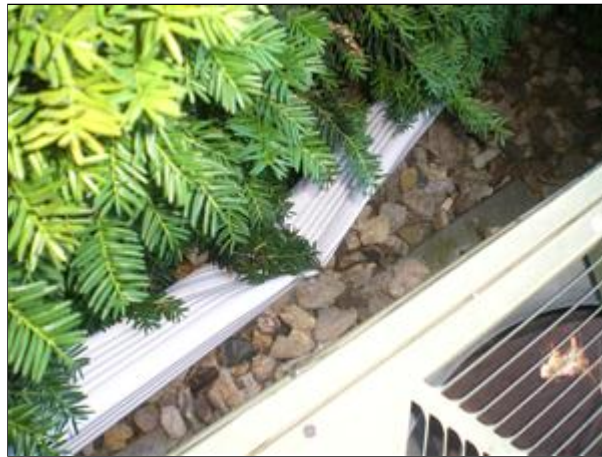
1.3 Picture 2

(2) Downspout at west side of house is damaged.

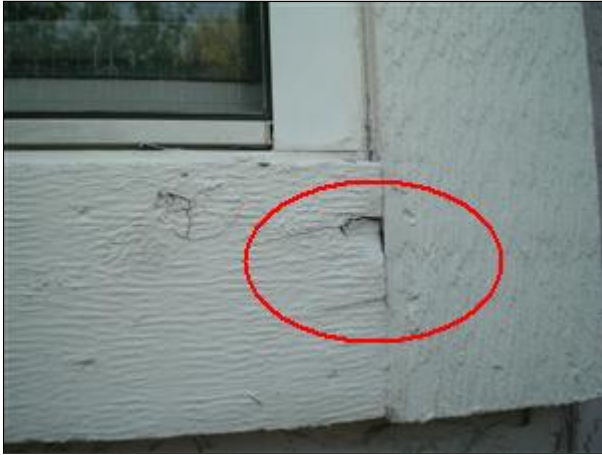
2.0 Picture 1 window at west side of house

(1) There is some deterioration / wood rot at some trim and at windows at the front of the house. Recommend trim above garage qualified contractor repair or replace as needed.

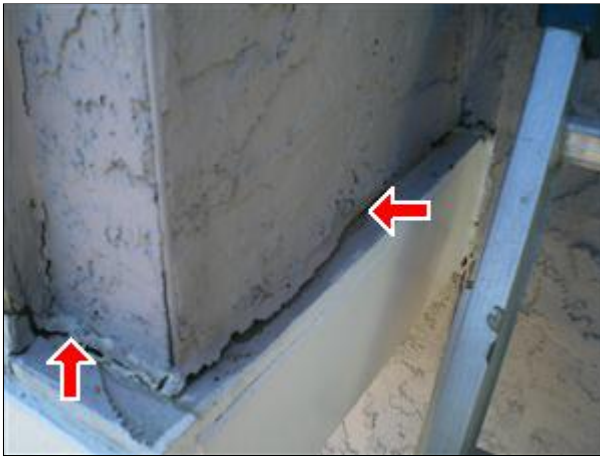
2.0 Picture 6 caulk

(2) There are several areas where gaps between the trim and stucco siding need to be caulked and sealed.

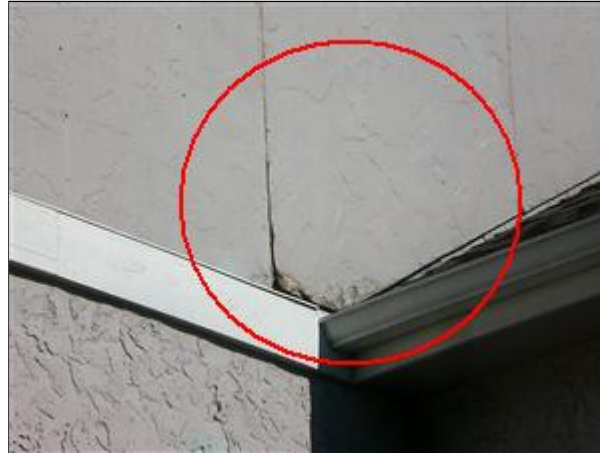
2.0 Picture 12

(4) There is a deteriorated section of trim on the east side of the house that needs to be repaired. Recommend qualified contractor repair or replace as needed.

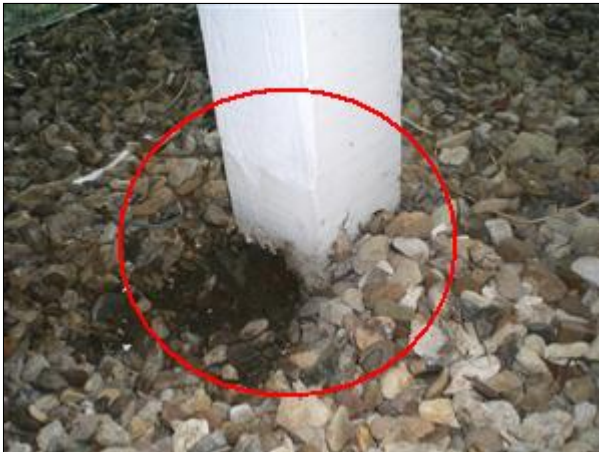
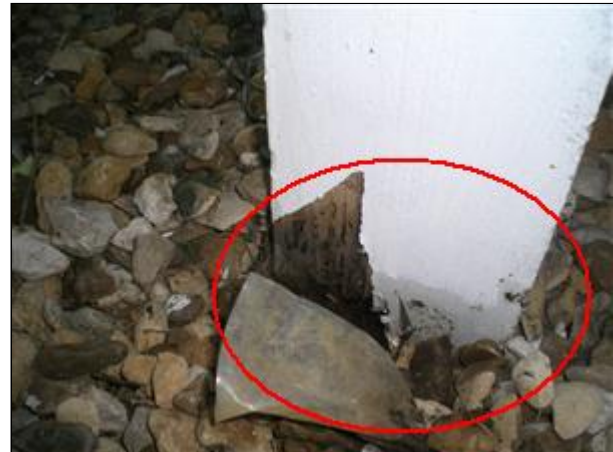
Gunter Pest Control found termite activity and damage at posts for stairs leading to front door. The bases of the posts are deteriorated to a point that they need to be replaced.

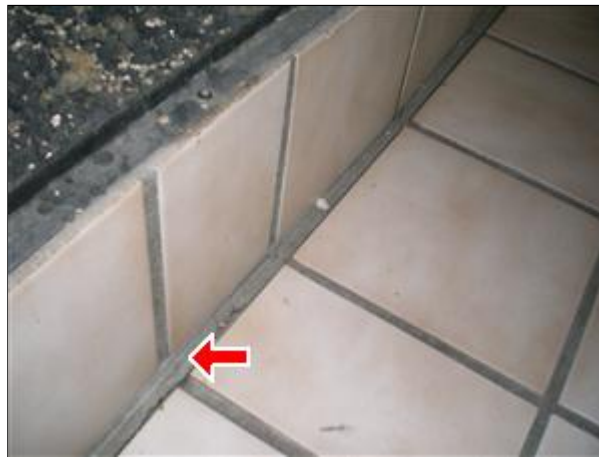
4.2 Picture 1

Grout in front of fireplace is damaged.

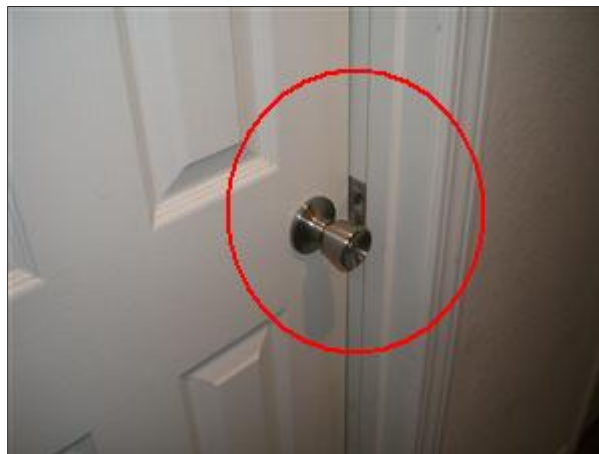
4.5 Picture 1

(1) Bathroom door in basement did not latch properly.

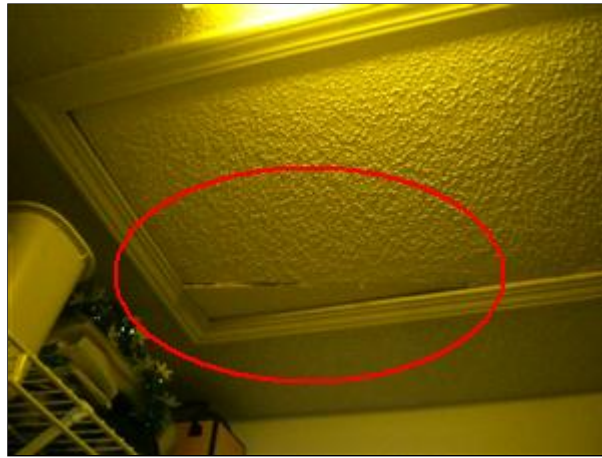
4.5 Picture 2

(2) Hatch to the attic was damaged and needs to be replaced.

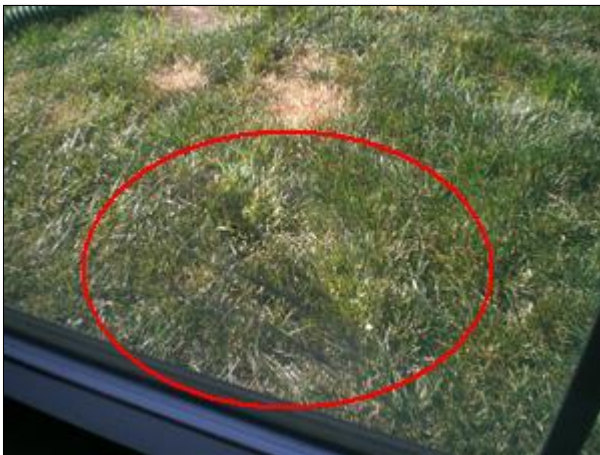
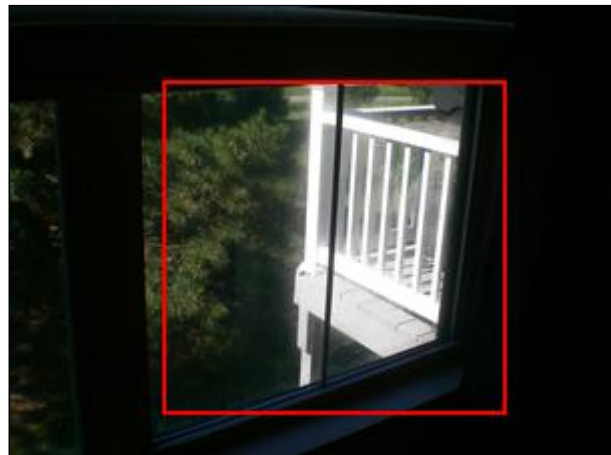
(1) There are several windows with damaged screens - noticed in dining room and basement office. The window in the dining room also has a damaged seal. The window is still operational but will not insulate as well as intended with a damaged seal.

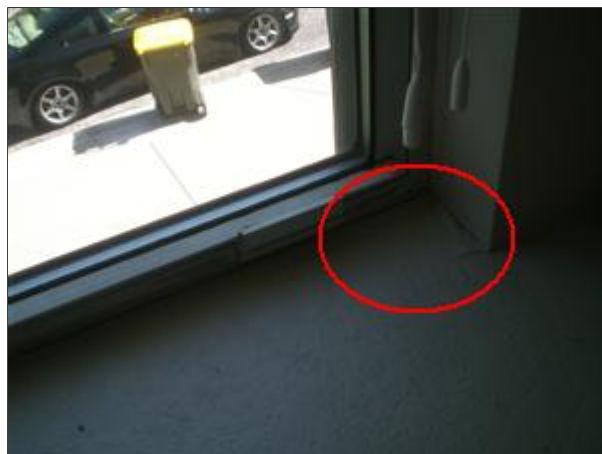
4.6 Picture 3

(2) There is some deterioration at the window in the master bedroom. Recommend qualified contractor repair as needed.

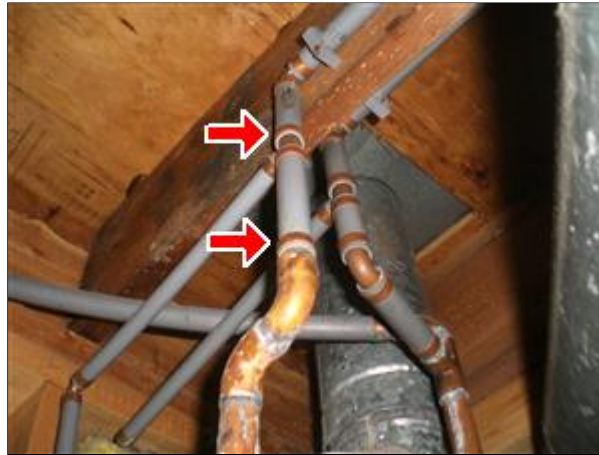
6.1 Picture 1

(1) Polybutylene plastic plumbing supply lines (PB) are installed in the subject house. Polybutylene has been used in this area for many years, but has had a higher than normal failure rate, and is no longer being widely used. Copper and Brass fittings used in later years have apparently reduced the failure rate. This subject house has copper fittings.

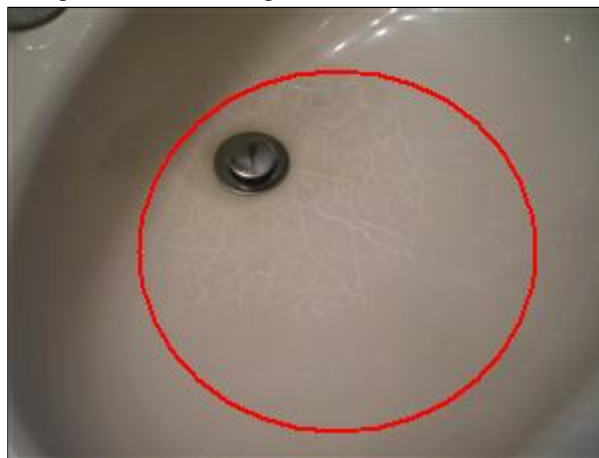
6.1 Picture 2

(2) There are several sinks that are starting to show some cracking at the time of the inspection. None were leaking at the inspection. Recommend monitoring for future leaking.

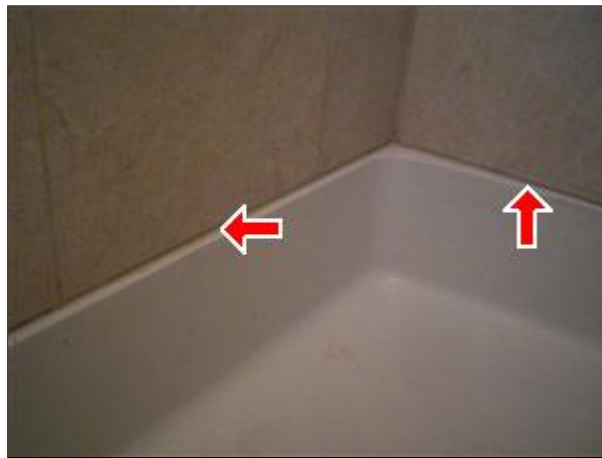
6.1 Picture 3

(3) Recommend caulking the bottom edge of the master bathroom shower.

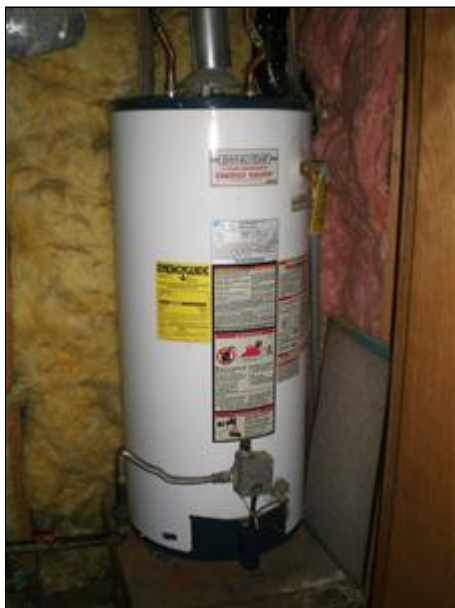
6.2 Picture 1

Hot water heater was operational at time of inspection. Manufactured in 2001. The hot water heater was missing the temperature adjustment dial.

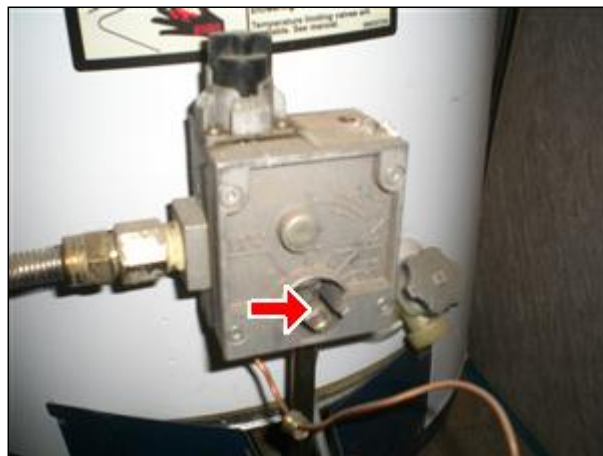
6.2 Picture 2 missing adjustment dial

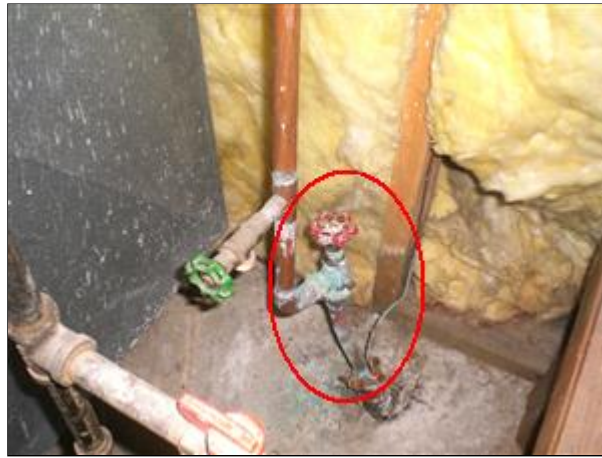
6.3 Picture 1

Main water shut off is located in the garage in the mechanical closet.

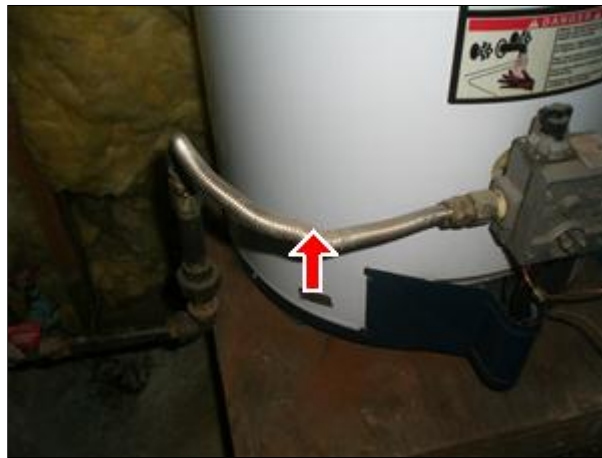
Flexible gas line servicing water heater is not up to modern safety standards. A flexible gas line may be used in this application but it must be vinyl coated.

6.4 Picture 1 replace

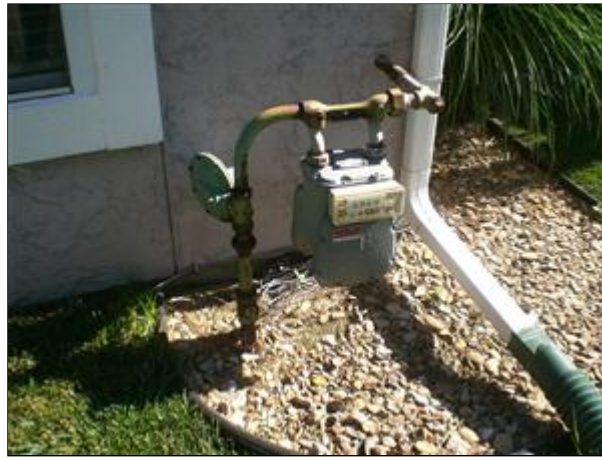
6.5 Picture 1

The main fuel shut off is at gas meter outside

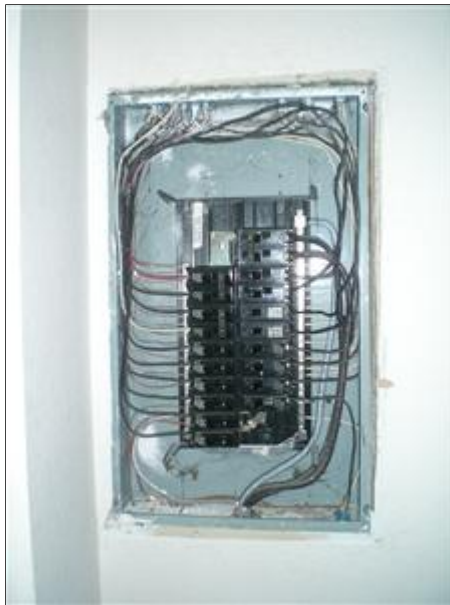
7.1 Picture 1

Main electrical in located in the basement on the east wall.

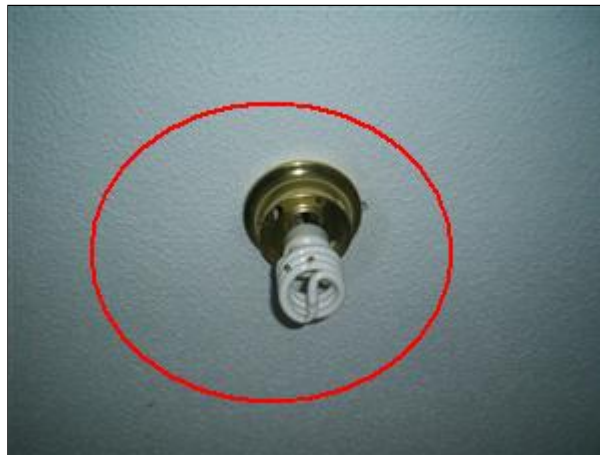
7.3 Picture 1

(1) By modern standards, exposed bulbs in closets are considered a safety hazard and should be replaced with an enclosed fixture. Several of the closets in this house have exposed bulb fixtures.

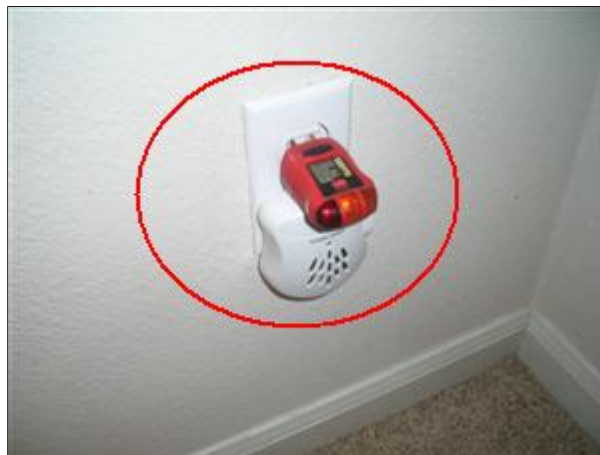
7.3 Picture 2

(2) There are several outlets that have the hot and neutral reversed. One is located on the east wall in the dining room, one in the north west bedroom on the east wall. Recommend qualified electrician service as needed.

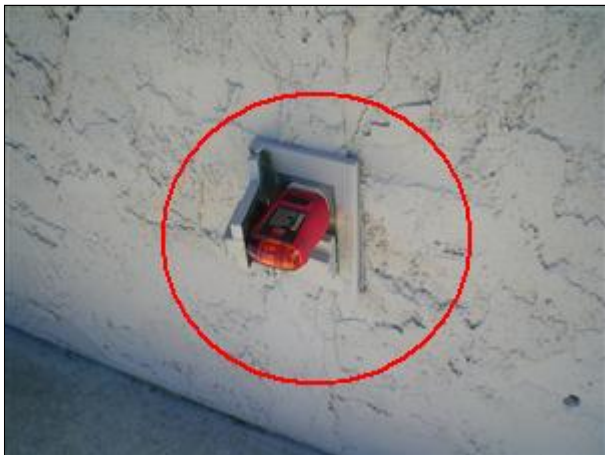
Outlets outside house need to be a GFCI protected outlet to comply with modern safety standards. Recommend qualified electrician perform all electrical repairs.

7.4 Picture 1 front of house outlet

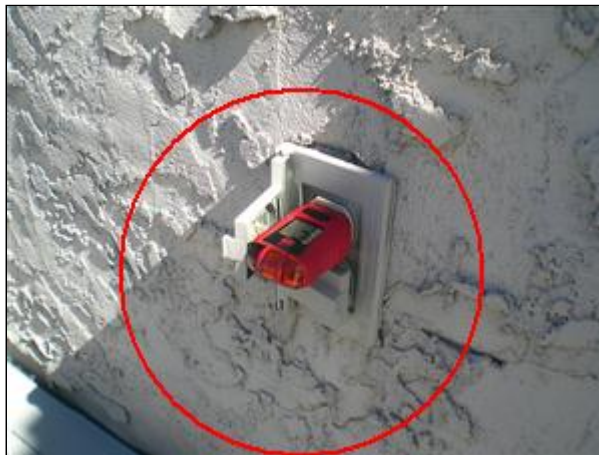
7.4 Picture 2 back of house outlet

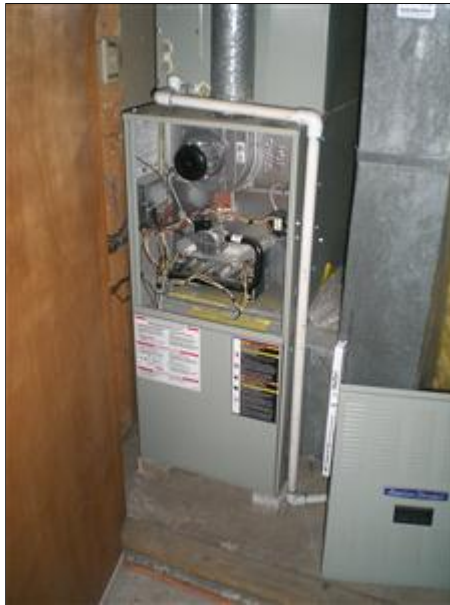
8.0 Picture 1

Furnace was operational at the time of the inspection. Manufactured in 2006.

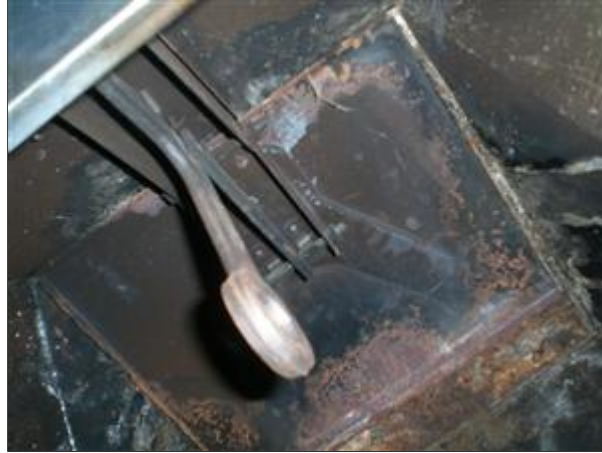
8.6 Picture 1

Gas logs must only be operated with the vent open. I recommend adding a vent clamp to make sure vent is always open to avoid accidentally operating gas logs without opening vent.

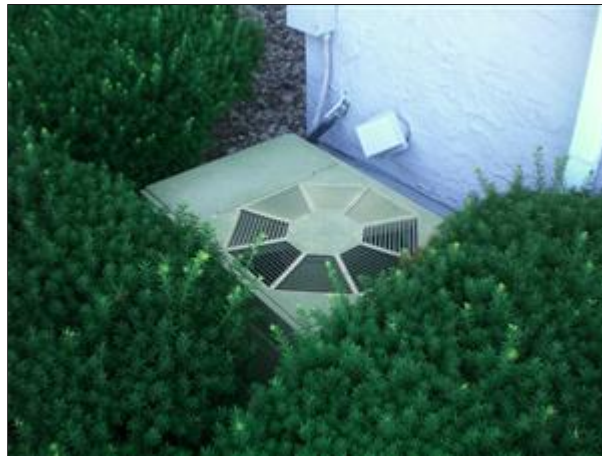
8.7 Picture 1

(1) The ambient air test was performed by using thermometers on the air handler of Air conditioner to determine if the difference in temperatures at the supply and return air are between 14 degrees and 22 degrees (the greater the difference, the better) which indicates that the unit is cooling as intended. The supply air temperature on your system was 58 degrees, and the return air temperature was 76 degrees. This indicates the range in temperature drop is normal. Unit was manufactured in 1988.

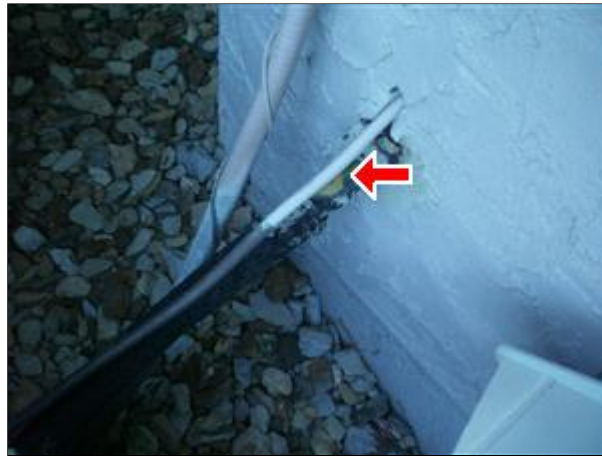
8.7 Picture 2

(2) Insulating foam at outside AC lines needs to be replaced

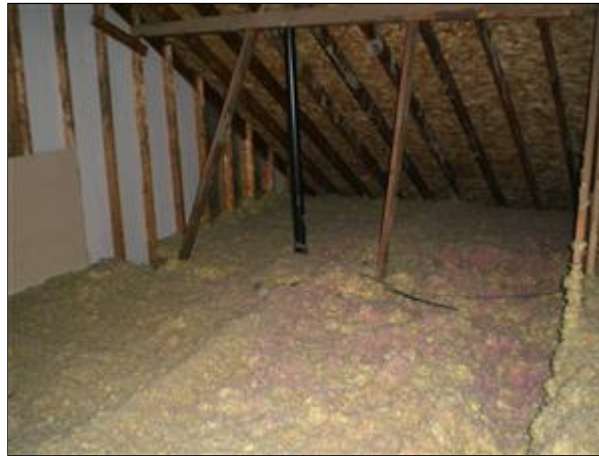
9.0 Picture 1

Attic is well insulated - there is an average of about 12" of insulation.
