PHILIPS ARENA

Atlanta, Georgia

CASE STUDY

SALVAGING PROBLEMATIC SEATING PLATFORMS

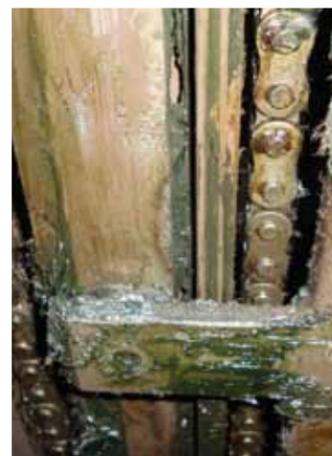
MSL Components

The chain-driven portion of the Multiple Site Line system causing issues in the upright frame columns also incorporates limit switches for the upper and lower deck positions that turn off the drive system when the decks reach the proper position.

Many of these limit switches were not properly set and adjusted, and consequently the decks were not locking into place. Under these conditions, an improperly engaged deck in the upper position could break free and drop down when loaded.

To fix the problem, all of the frames were disassembled. Each component was cleaned and inspected. Damaged parts were repaired or replaced, and the frames were then reassembled to the original specifications. After all the necessary reinforcements to the upright frames were complete to solve the issues in that area, the limit switches were reset to ensure that all decks would stop in the correct position and lock into place.

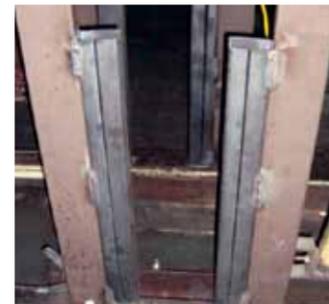
Upright Tubes

The MSL design does not have an interlock at the top of the frames, causing a lot of "sway" at the top of the frames during operation. Over time this stress on the upright frames had caused the steel to lose its original shape and positioning, resulting in binding during operation.

A custom designed hydraulic ram jack was used to re-align casterhorns and the upright frame columns back to square. Once the frames were in the proper position, steel tubing was welded into place to hold the frames square. Adding this steel tubing at the base of the frames alleviated much of the "sway" during operation. The reduction in sway provides a safer platform, improves operational efficiency, and extends the life of the system.

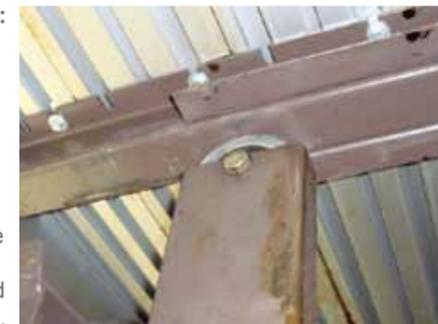
Upper Guide Wheel Before

The MSL system raises and lowers the decks via a chain drive system inside the frame columns. With this design, no connection exists between the frames at the top where the decks connect. This also contributed to the problem of "sway" during opening, closing, raising, and lowering on the higher tiers of the frame column. The result was binding during operation and the inability to get the units to align properly when they were fully open or closed.

Steel channel was welded to the upper ends of the frame columns to strengthen this area and deliver greatly improved operation. In addition, all rolling wheels at the cantilever arm were inspected and repaired or replaced as needed. This reduced friction and allowed the frames to track better during opening and closing operations.

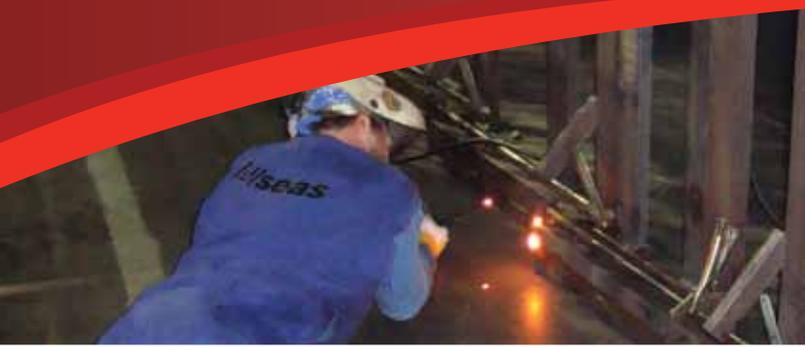
Replacing a track bearing on the casterhorn

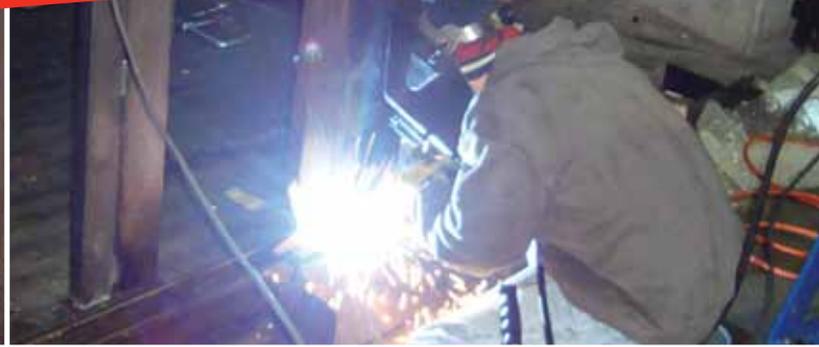
Welding to square the frame upright and casterhorn
