White Pine Tree Assessment

Prepared for:
Mrs. Lois Lane
60 Wehee Ln.
Gotham, NY

Prepared by:
Howard Gaffin
MCA #1468
BCMA # NE-0363B
RCA #458

August 13, 2012

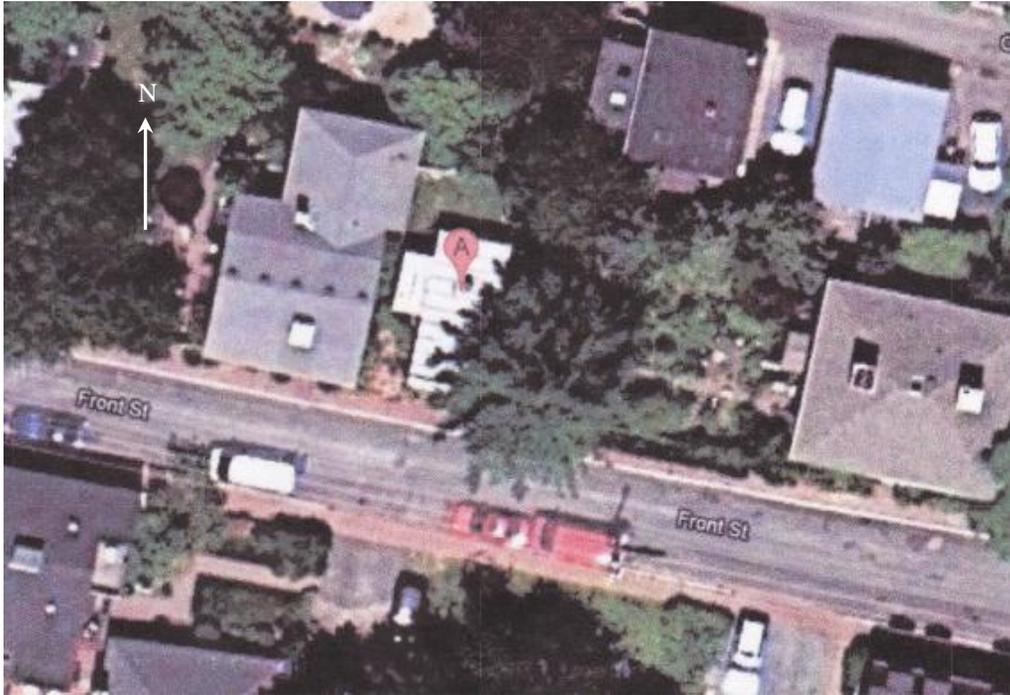
Site Map

The subject house is indicated by the 'A' symbol. The white pine to the right of the house has a major influence on the house and property.
