H. Gaffin  
*Consulting Arborist*

## Hemlock Hedge Appraisal

Prepared for:  
Mr. Jack Shea  
221 Conant Road  
Hooterville, MA

Sept. 27, 2011

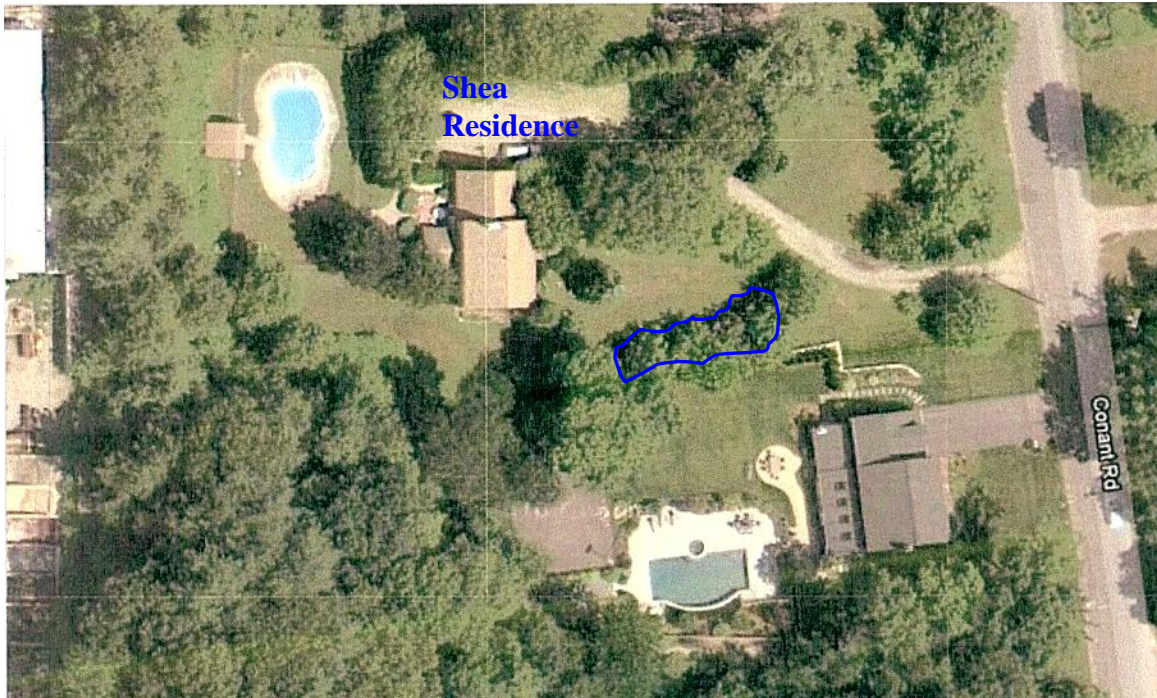
## Site Map

*An overhead view of the Shea residence and the neighboring property. The hemlock trees in question are circled in blue (Image from Google Maps)*
