City Hall Park Tree Assessment

Prepared for:
Tree Guy
Green Park
Treetown, MA

Prepared by:
Howard Gaffin
MCA #1468
BCMA # NE-0363B
RCA #458

May 14, 2018

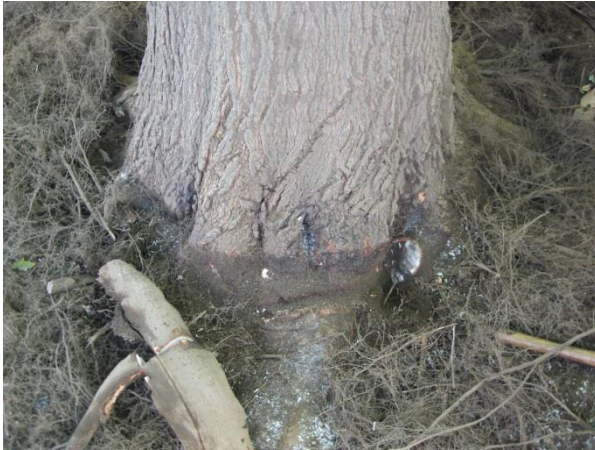
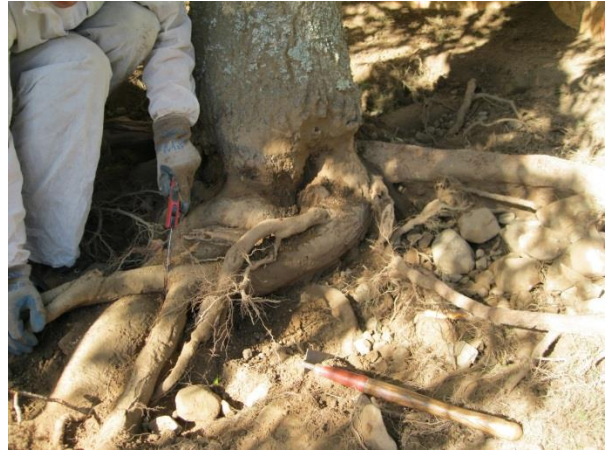
Above: Removal of a girdling root (left image) and a root girdling root.

- A qualified arborist (State, ISA, or TCIA certified) shall be present during any excavation activities.
- Perform a root crown excavation using hand tools and an air spade.
- Determine if and where any girdling roots or root-girdling roots may be cut.
- Cuts shall be made with a sharp, medium to fine toothed saw, lopping shears, or sharp chisel
- Loosen compacted soil within the designated Tree Protection Zone with an air-spade. Soil should be moistened before air-spading operations
- Incorporate compost material into the area of loosened topsoil.
- Cover area with a 3-4" layer of mulch, preferably wood chips.
- Create a tree protection zone a **minimum** of 1 foot for every inch of tree diameter.
- Monitor for soil moisture and supply water as needed.

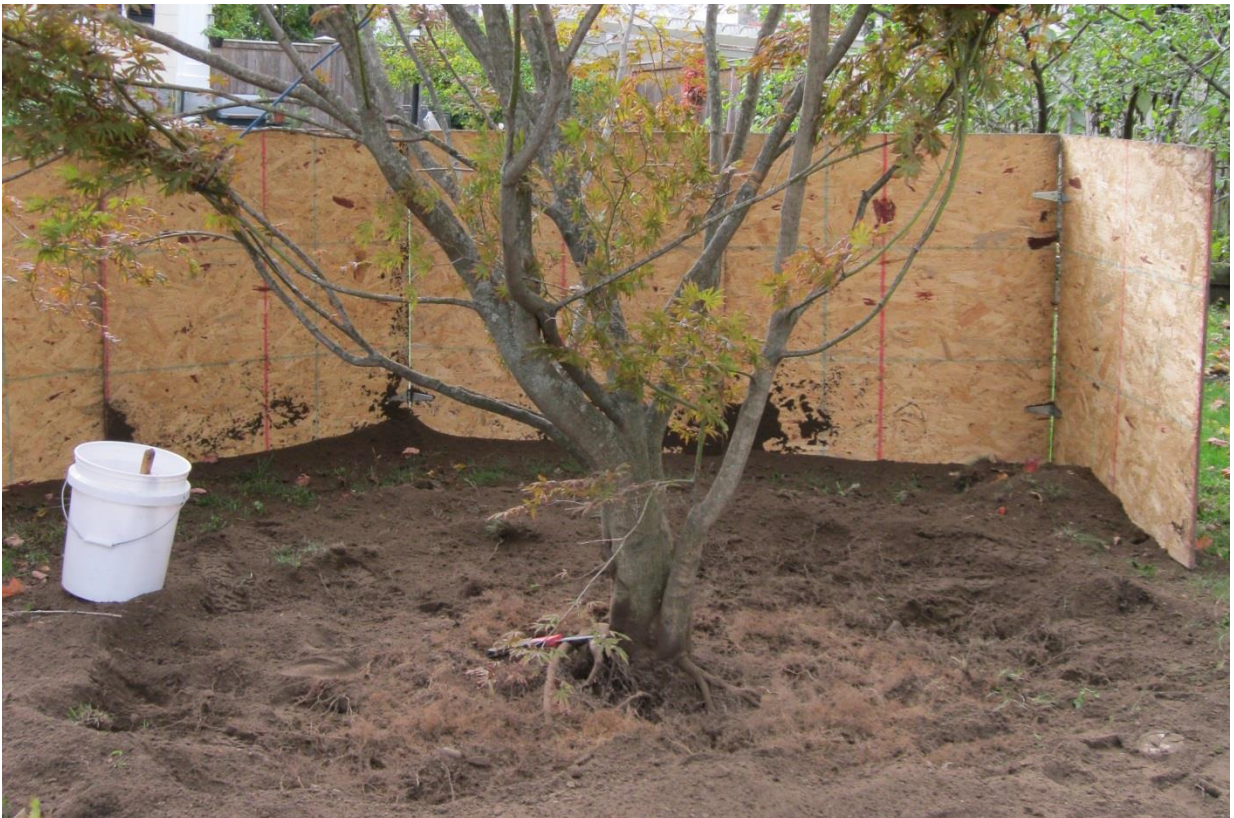
Red maple roots exposed after de-compaction with an air-spade.
