SUBJECT: FERMI UNIT 2 – PETITION PURSUANT TO 10 CFR § 2.206 SEEKING DEMANDS FOR INFORMATION (***EXPEDITED RELIEF REQUESTED***)

Requested Action No. 1: Formal Risk Assessment of Torus Coating Conditions

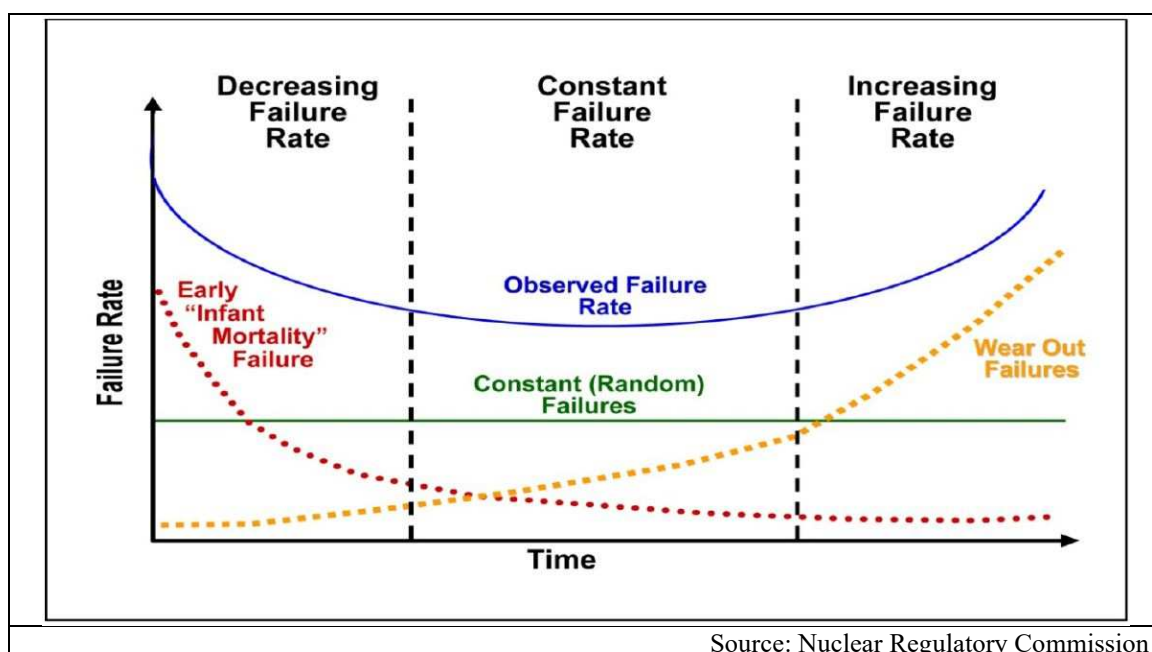
2. The qualified coating to be applied below the torus waterline is stated to be capable of withstanding design basis accident conditions. Some of the older, unqualified coating will remain in the torus above its waterline. This situation involves both ends of the “bathtub curve” of failure rate versus time:

The older, unqualified coating above the torus waterline are heading towards, if not already within, the Increasing Failure Rate region on the right. The newly applied qualified coatings below the torus waterline are solidly within the Early “Infant Mortality” Failure¹ region on the left. Right or left, the chances of the coating failure are elevated (i.e., not zero.)
