# Thoughts From The Top: TPO

## What Are You Really Getting?

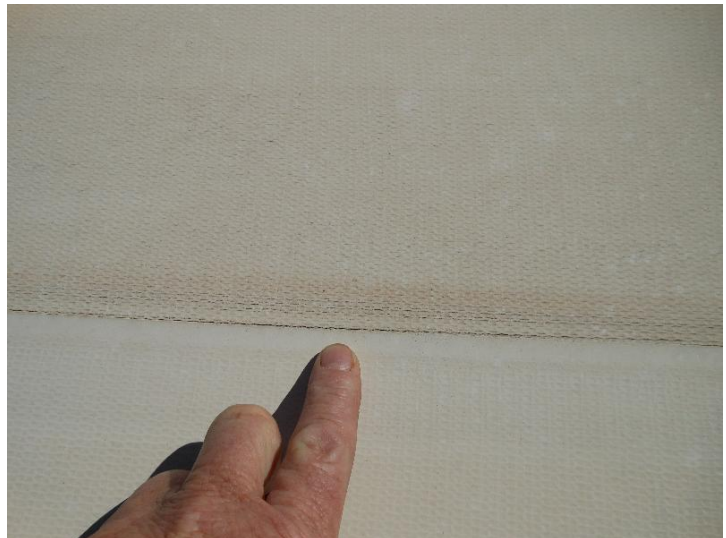
The top layer of polymer on this TPO roof has broken down to the point where the scrim is clearly visible to the unaided eye.

Research and history have shown that UV rays have a dramatic effect on the deterioration of all roofing systems, especially the top layers of TPO membranes. As soon as the top polymer degrades down to the scrim, the entire roofing system will begin to fail. Typically, the polymer above the scrim breaks down at a rate of 1 - 2 mils every year with some variance depending on the region it is installed. As a result, a 45-mil TPO membrane will last only twelve years on average, while an 80-mil TPO roof may last over thirty years if properly designed and maintained. Unlike other membranes on the market, TPO provides a small percentage of actual weather protection. As a relatively young product, there is limited research into the historical performance of TPO, and TPO has no standard specification. It can be a good membrane, if you have limited foot traffic, few penetrations and when short-term cost considerations take precedence over long-term performance. There are plenty of other membranes and roofing systems that outperform TPO, but are less popular due to being both more difficult to install and more expensive.
